MAPLEWOOD HOUSE

3701 Ponderosa St.

BUILDING SURVEY, July 2015

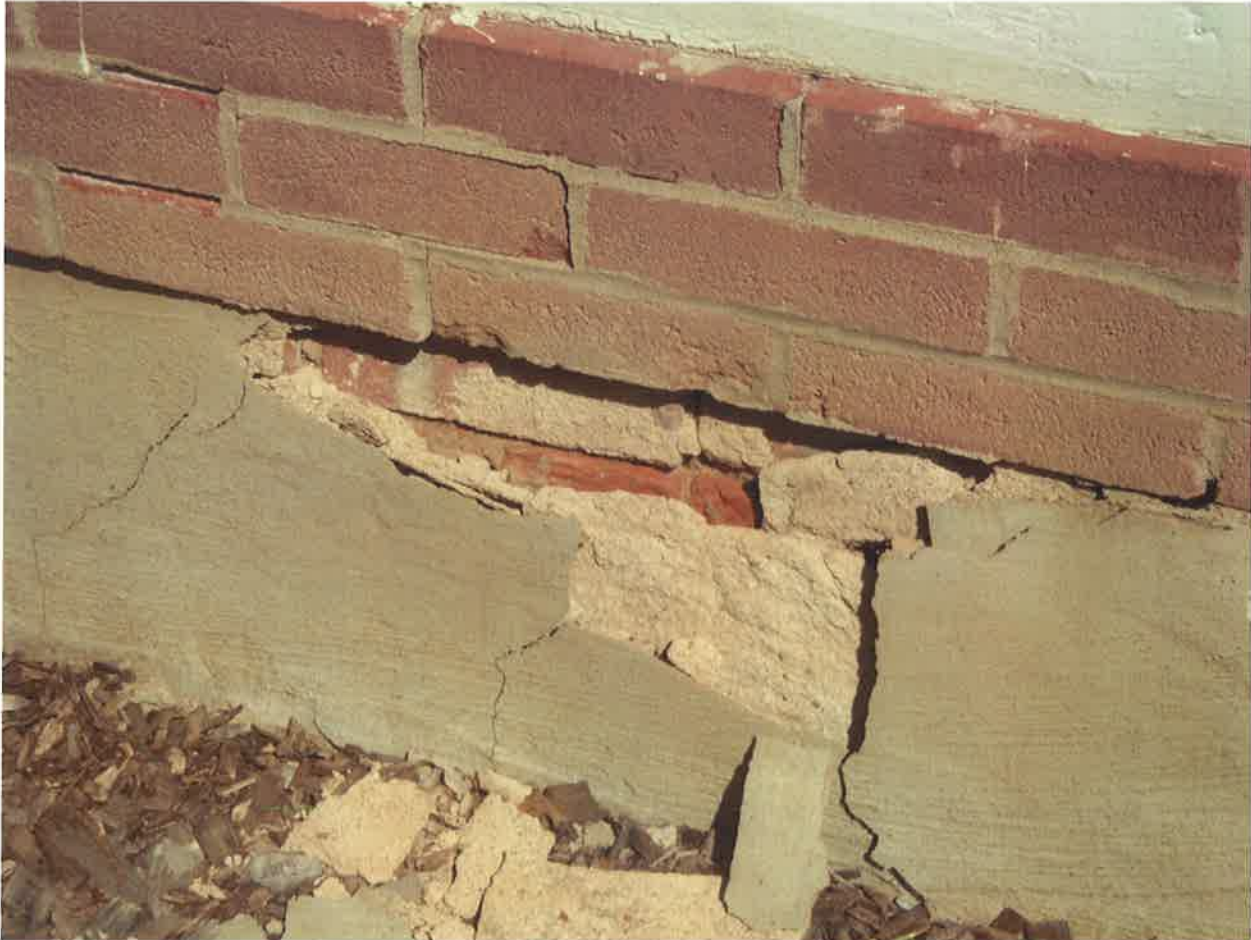
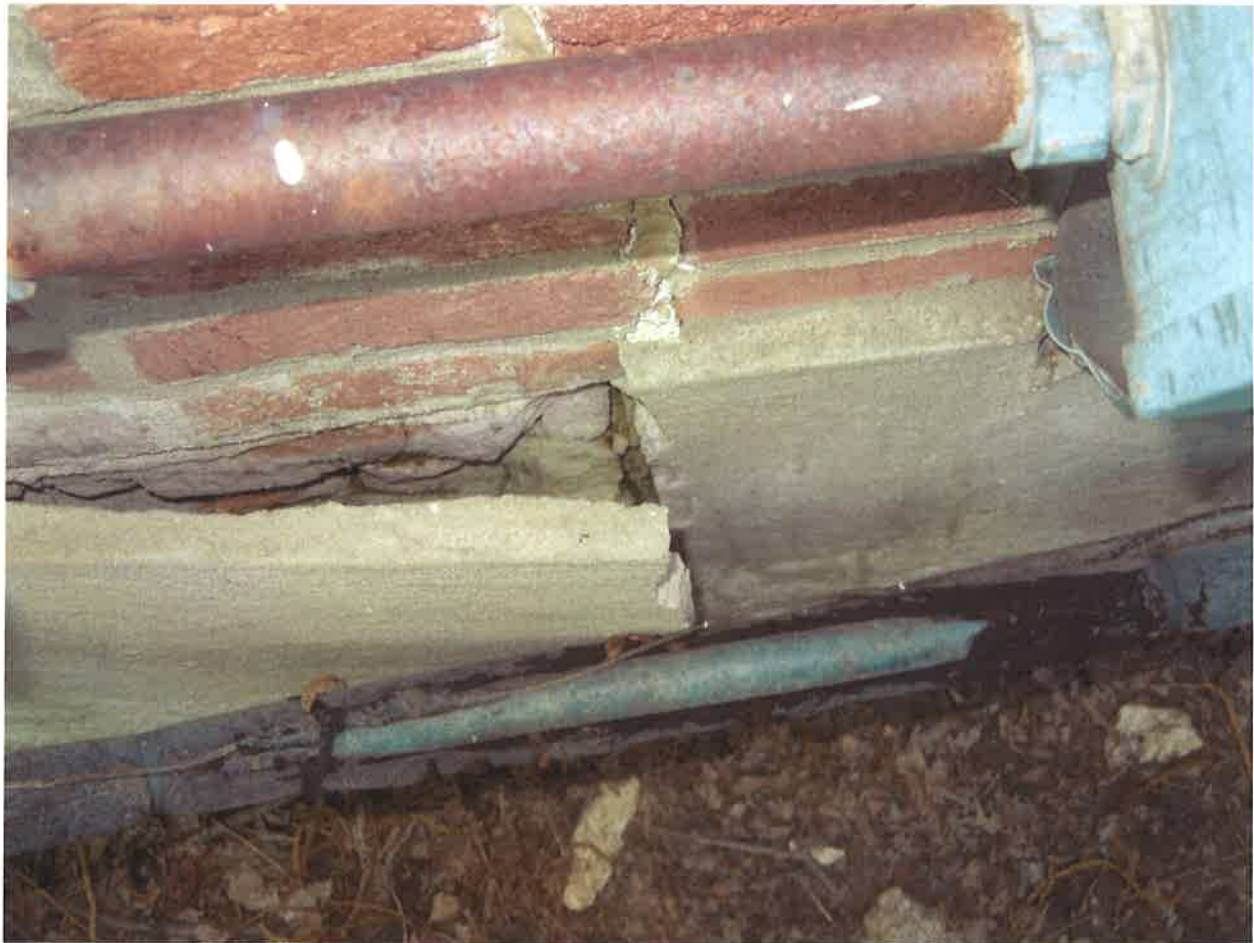
Foundation Parging

The building sits on a brick foundation which appears to be the same brick the above grade exterior walls are constructed. A parge coat of mortar covers the foundation brick. The parging extends below grade and I assume terminates at the foundation footing. The above grade foundation parging is damaged / deteriorated in several locations. Due to the weathering effect of the soil and moisture, and the likely movement of the foundation it is credible the below grade parging is in poorer condition explaining basement ground water infiltration and excessive crawl space moisture.

It is my experience the most effective method for waterproofing / damp-proofing a foundation is done on the exterior. The process begins by excavating along the wall, all the way down to the footings. Dirt, loose mortar, brick dust and parging are removed from the foundation wall and a "parge" coat of mortar is applied over the entire wall that provides a more uniform and above grade decorative surface.

Once the parge coat has cured, an exterior waterproofing membrane consisting of asphalt-modified polyurethane is applied to the below grade wall. Next install a foundation drain tile system with a sump pump. The excavated trench is filled to within two feet of the final grade with a granular backfill such as 1" clean rock. The remaining portion of the ditch is backfilled with clean soil and graded causing positive surface water drainage away from the foundation.

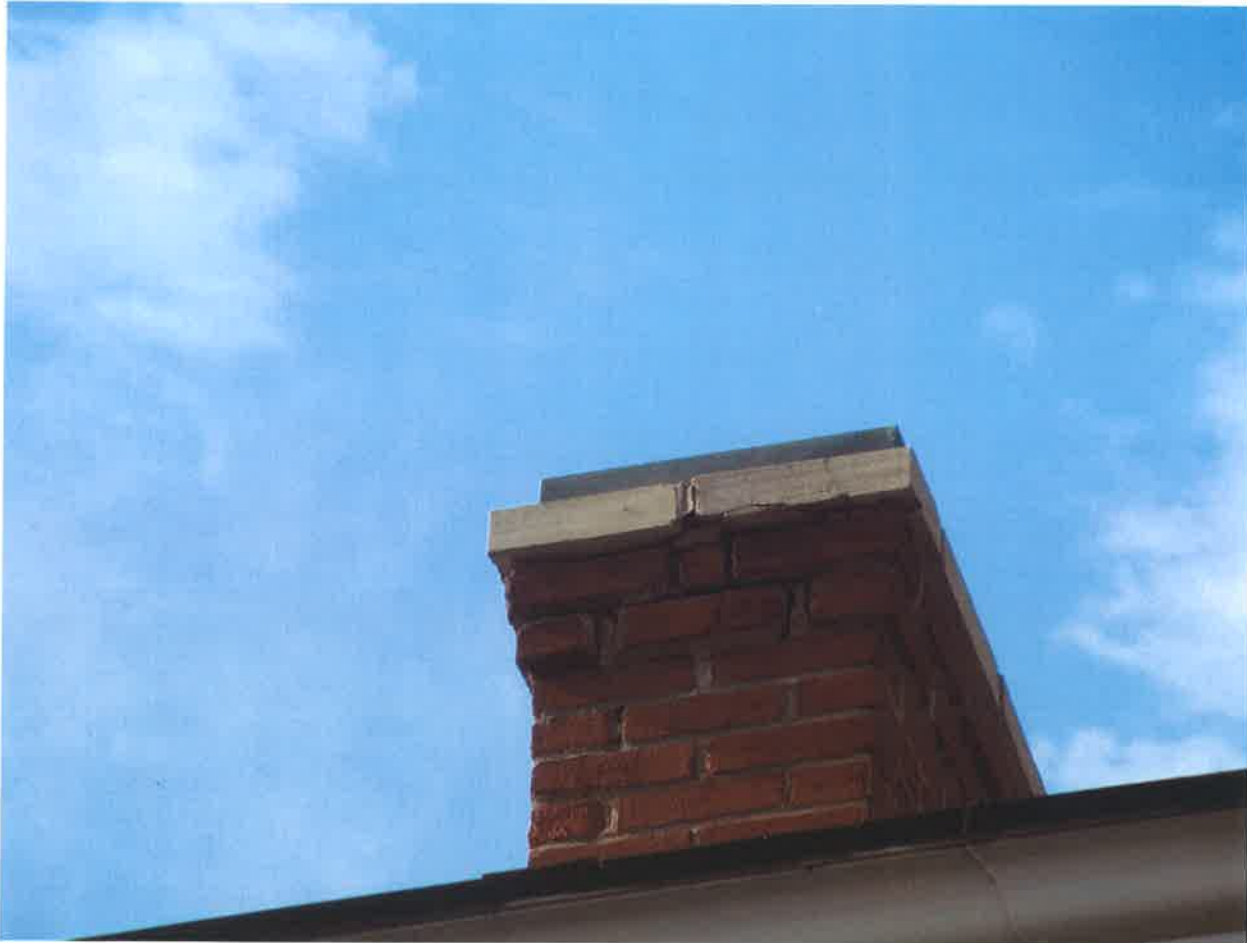
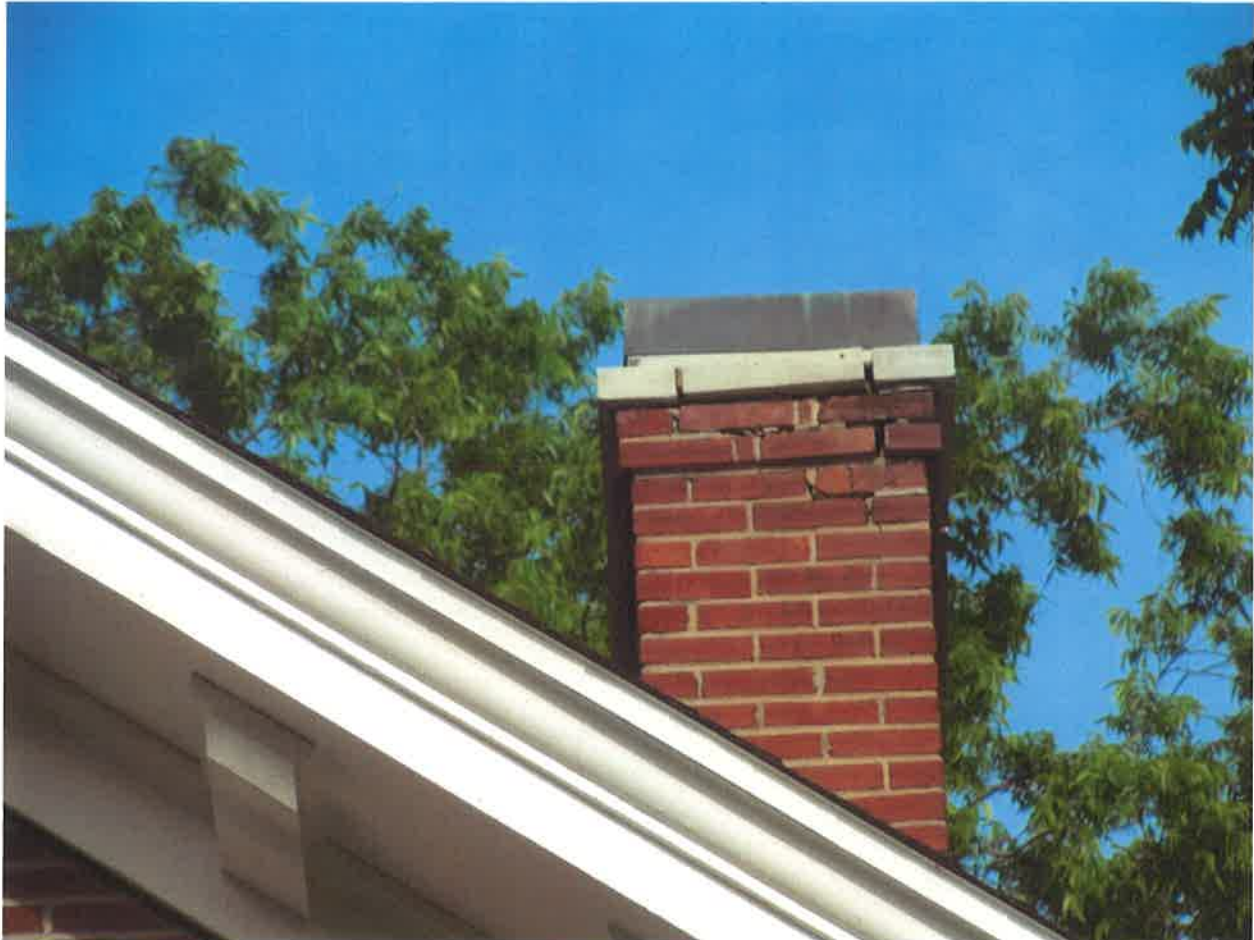
Brick Chimney

There are four brick chimneys, three are nonfunctional, one is used as a metalbestos furnace flu chase. All four brick chimneys need repointing, and portions of three chimneys needed to be rebuilt above the roof line. All sheet metal chimney caps are not properly secured and sealed.

As a general rule conditions which require repointing include: (1) mortar erosion equal to or greater than one quarter (1/4) inch (2) crumbling mortar, (3) hairline cracks in the mortar, and (4) cracks between the brick and mortar. As shown in the attached photos (BrickChimney1-7) portions of the Maplewood House chimneys' mortar deterioration exceeds the above guidelines warranting a partial rebuild.

The occasional repair of the mortar joints is expected over the life of the brick masonry. Unfortunately the occasional repair of the brick chimneys' mortar joints has not occurred. That is why portions of the chimneys are deteriorated to the point warranting a partial rebuild.

An imperative reason for repointing brick masonry is to improve water penetration resistance and maintain structural integrity. Repointing mortar joints is one of the most effective and permanent ways of decreasing water entry into brickwork. This is because the most common means of water entry into brick masonry is through deboned, cracked or deteriorated mortar joints.

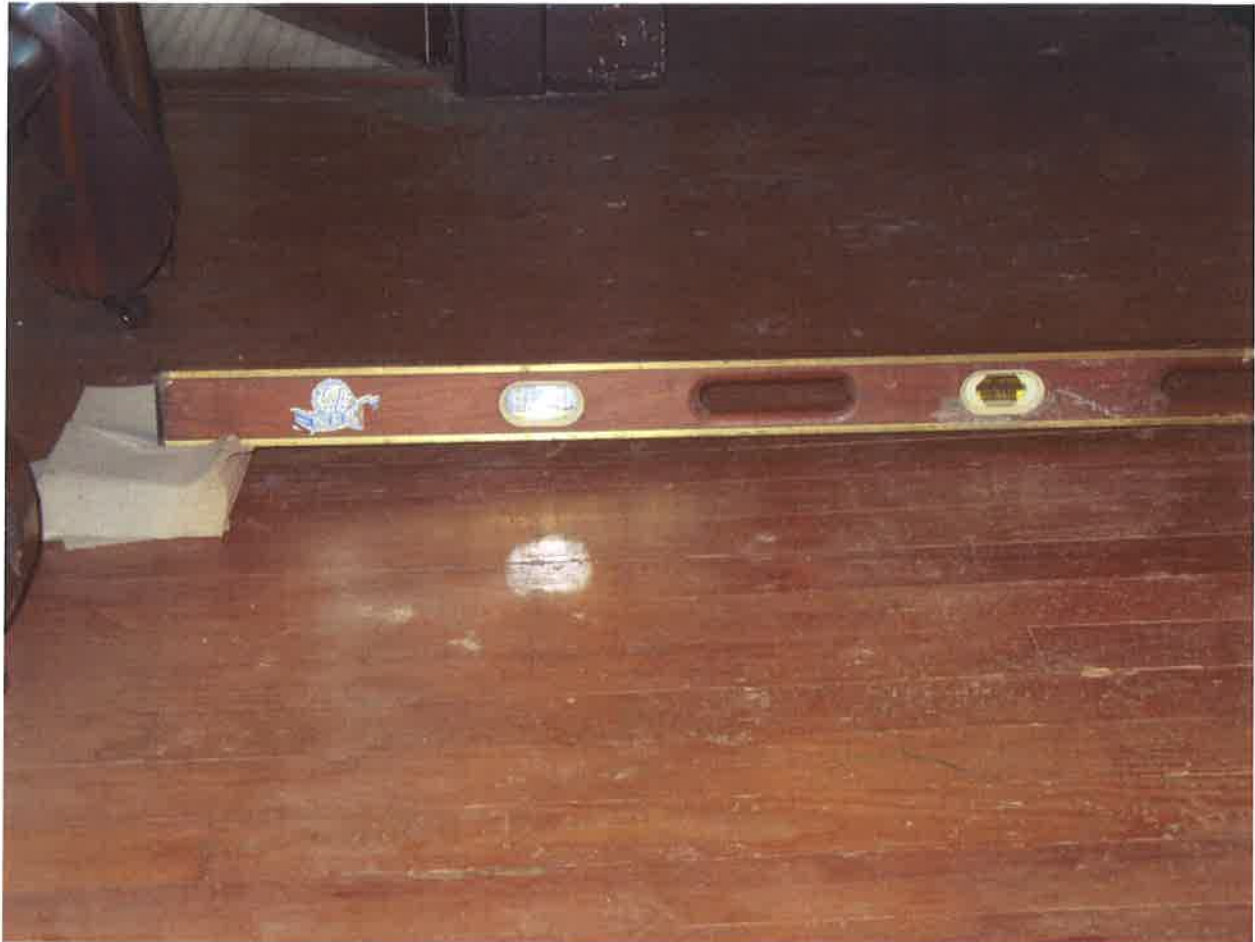
Unlevel Floor

The down stair bathroom, the adjoining utility room and the adjoining hall way floor assemblies have failed. These floors are out of level three quarters of an inch (3/4") in three (3) feet meaning a 2% slope. The down stair bathtub is falling through the subflooring. These conditions are due to improperly support floor joists and beams, rotting/damaged floor joists and rotting subflooring. Defective conditions include improper bearing and support, termite damage and dry/wood rot due to excessive moisture.

The observed structural deficiencies are limited to the kitchen, the adjacent hallway, first floor bathroom and the utility room floor assemblies (beams, beam supports, floor joist and subflooring). The majority of this area is above a crawl space which I was unable enter. My assessment is based upon visual observations from the basement, an access opening in the basement to the adjoining crawl space and the finished spaces above. Though I did not inspect every framing member for material damage, fatigue, bending, bearing, etc., I did note conditions such as floor slope and specific deficiencies such as wood decay and improper support to warrant my recommending a compressive structural analysis of these areas and subsequent repairs.

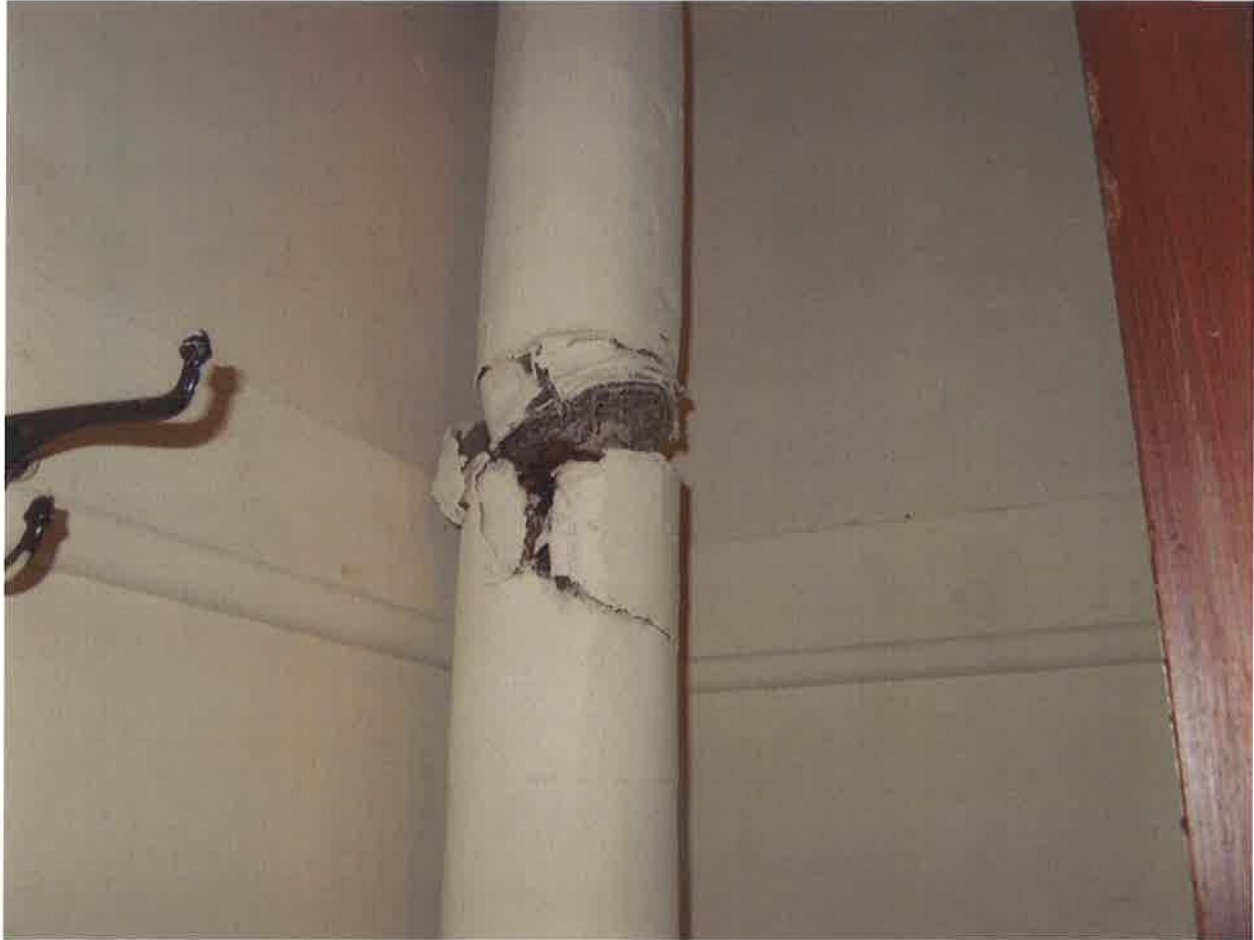
Asbestos

There is evidence the Maplewood house was heated by a steam boiler, supply and return piping and radiators. I am unable to determine when that heating system was installed or removed. There is a remaining supply circulation line in a closet located in what I call the living room. This room is located on front southeast corner of the structure. This line is wrapped with what I believe to be asbestos insulation. I believe the material is asbestos based upon its appearance and the common use of asbestos insulation for many decades.

Due to its age and appearance it is prudent the abandoned insulated boiler piping be tested for asbestos and abated based upon the reports finding. The City has a Term and Supply Contract with ARSI for asbestos testing and abatement. Due to the nature of this possible hazard I recommend the City go forward with the testing and possible abatement of this material as soon as possible.

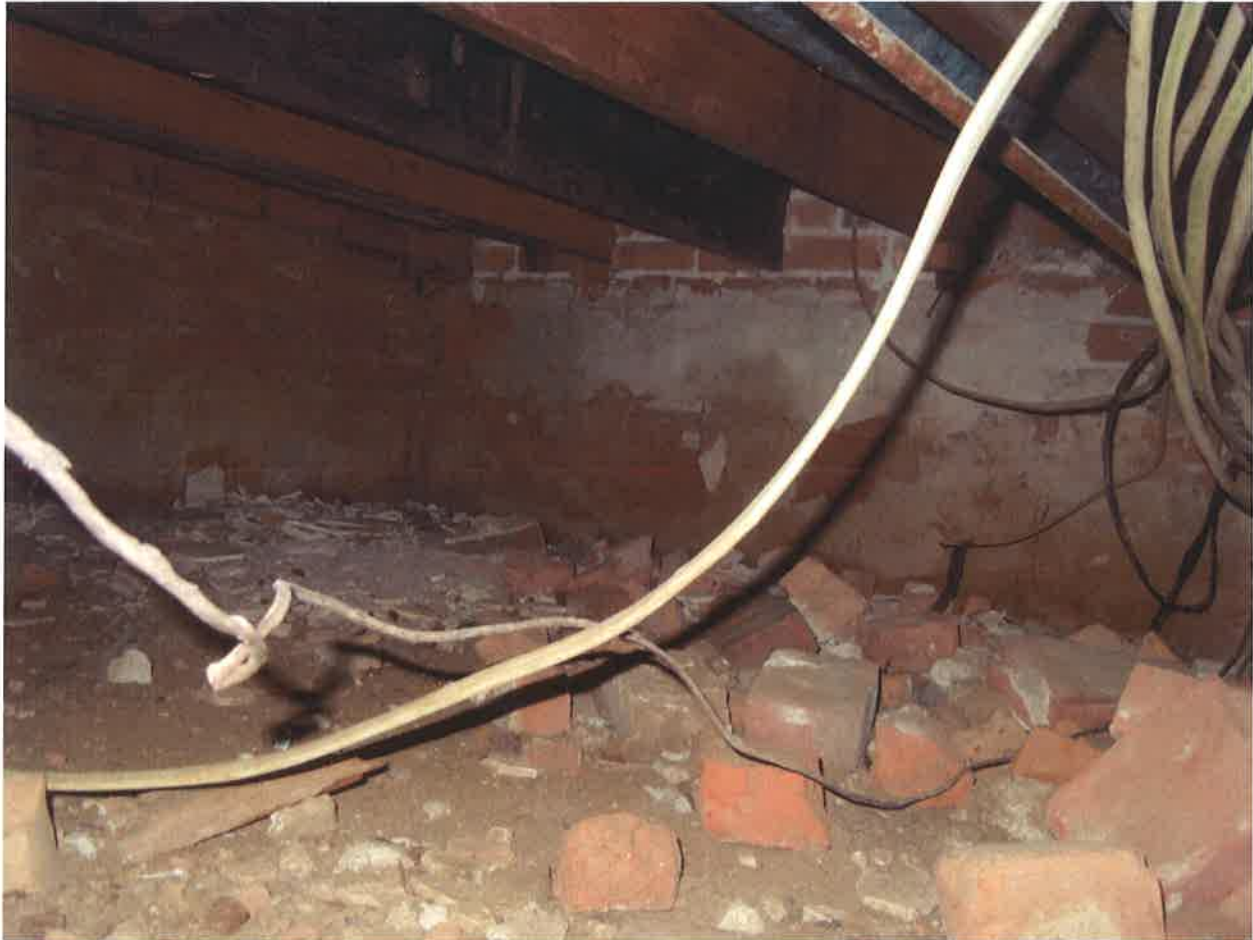
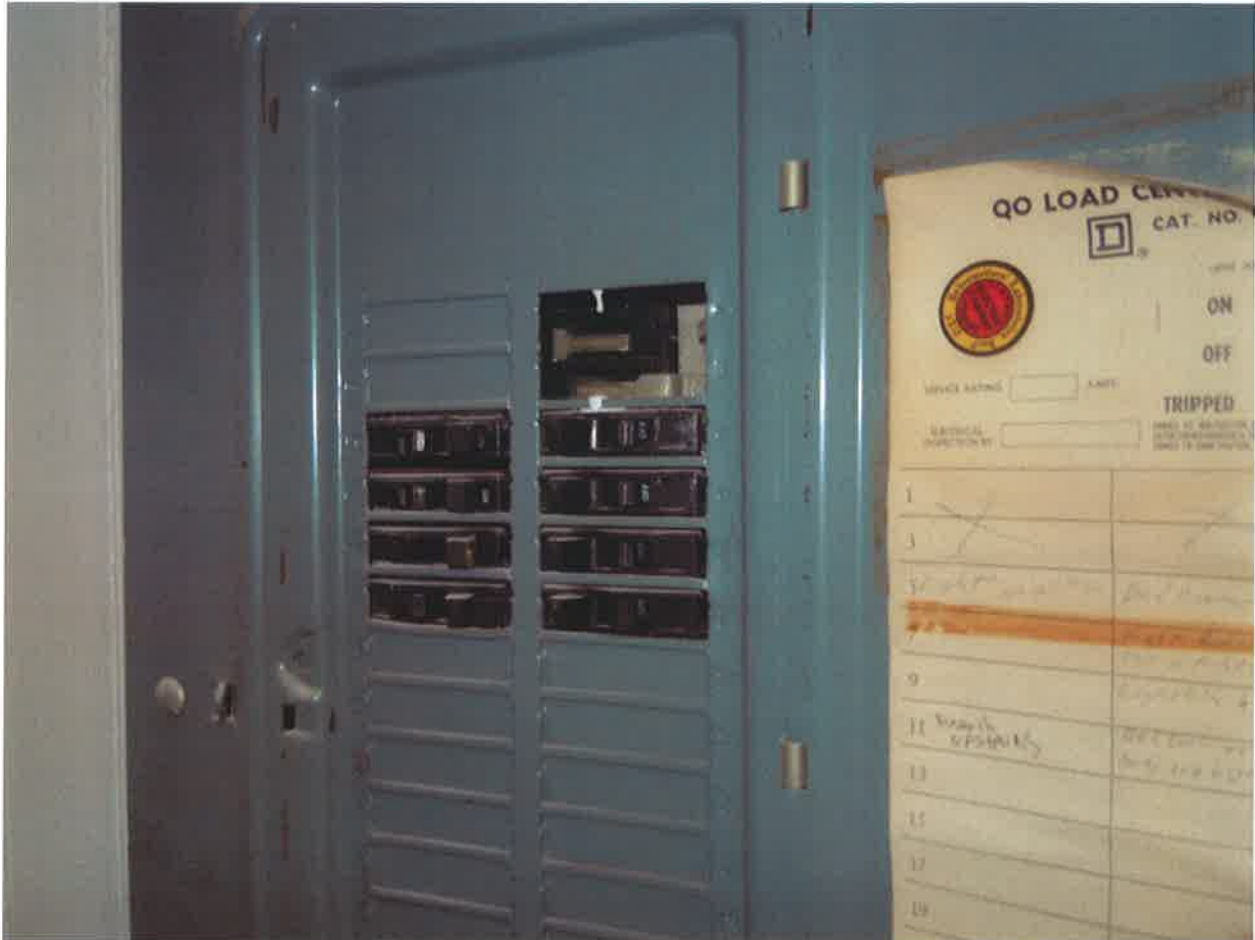
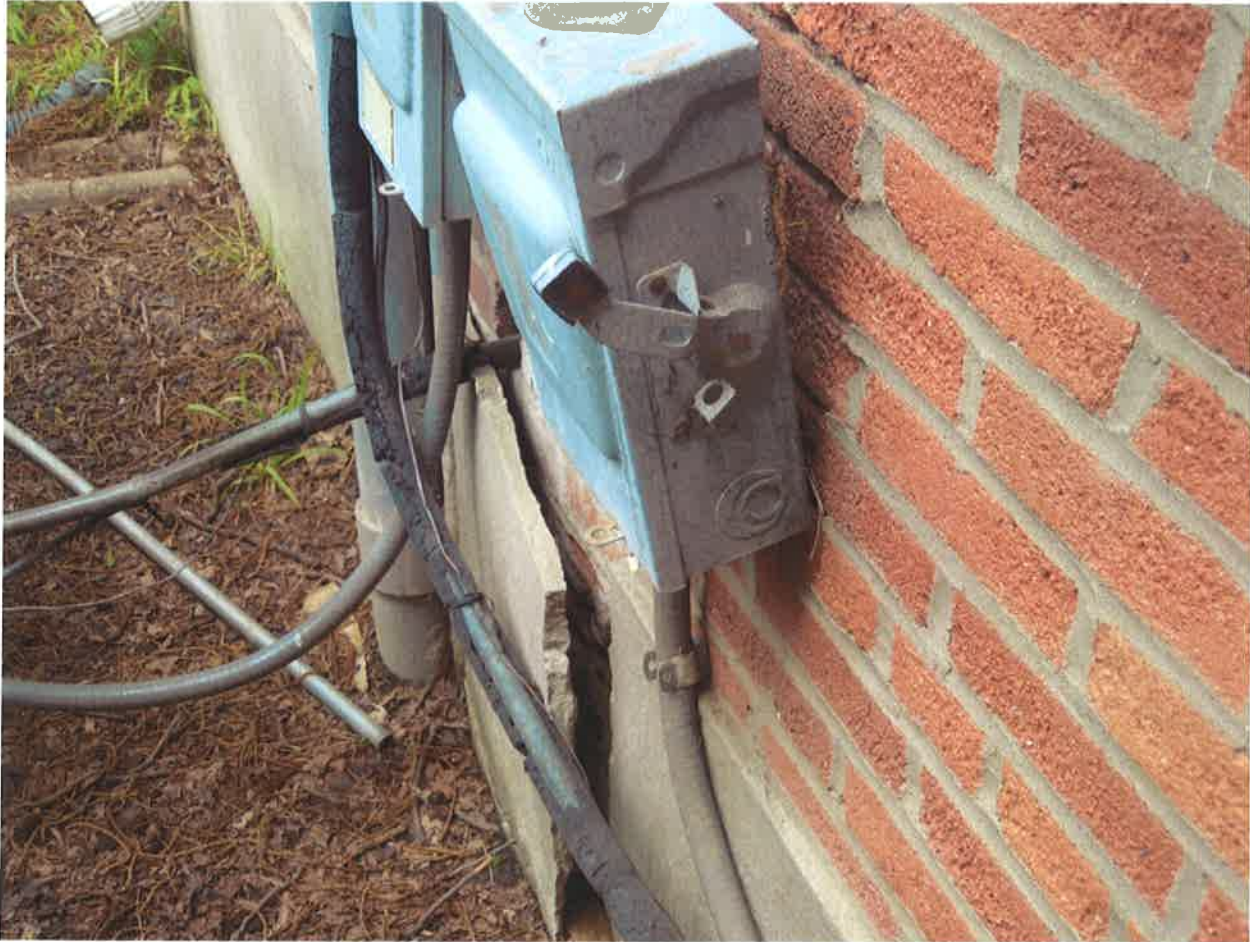
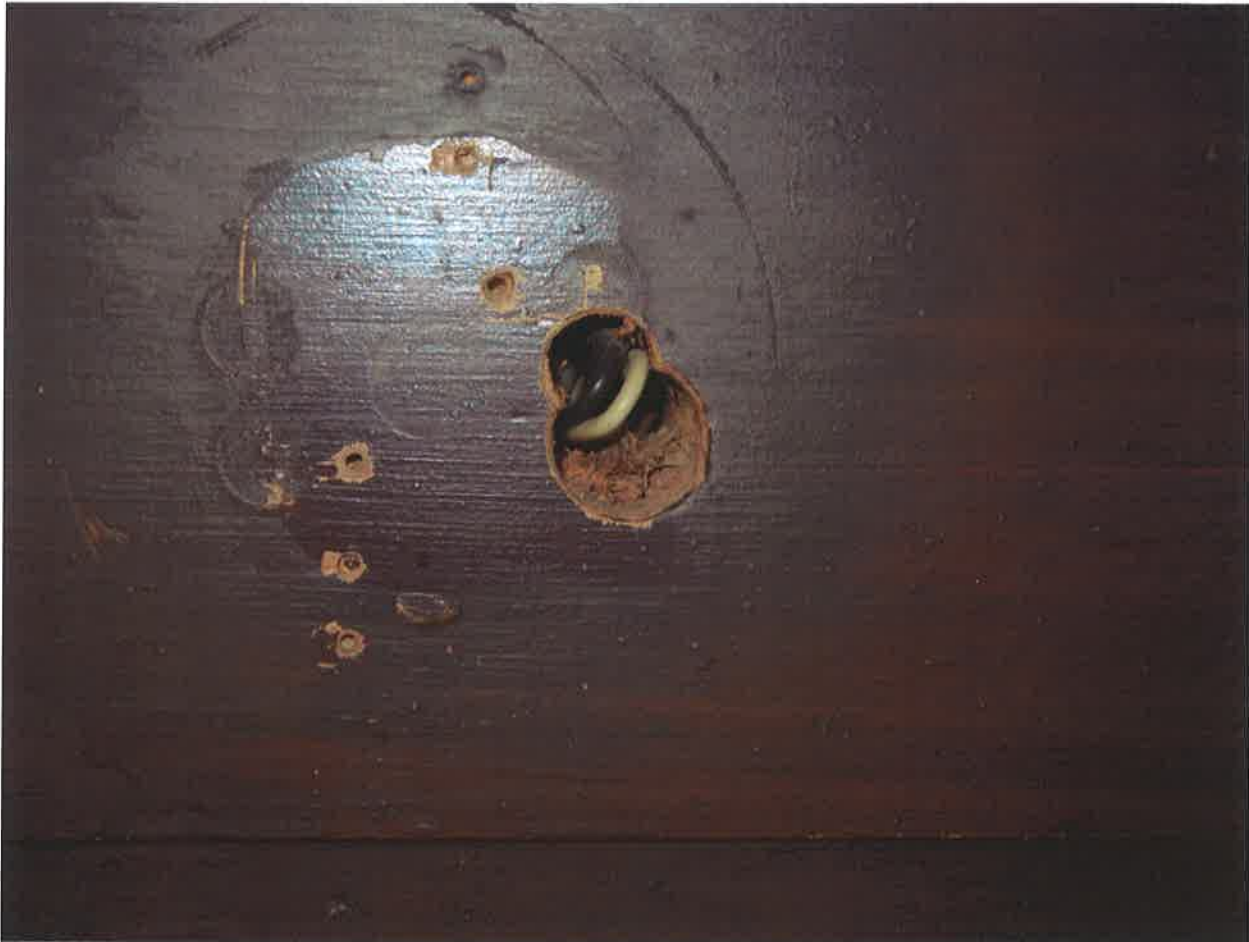
1. Pinched wire in basement light.
2. Improperly supported / secured non-metallic cable in basement and crawl space.
3. Coils of non-metallic cable in basement improperly terminated.
4. Eliminate use of extension cord in basement.
5. Exposed electrical wires and open j-boxes.
6. Electrical surface raceways improperly strapped / secured.

7. Exterior AC disconnect box not secured to the structure.

The electrical system is a potential fire hazard in any structure if the integrity of the system's electrical service, distributions panels, controls, wiring, fixtures, equipment, devices and appurtenances are not properly maintained. There are a number of conditions, which I have previously listed, which qualify for classification as unsafe or hazardous. A thorough inspection and testing by a licensed electrician of the structures electrical system is needed. The inspection and testing should include:

1. Continuity
2. Bonding Conductors Continuity
3. Polarity
4. Earth Electrode Resistance
5. Wiring Methods
6. Boxes and Conduit Bodies
7. Cabinets and Cutout Boxes
8. Switches, Receptacles and Fixtures
9. Replace circuit breakers AFCI breakers

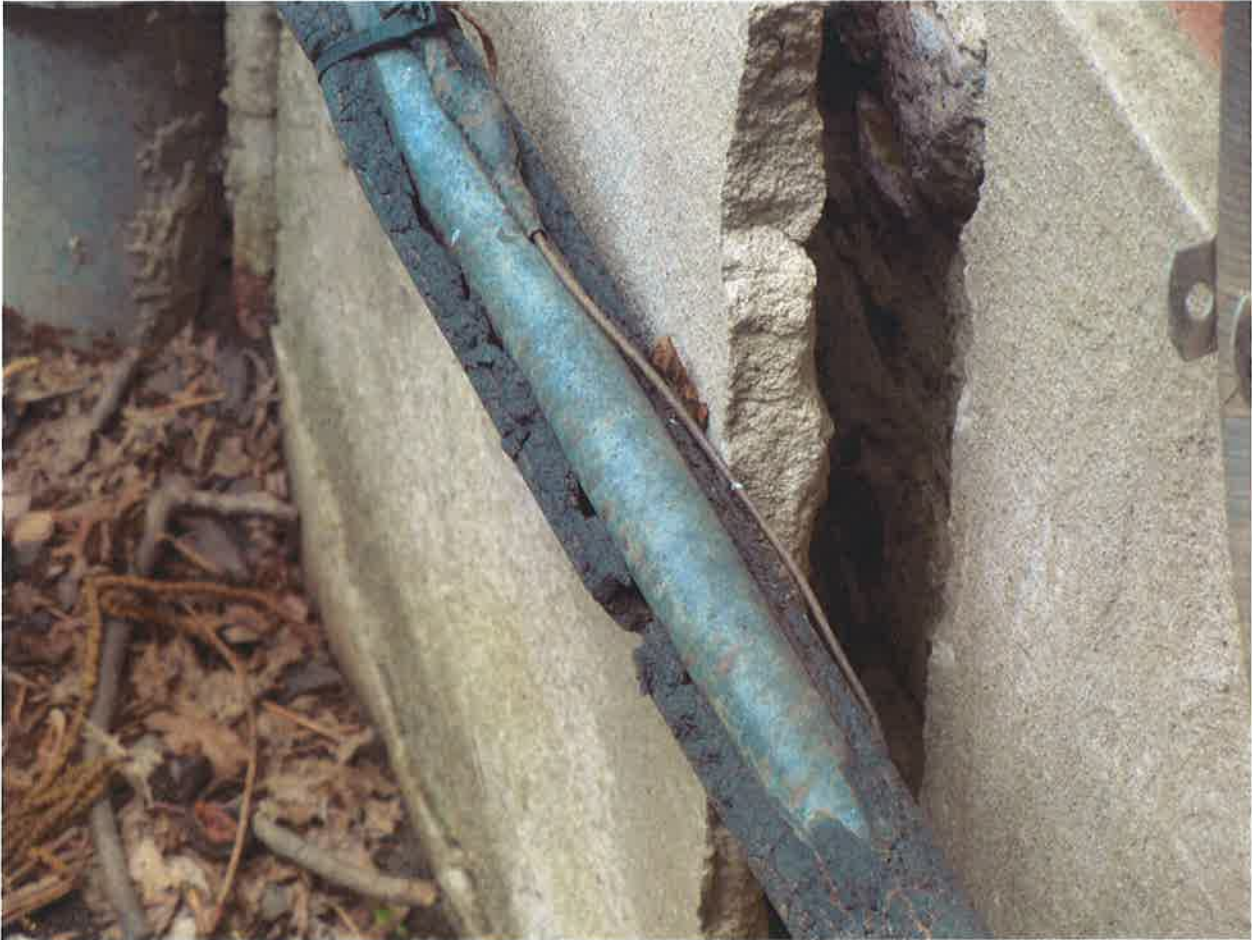
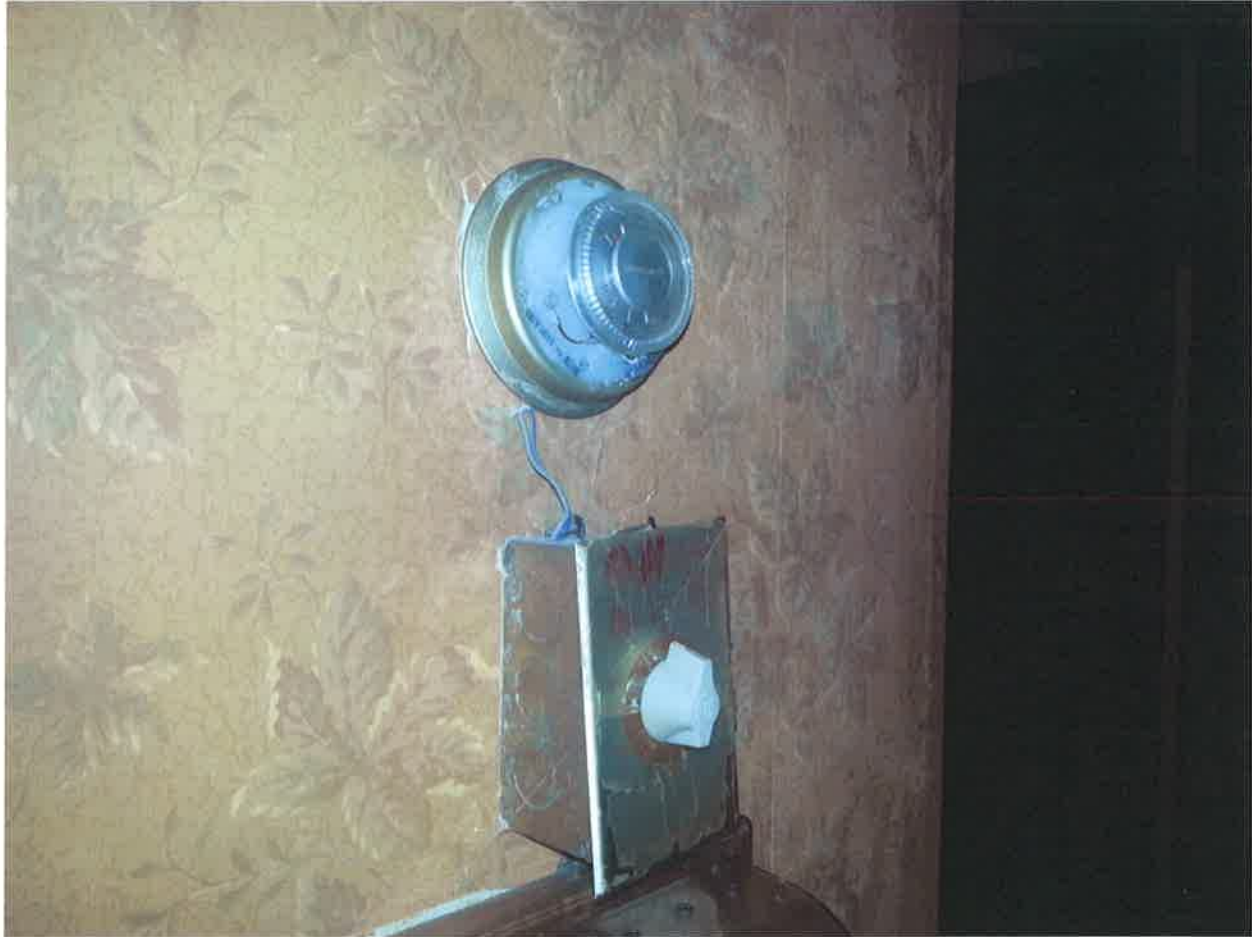
The HVAC system consists of a horizontal gas fired air handling unit in the attic, a vertical gas fired air handling unit in the basement and two exterior air conditioning condensing units. As best I can determine the gas valve, limit switches, fan motor compressors etc. are original equipment in excess of twenty years old. Due to the equipment's age and condition a system or component failure is likely. I question the benefit of maintaining outdated and inefficient equipment, and more importantly this equipment is incapable of creating and regulating an interior climate needed for the preservation of historical items and materials.

1. The first floor air handling unit (furnace) located in the basement is dated, inefficient and possibly unsafe. Due to basement ground water infiltration the furnace is rust damaged. Of greatest concern is the integrity of the heat exchanger, and the real possibility the heat exchanger rust has caused pitting and the potential release of carbon monoxide. The manufacturer's equipment plate is illegible so I am unable to determine the manufacturing date and the unit's designed efficiency based upon BTU input and output. In looking at the furnace cabinet, the gas valve, limit switch etc.; I estimate this unit was manufactured in the late seventies or early eighties at best. For equipment of this age the designed thermo-efficiency is typically around 76% under optimum conditions.

2. The two air conditioning units are at least 20 years old. Equipment of this age typically has a SEER Rating (BTUs of Cooling per watt) of 10. All equipment becomes less efficient with time, and Water & Light Energy Services staff estimates the unit's efficiency to be 7-8 SEER. The current model energy code specifies a minimum SEER rating of 13.

4. The thermostat controls are dated analog bimetallic strip controls, and probably out of calibration. These controls are inefficient, they require manual temperature setting and regulation providing minimal operational control and information such as humidity levels, when it's time to change filters and alerts when there are problems with the system.

I am recommending the replacement of the first floor air handling unit and the two air conditioning condensing units with high efficiency equipment with humidifying capabilities and smart Wi-Fi thermostats. The existing HVAC equipment and controls are inefficient and lack the capability of creating and regulating the needed interior climate.

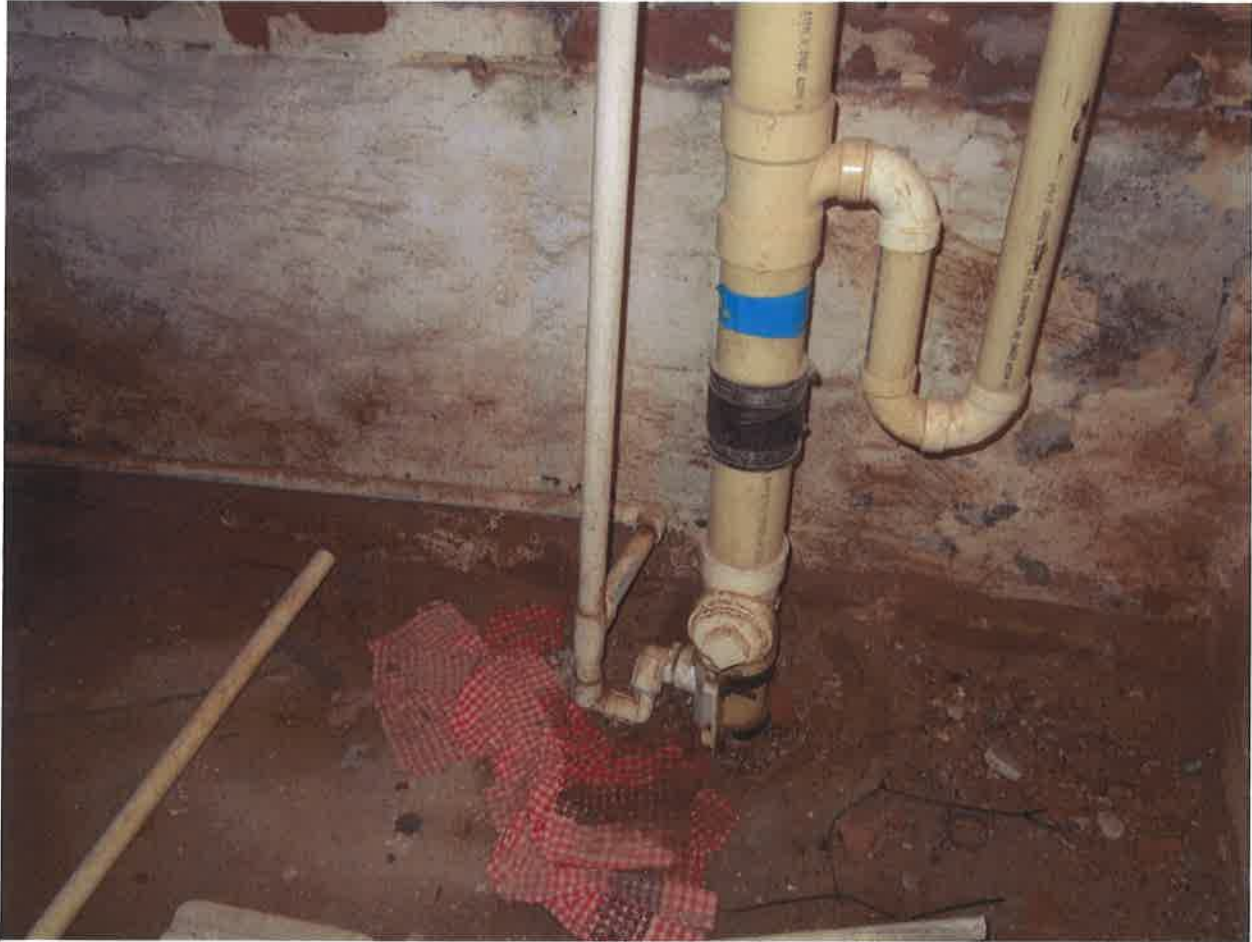
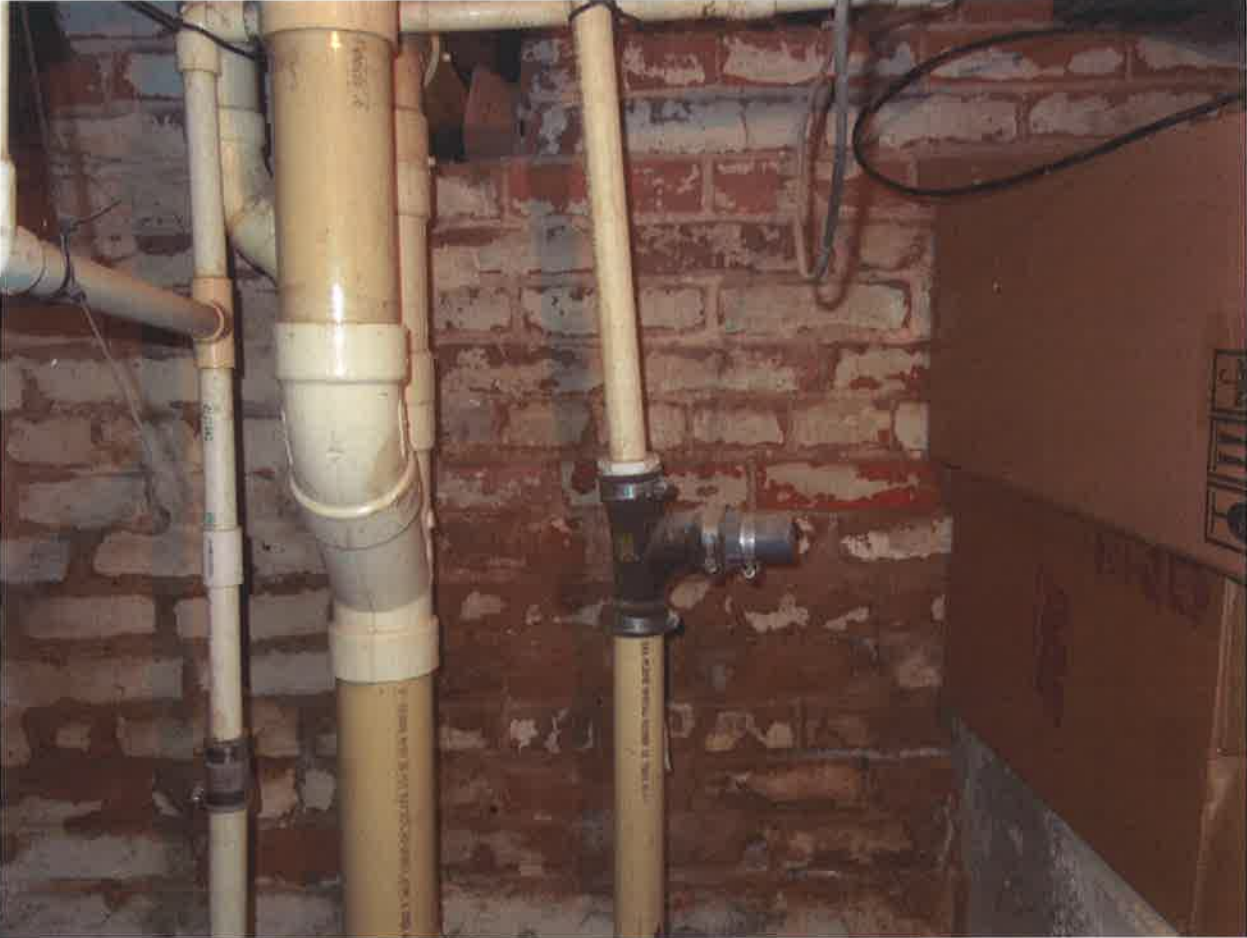
Plumbing

There are no working plumbing fixtures in the structure. The abandoned plumbing piping is unsanitary. There are four DWV unprotected openings meaning sewer gas can pass into the structure.

7. Seal all exterior penetrations.
8. Caulk and paint all wood finish gapped butt and mitered joints.
9. Though not historically correct in the short term install an aluminum door threshold at the kitchen exterior door.
10. Demolished abandoned plumbing piping. The main stack should remain capping openings and one protected (trapped) opening to receive condensate water from the A-Coils.
11. Comprehensive cleaning of the basement including the demolition rotted framed walls, removal of abandoned electrical conductions and plumbing pipes.
12. Construct a twenty (20') inch wide and secured walking starting at the attic access opening and thirty by thirty (30"x 30") inch work platform.
13. Place the batt insulation removed to build the walking way and platform and place over duct runs and furnace supply plenum.

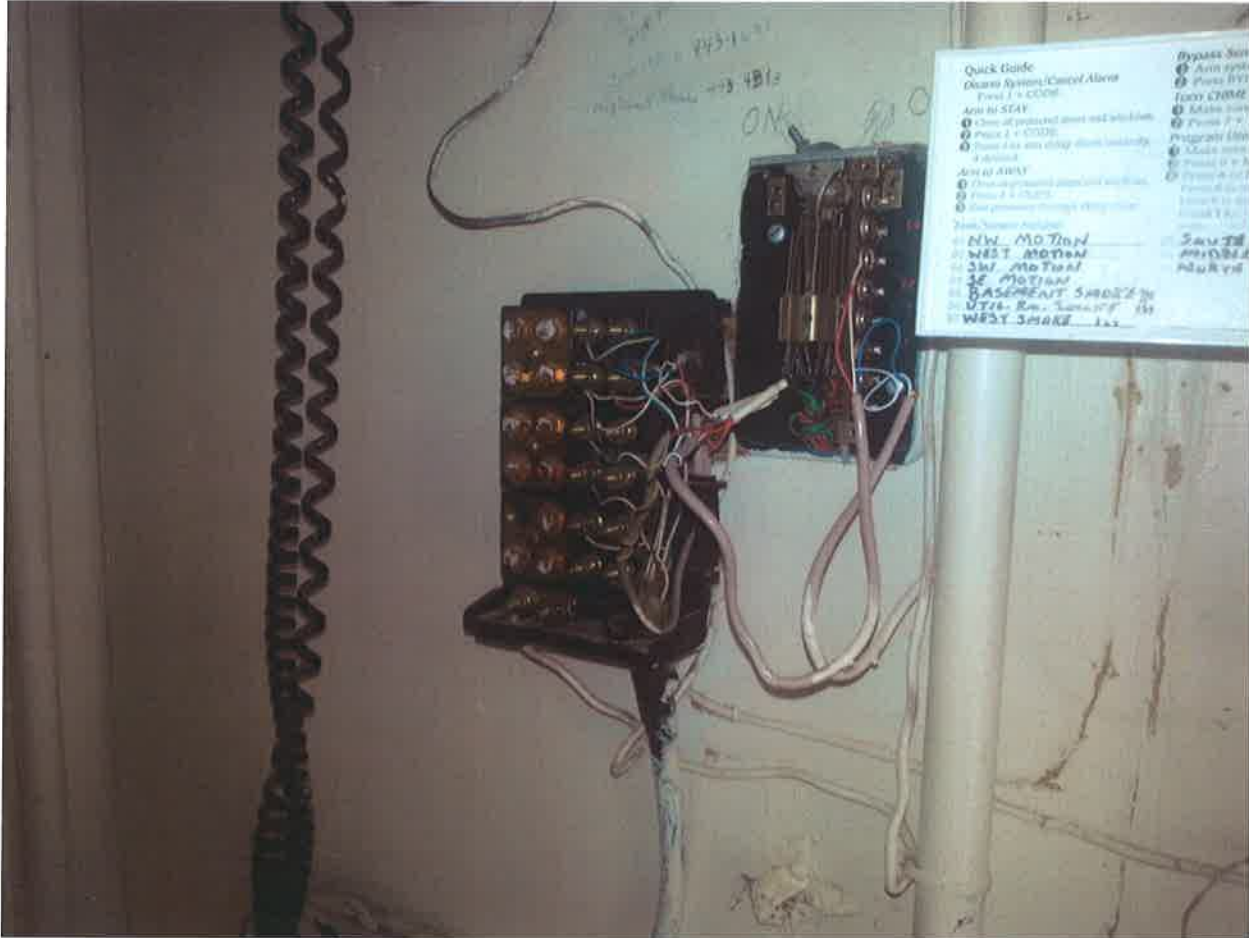
Alarm Wiring Phone Dmarc

1. The control panel has a single network line for communication and monitoring.
2. The audible alarms are built into the smoke detectors which is indicative of a residential fire detection system. Fire notification should include an indoor siren and visual strobe notification.
3. There are no manual fire alarm pull stations.
4. There is no detector in the attic monitoring the attic HVAC system.
5. The detectors in furnace locations should be both heat and smoke devices.
5. The telephone demarcation point equipment is old, I am guessing circa 1950s. For an unknown reason some of the on premise fire detector wiring is switched meaning a portion of the fire protection system can be manually switched off. See Photo "Alarm Wiring"

1. Contemporary control panel
2. Wireless receiver
3. Landline and cellular communicator
4. Wireless synchronized smoke detectors
5. Wireless motion sensors
6. Wireless door sensor
7. Indoor siren
8. Visual (strobe) alarm
9. Smoke and heat detectors in furnace locations
10. Manual alarm pull station
