MAPLEWOOD HOUSE

3701 Ponderosa St.

BUILDING SURVEY, July 2015

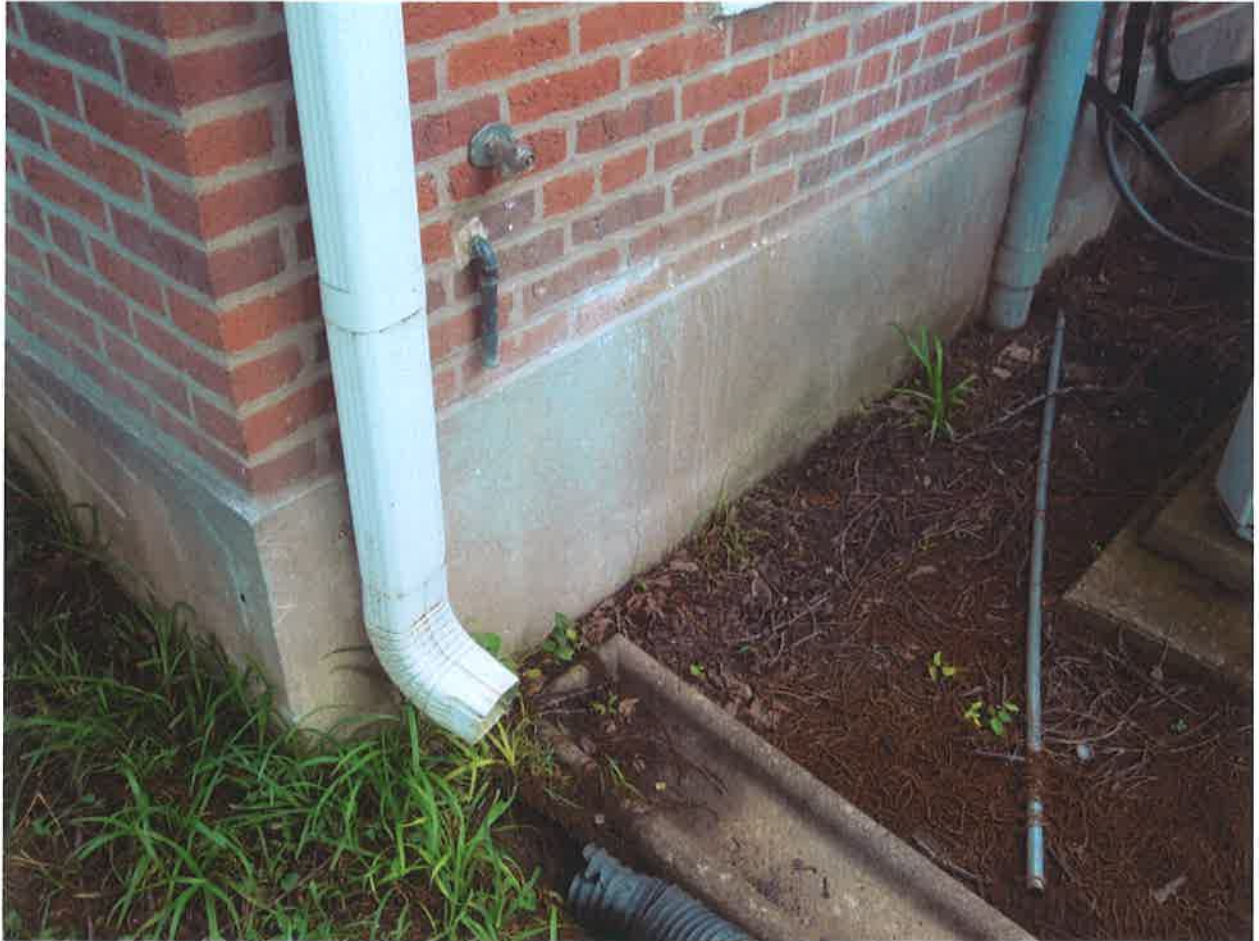
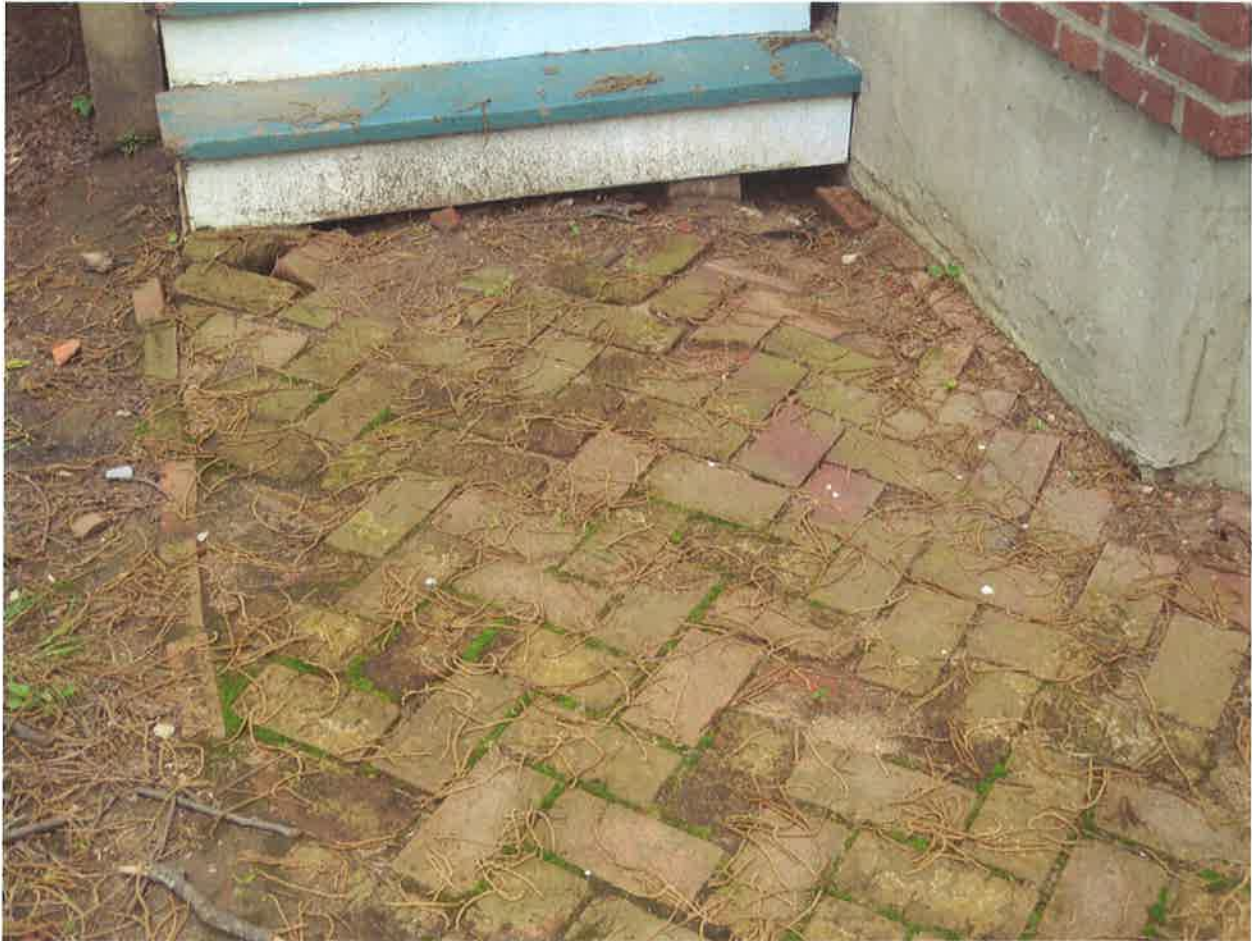
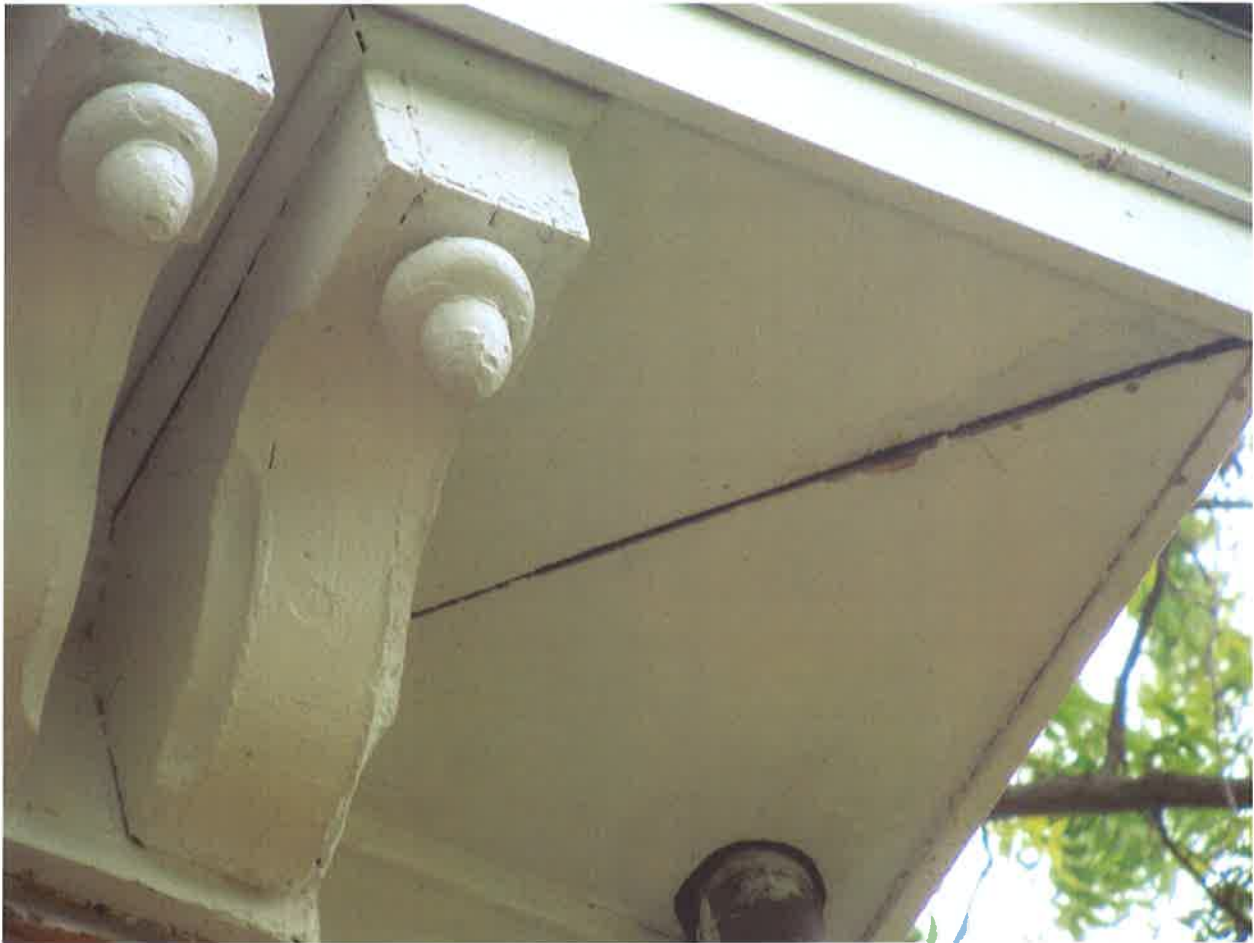
Maintenance

1. There are a few exterior masonry wall locations where repointing is needed.
2. Window wells are filling with debris and some plant growth.
3. There are several exterior locations where the paint is bubbling or peeling.
4. Several window shutter metal hinges are experiencing surface rust.
5. The guttering down spout horizontal piping is not properly connected and need cleaning.
6. A brick landing/walkway on the southwest corner of the structure is in bad repair. The bricks have settled causing storm water accumulation. Several of the bricks are damaged in addition to the settlement creating an irregular walking surface and a trip hazard.
7. There are several unsealed exterior penetrations such as the air conditioning condensing unit's set line penetrations.
8. There are several locations were the wood finish butt and mitered joints are gapped and need caulking.

9. There is a one (1") inch gap between the bottom of the kitchen's exterior door leaf and the threshold flooring. Obviously this condition allows for air infiltration and exfiltration and the entry of insects and vermin.

1. Repoint exterior masonry walls as needed. Repointing needs should be based upon the following; mortar erosion equal to or greater than one quarter (1/4) inch, crumbling mortar, hairline cracks in the mortar, and cracks between the brick and mortar.
2. Clean and remove debris and plant life from the window wells.
3. Scrap, prime and repaint bubbling or peeling exterior paint.
4. Wire brush, coat with a rust inhibitor and finish paint rusting window shutter hinges.
5. Cleaning and securely connect guttering down spout horizontal piping.
6. Rebuild the brick landing/walkway on the southwest corner of the structure.

7. Seal all exterior penetrations.
8. Caulk and paint all wood finish gapped butt and mitered joints.
9. Though not historically correct in the short term install an aluminum door threshold at the kitchen exterior door.
10. Demolished abandoned plumbing piping. The main stack should remain capping openings and one protected (trapped) opening to receive condensate water from the A-Coils.
11. Comprehensive cleaning of the basement including the demolition rotted framed walls, removal of abandoned electrical conductions and plumbing pipes.
12. Construct a twenty (20') inch wide and secured walking starting at the attic access opening and thirty by thirty (30"x 30") inch work platform.
13. Place the batt insulation removed to build the walking way and platform and place over duct runs and furnace supply plenum.
