# **MAPLEWOOD HOUSE**

3701 Ponderosa St.

**BUILDING SURVEY, July 2015**

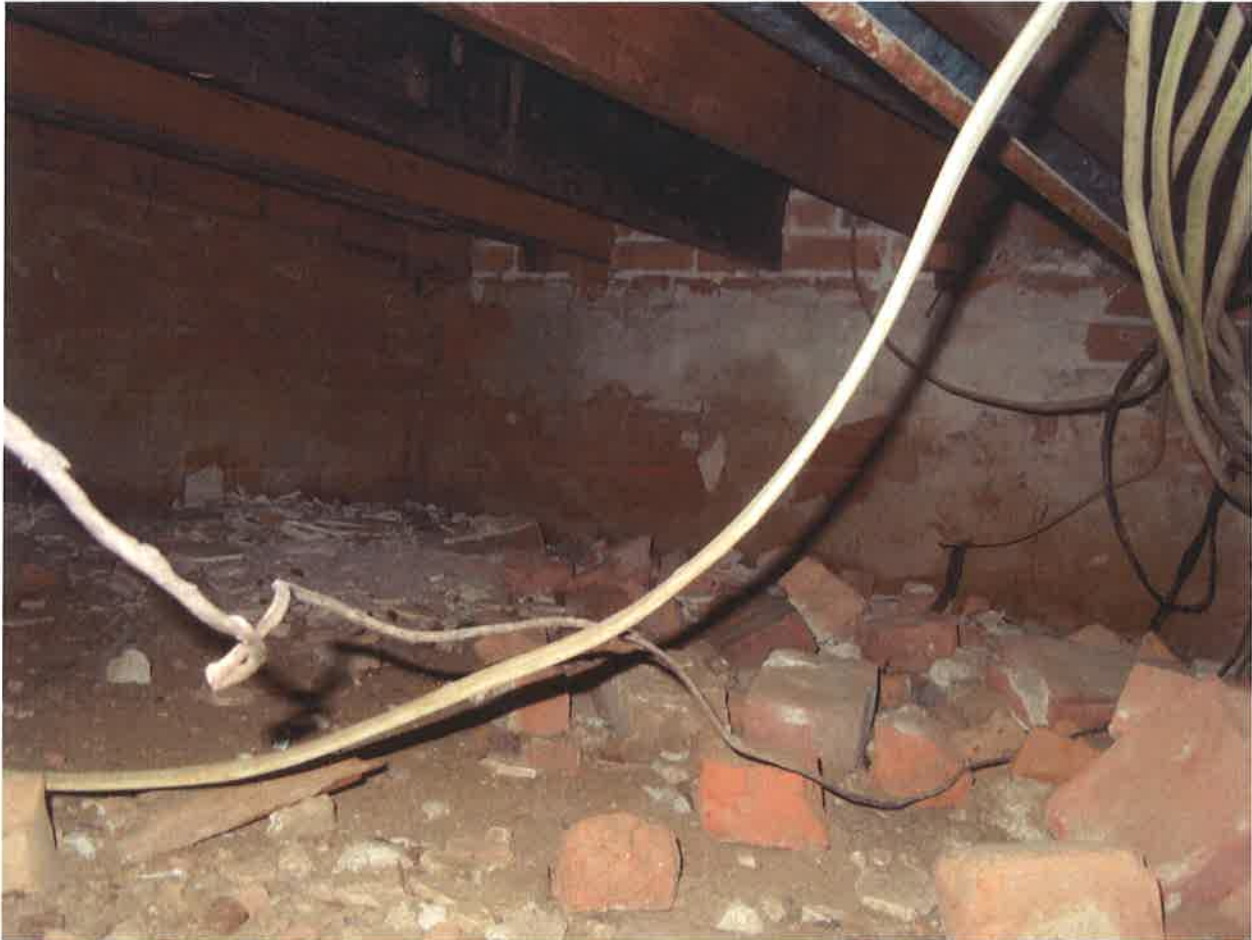
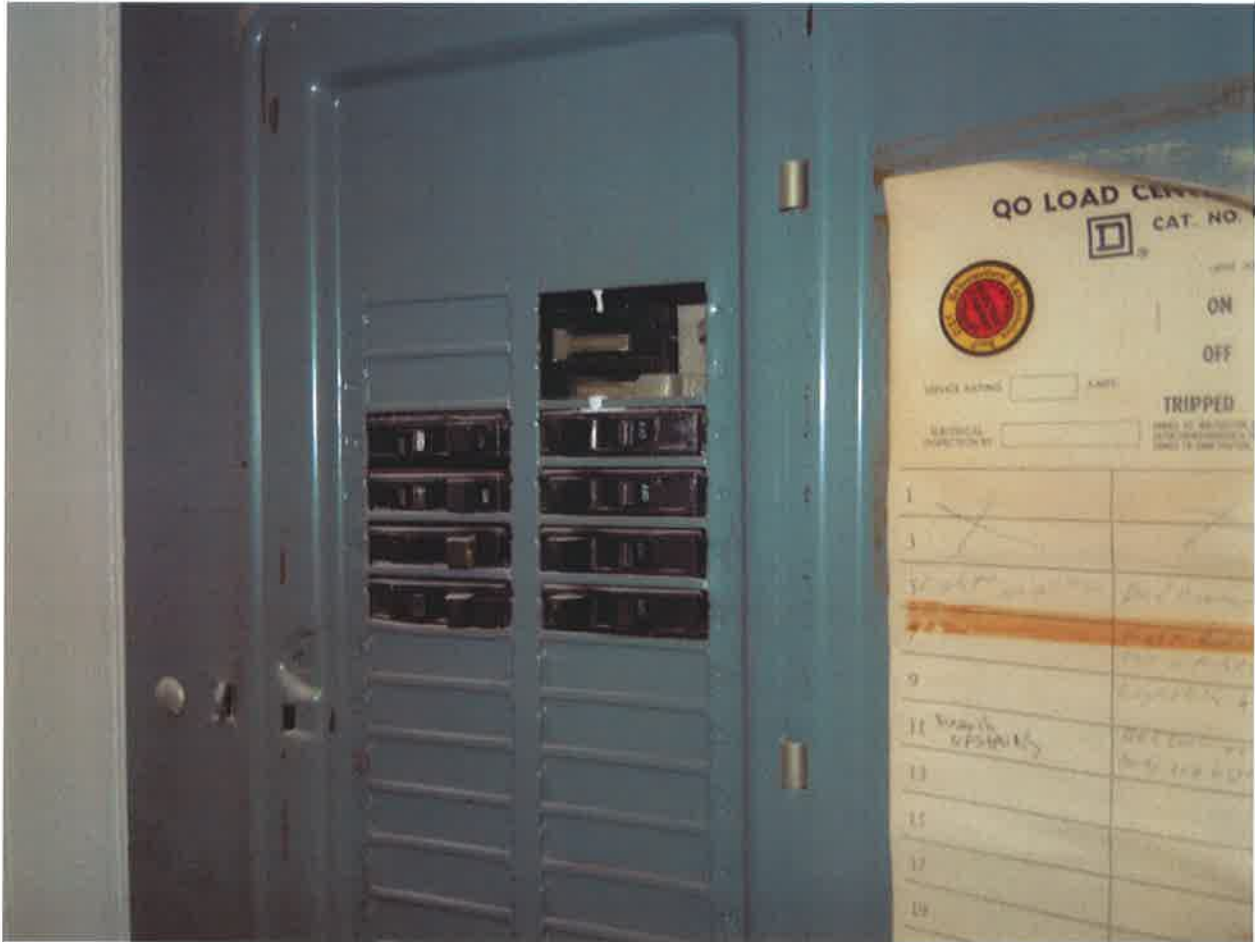
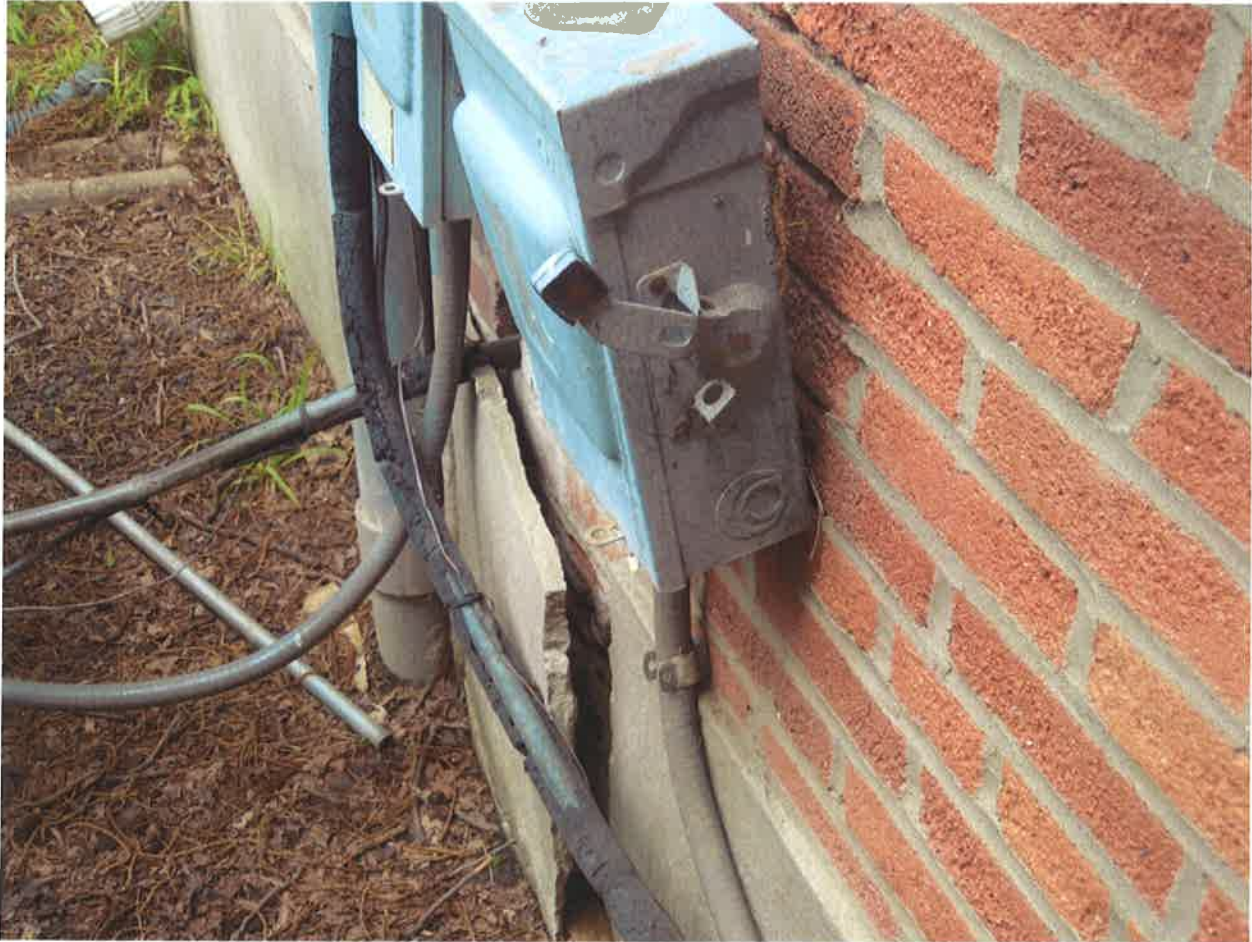
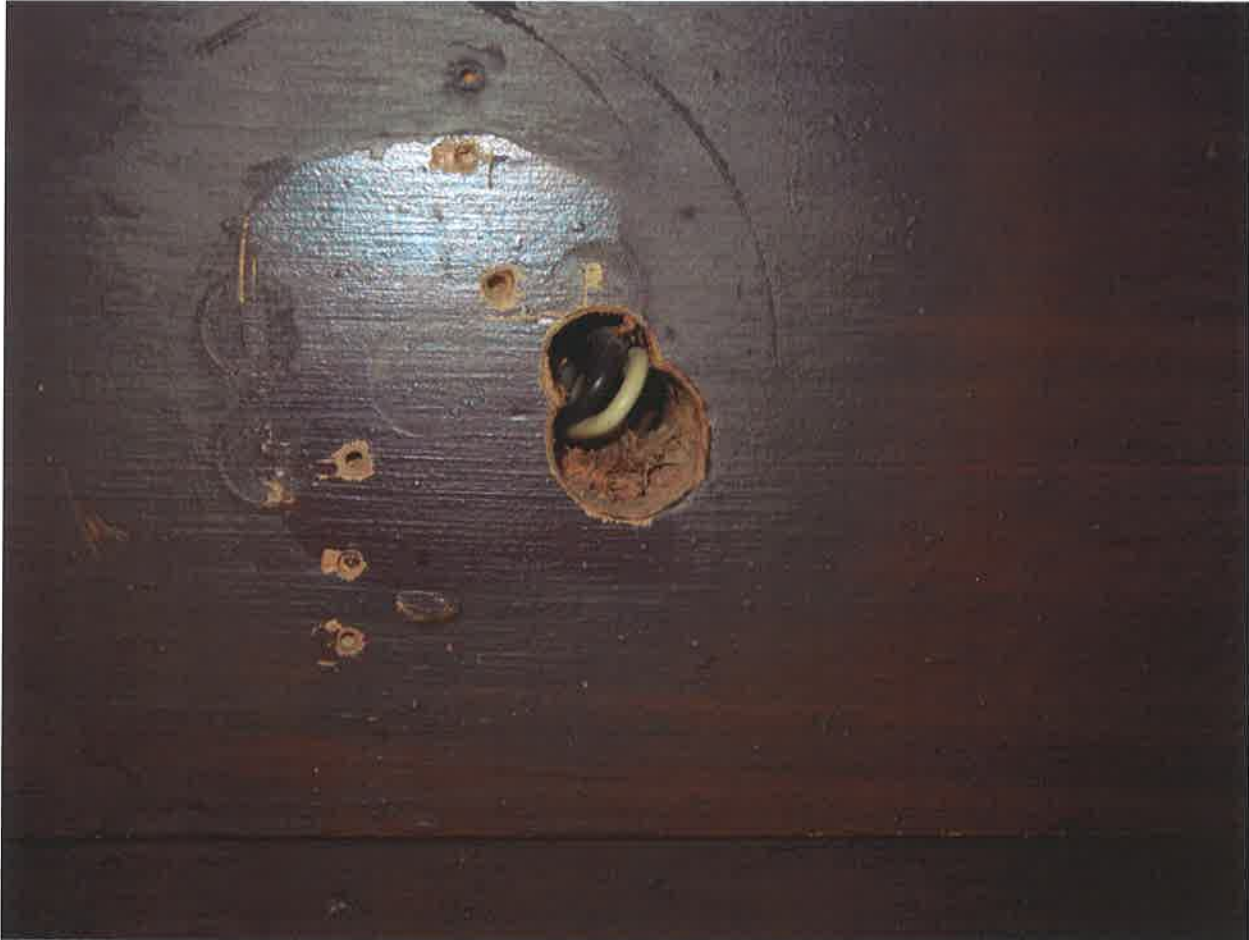
1. Pinched wire in basement light.
2. Improperly supported / secured non-metallic cable in basement and crawl space.
3. Coils of non-metallic cable in basement improperly terminated.
4. Eliminate use of extension cord in basement.
5. Exposed electrical wires and open j-boxes.
6. Electrical surface raceways improperly strapped / secured.

7. Exterior AC disconnect box not secured to the structure.

The electrical system is a potential fire hazard in any structure if the integrity of the system's electrical service, distributions panels, controls, wiring, fixtures, equipment, devices and appurtenances are not properly maintained. There are a number of conditions, which I have previously listed, which qualify for classification as unsafe or hazardous. A thorough inspection and testing by a licensed electrician of the structures electrical system is needed. The inspection and testing should include:

1. Continuity
2. Bonding Conductors Continuity
3. Polarity
4. Earth Electrode Resistance
5. Wiring Methods
6. Boxes and Conduit Bodies
7. Cabinets and Cutout Boxes
8. Switches, Receptacles and Fixtures
9. Replace circuit breakers AFCI breakers

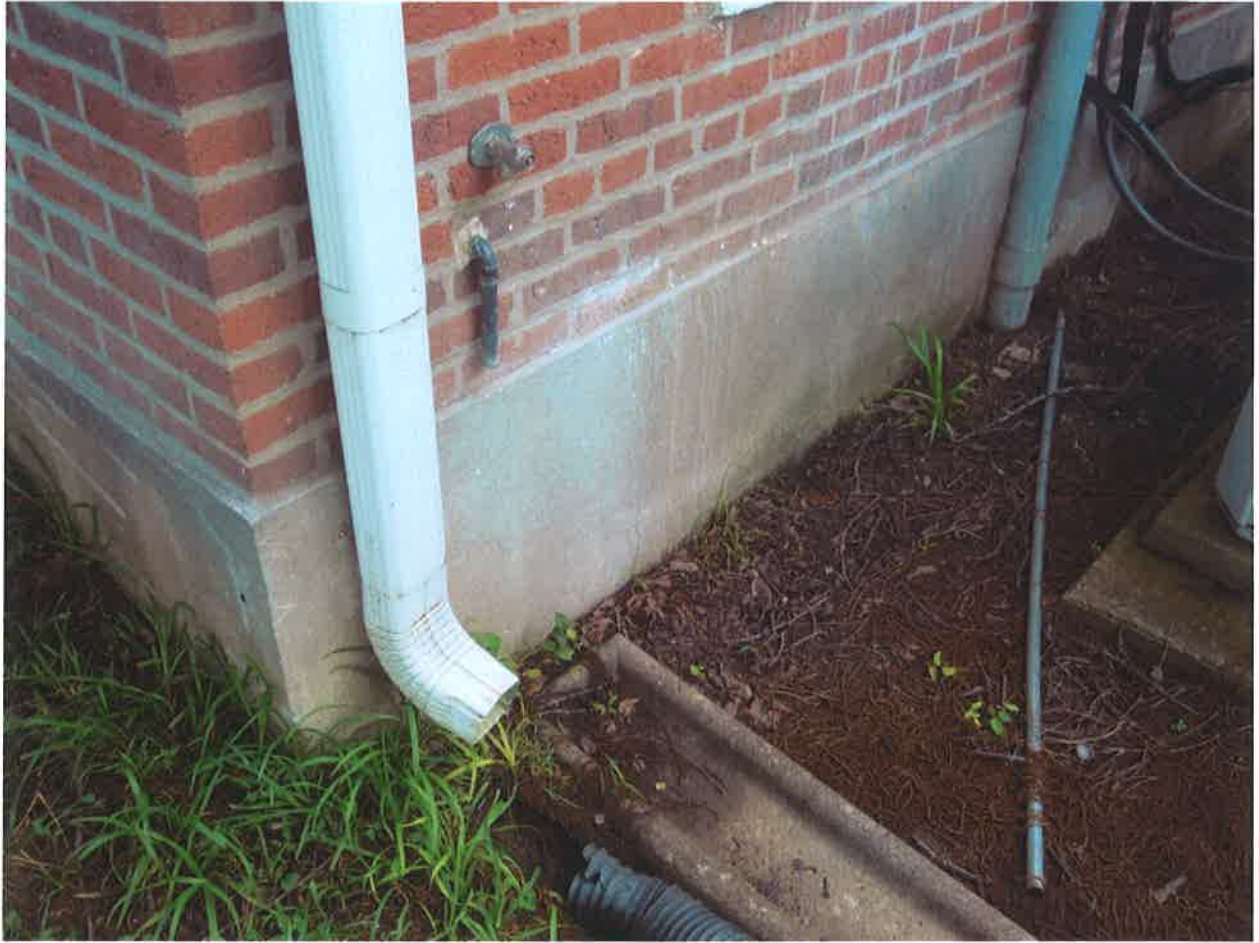
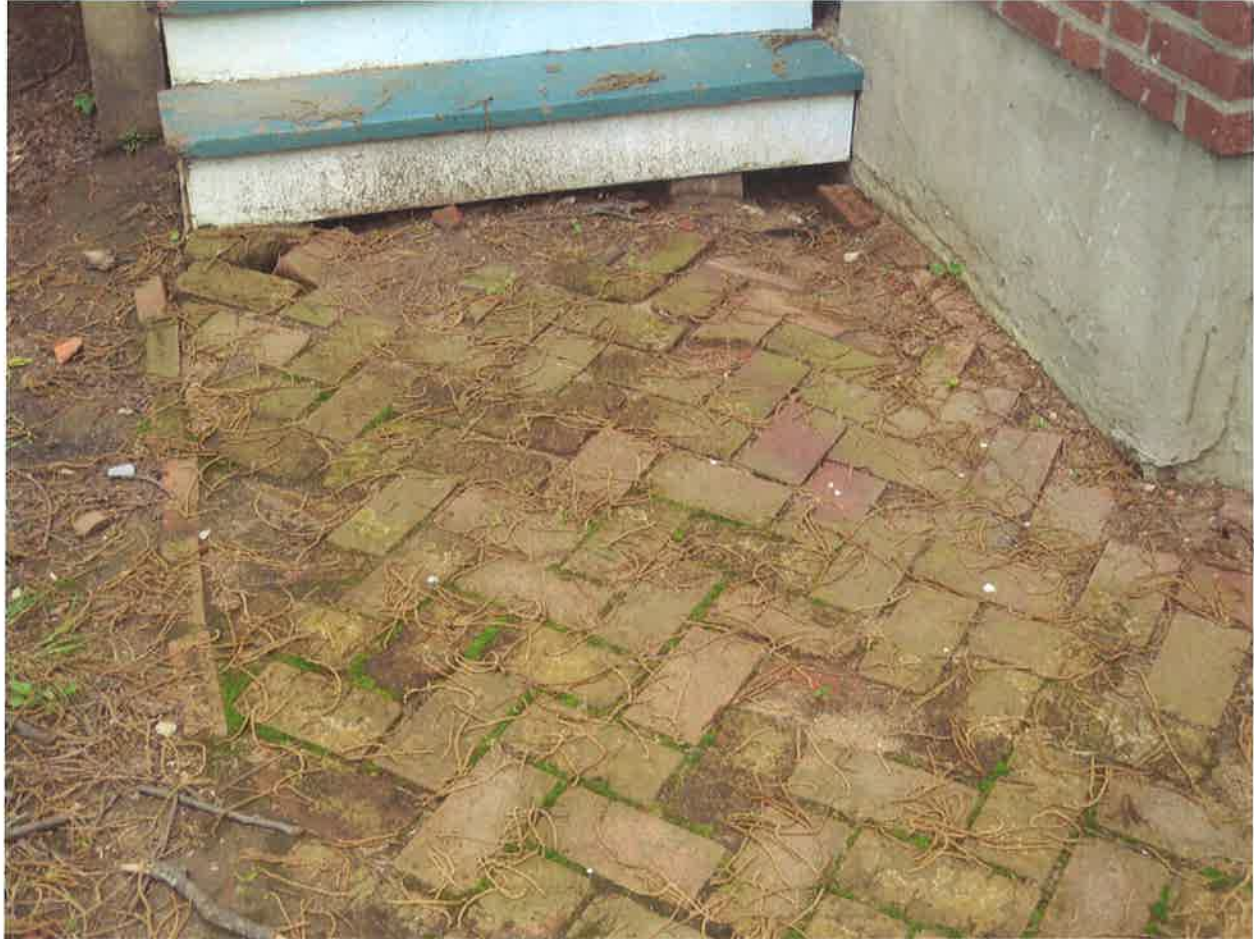
# Maintenance

1. There are a few exterior masonry wall locations where repointing is needed.
2. Window wells are filling with debris and some plant growth.
3. There are several exterior locations where the paint is bubbling or peeling.
4. Several window shutter metal hinges are experiencing surface rust.
5. The guttering down spout horizontal piping is not properly connected and need cleaning.
6. A brick landing/walkway on the southwest corner of the structure is in bad repair. The bricks have settled causing storm water accumulation. Several of the bricks are damaged in addition to the settlement creating an irregular walking surface and a trip hazard.
7. There are several unsealed exterior penetrations such as the air conditioning condensing unit's set line penetrations.
8. There are several locations were the wood finish butt and mitered joints are gapped and need caulking.

9. There is a one (1") inch gap between the bottom of the kitchen's exterior door leaf and the threshold flooring. Obviously this condition allows for air infiltration and exfiltration and the entry of insects and vermin.

1. Repoint exterior masonry walls as needed. Repointing needs should be based upon the following; mortar erosion equal to or greater than one quarter (1/4) inch, crumbling mortar, hairline cracks in the mortar, and cracks between the brick and mortar.
2. Clean and remove debris and plant life from the window wells.
3. Scrap, prime and repaint bubbling or peeling exterior paint.
4. Wire brush, coat with a rust inhibitor and finish paint rusting window shutter hinges.
5. Cleaning and securely connect guttering down spout horizontal piping.
6. Rebuild the brick landing/walkway on the southwest corner of the structure.

7. Seal all exterior penetrations.
8. Caulk and paint all wood finish gapped butt and mitered joints.
9. Though not historically correct in the short term install an aluminum door threshold at the kitchen exterior door.
10. Demolished abandoned plumbing piping. The main stack should remain capping openings and one protected (trapped) opening to receive condensate water from the A-Coils.
11. Comprehensive cleaning of the basement including the demolition rotted framed walls, removal of abandoned electrical conductions and plumbing pipes.
12. Construct a twenty (20') inch wide and secured walking starting at the attic access opening and thirty by thirty (30"x 30") inch work platform.
13. Place the batt insulation removed to build the walking way and platform and place over duct runs and furnace supply plenum.
