CONDITION ASSESSMENT

**SIXTH AND CHERRY  
PARKING STRUCTURE**  
COLUMBIA, MISSOURI

Prepared for:  
CITY OF COLUMBIA

WRC PROJECT NO. 31-7734.00  
SEPTEMBER 2014

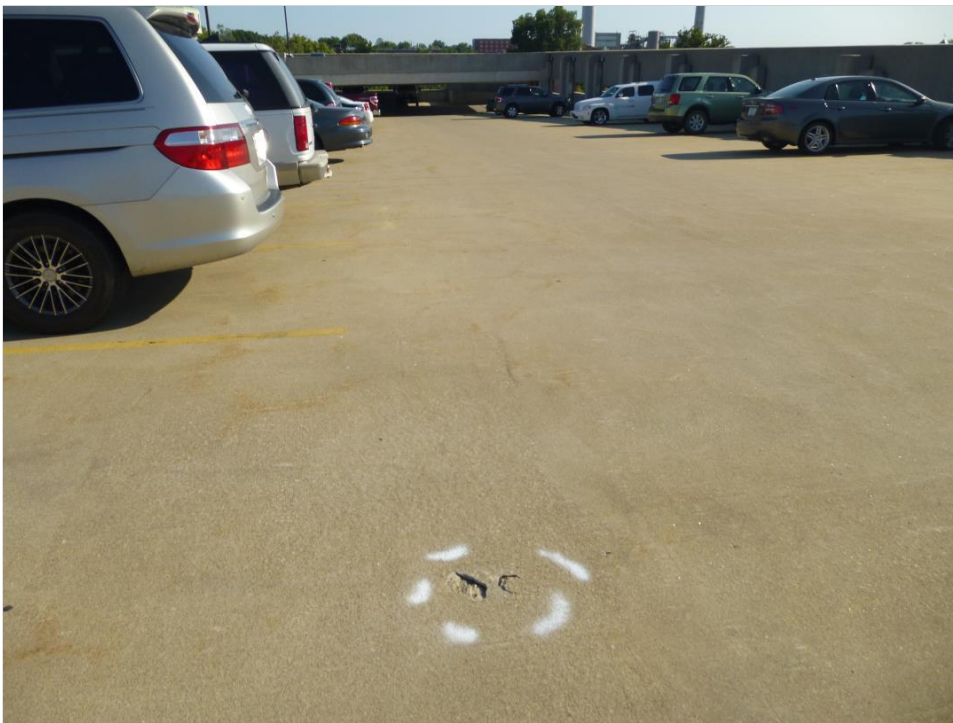
1. Chain dragging of the supported floor surfaces revealed a few minor isolated floor spalls throughout the parking structure. No signs of corrosion at these locations were observed (Photo 4).
2. Some minor concrete wall spalls were noted at a few decorative façade grill connections throughout the structure (Photo 5).
3. An isolated spall was observed at a column-to-façade panel connection on the west bay, Ground Level ramp (Photo 6).
4. Spalled concrete was observed at a thin concrete overlay at the east entrance of the structure (Photo 7).

Photo 4 – Isolated area of deteriorated concrete at floor surface, Roof Level.

We also noted some minor wall spalls at grade level, some spalls at the façade panel grill connections (the grills are partially loose), and an isolated spall at a column-to-façade panel connection on the west elevation Ground Level ramp. We recommend performing partial depth repairs at these locations to restore the integrity of these members and mitigate additional deterioration. Additionally, we observed a cracked and spalled thin concrete overlay near the east entrance of the structure. The overlay appears to have been installed to mitigate water ponding but without the proper surface preparation. To address this, we recommend removing the current overlay and installing a new thin concrete overlay using latex-modified concrete. The properties of latex-modified concrete allow for better bonding to the existing floor surface. Additionally, a properly prepared substrate will allow for greater durability at this high traffic region.

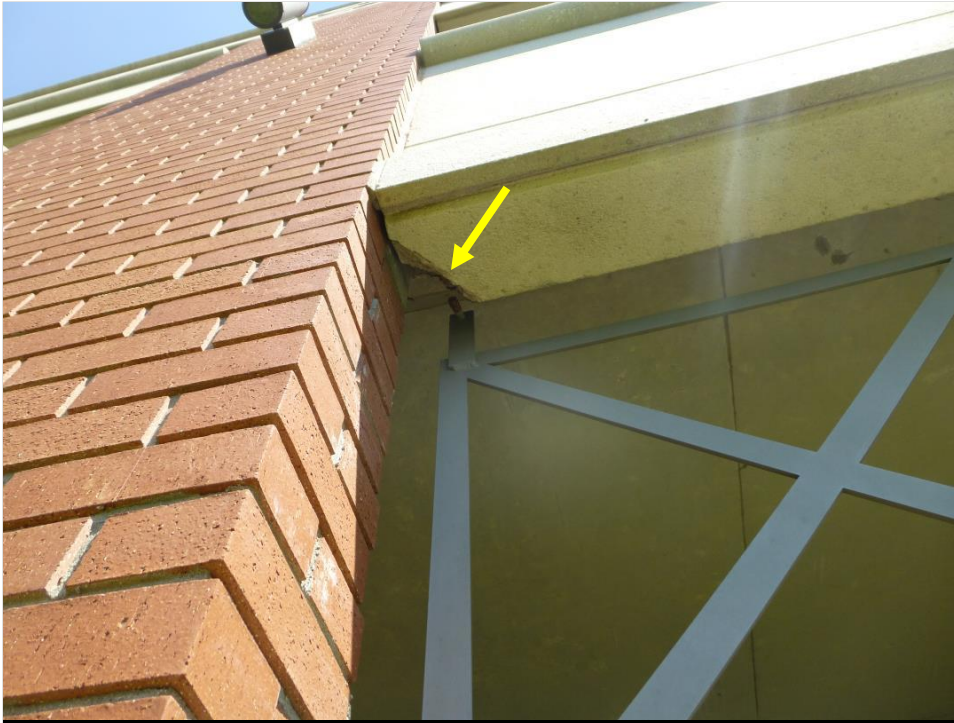
Photo 5 – Spalled façade panel concrete at grill connection.

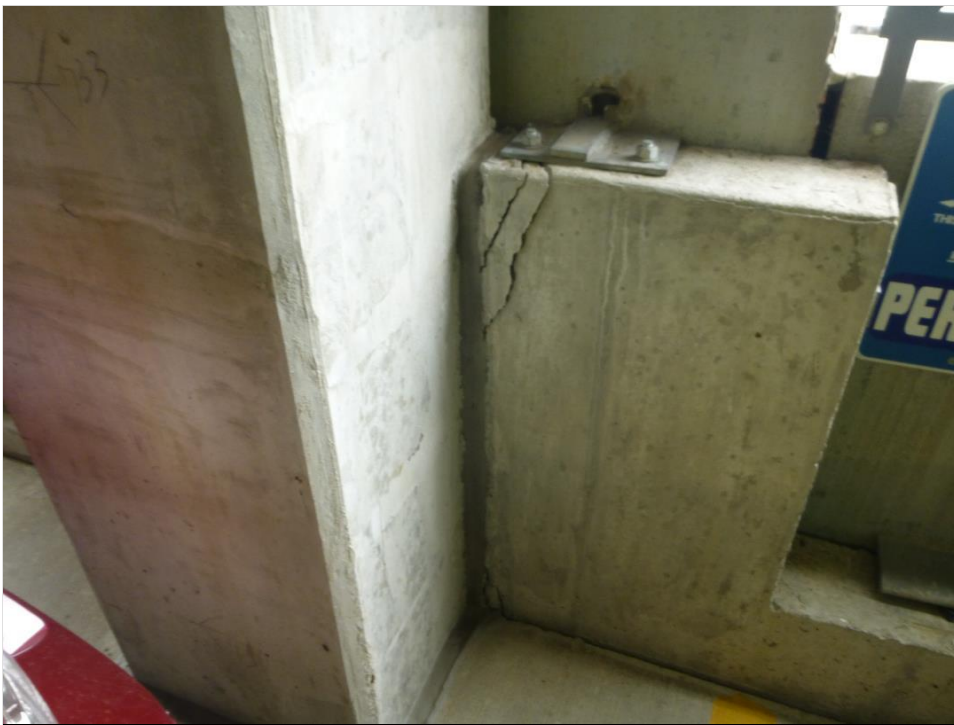
Photo 6 – Cracked and spalled concrete at column-façade panel connection.

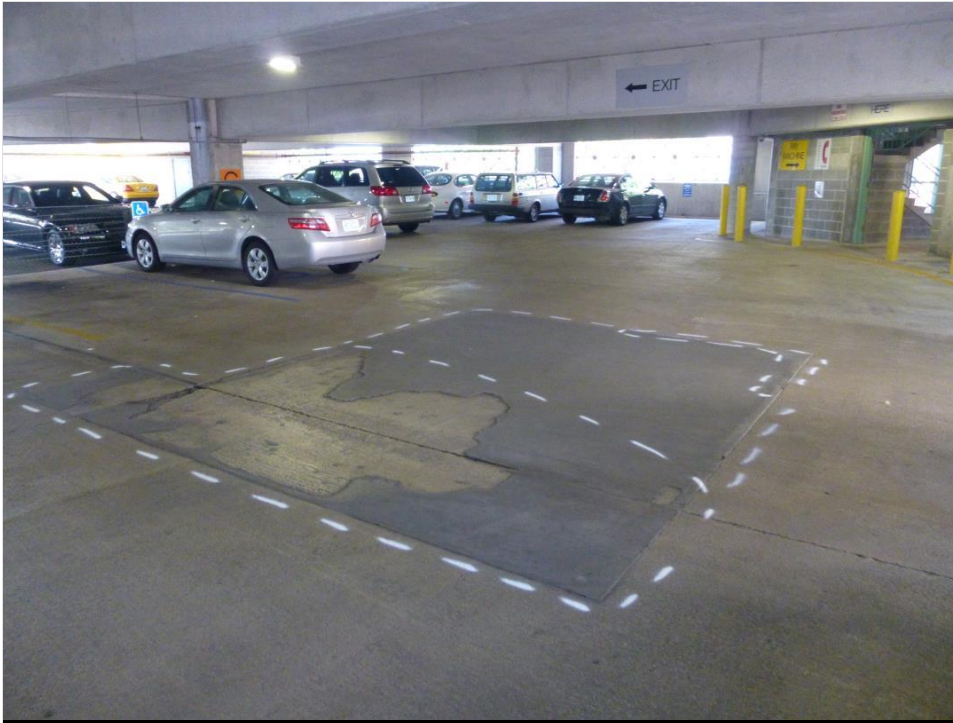
Photo 7 – Spalled and delaminated thin overlay concrete to mitigate water ponding, east elevation entrance.

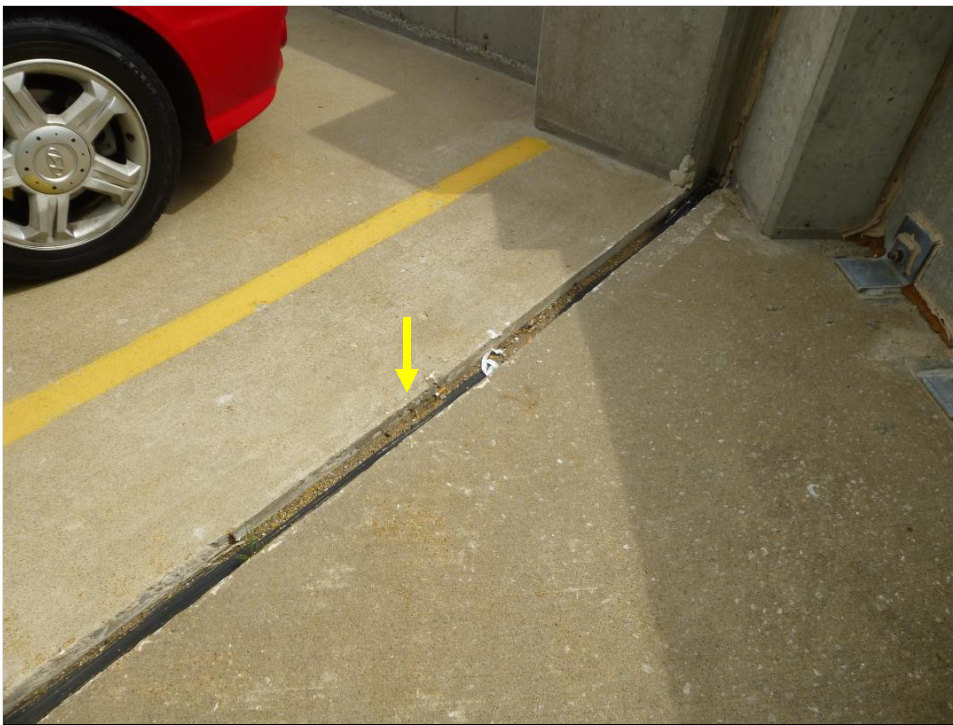
1. The expansion joints at the north and south stair towers are exhibiting adhesion failures at all levels. Daylight can be seen from underneath and are leaking (Photos 8 and 9).
2. Moisture and grease stains were observed at the underside of the control joint sealants throughout the parking structure. The sealants appear to be in fair condition with some alligator cracking observed at the ends (Photos 10 and 11).
3. The Roof Level stub column vertical sealants and isolated Roof Level cove sealant have failed (Photos 12 and 13).
4. Most of the exterior façade sealants on the exterior have failed. Cracking was observed on most vertical sealants on the precast façade panels, isolation joints, and window perimeter joints (Photos 14 through 19).

Photo 8 – Adhesion failure observed at Roof Level compression expansion joint.

The expansion joints used at the stair towers are compression-type joints. We noted adhesion failures at several locations throughout the expansion joints. At some locations, daylight can be seen from underneath. Failure at these expansion joints allows water to pass through to the lower levels. During the winter season, this water may freeze on the floor surfaces and can potentially create a slipping hazard. To address these issues, we recommend replacing the existing expansion joints with a wide silicone seal protected by a cover plate. Silicone seals are more durable and are capable of accommodating greater expansions. However, they require a cover plate for ADA compatibility. Their overall cost of the recommended system is comparable to that of a compression expansion joint.

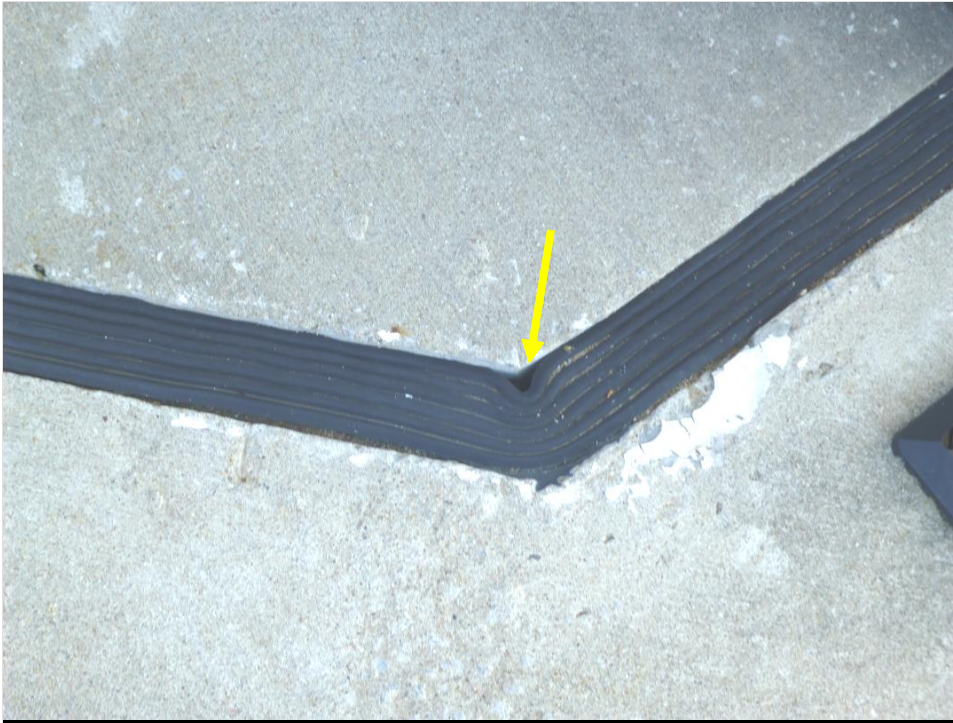
Photo 9 – Opening at compression joint seal.

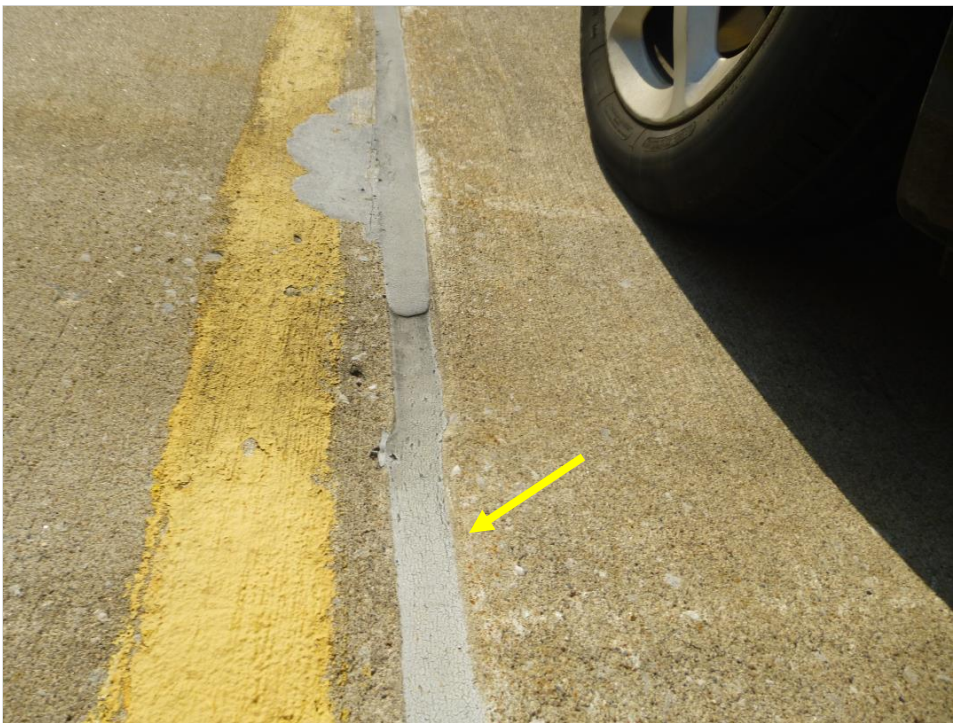
Photo 10 – Alligator cracking observed at control joint.

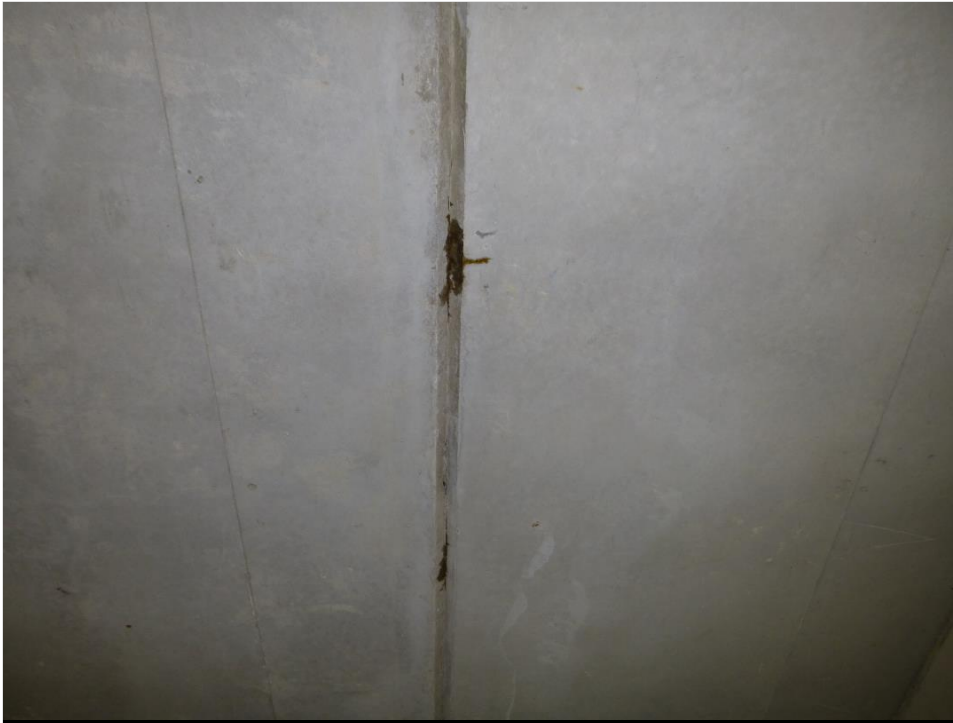
Photo 11 – Water/grease stains on ceiling below control joints.

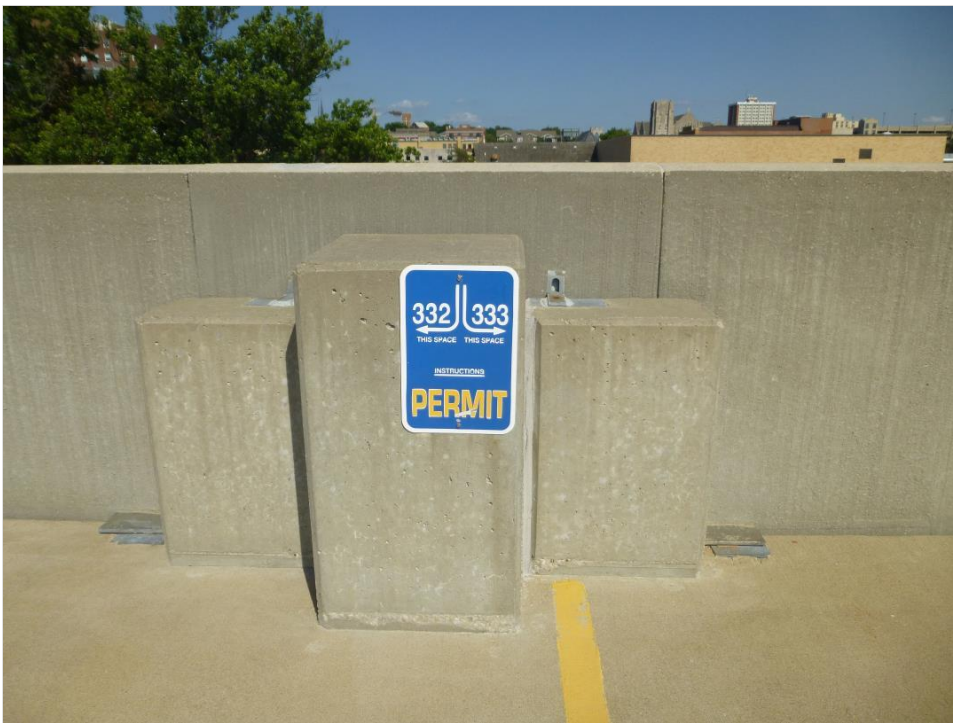
Photo 12 – View of Roof Level stub columns and failed vertical sealant.

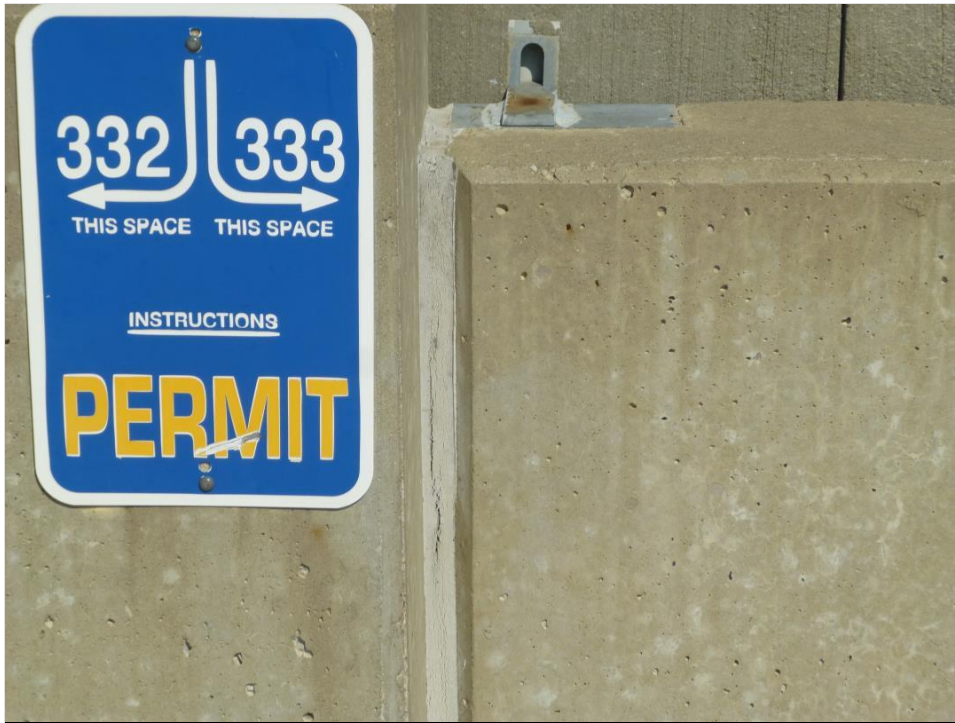
Photo 13 – Failed vertical joint sealant at stub column.

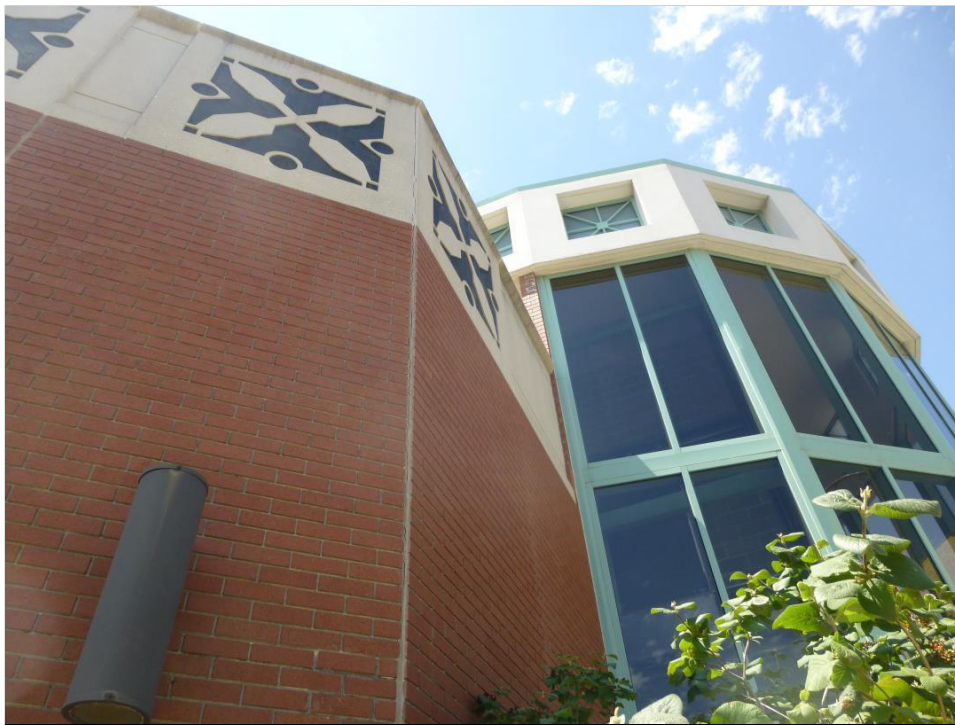
Photo 14 – View of typical vertical isolation joint installed throughout façade.

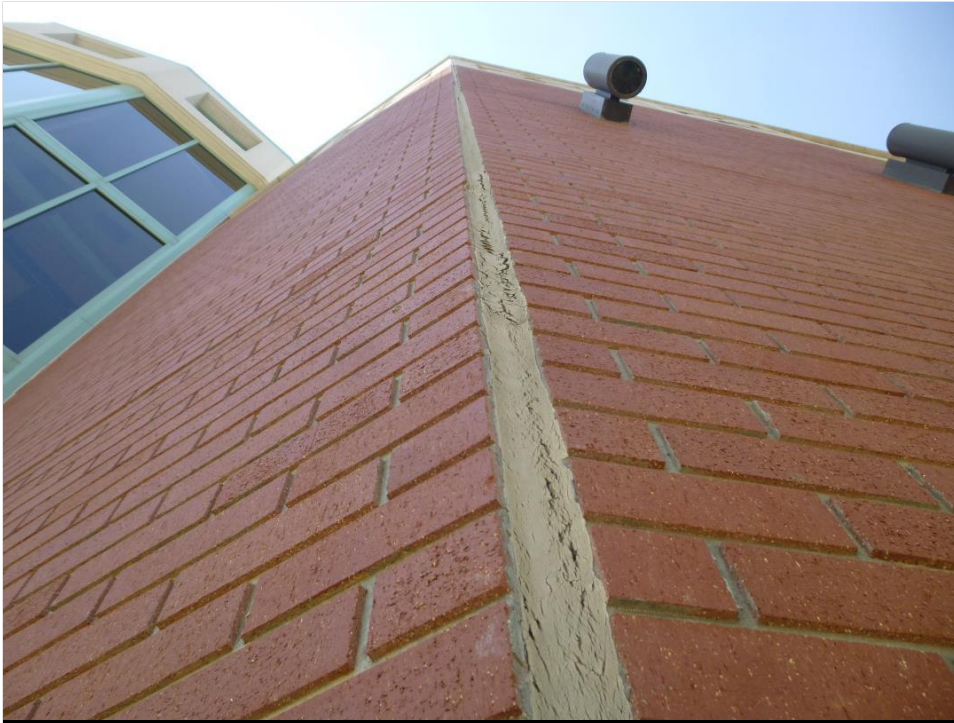
The waterproofing sealants on the façade panels as well as the roof-level stub columns have totally failed and are exhibiting alligator cracking. Water is allowed through these joints and can lead to corrosion of the embedded connections which hold the façade panels to the structure. Failure of the embedded connections can lead to the panel falling off the structure. These failed sealants may be allowing water to enter behind the brick veneer which can ultimately lead to spalling bricks. Also, we noted alligator cracking at the window perimeter

Photo 15 – Close-up of failed sealant at façade isolation joint.

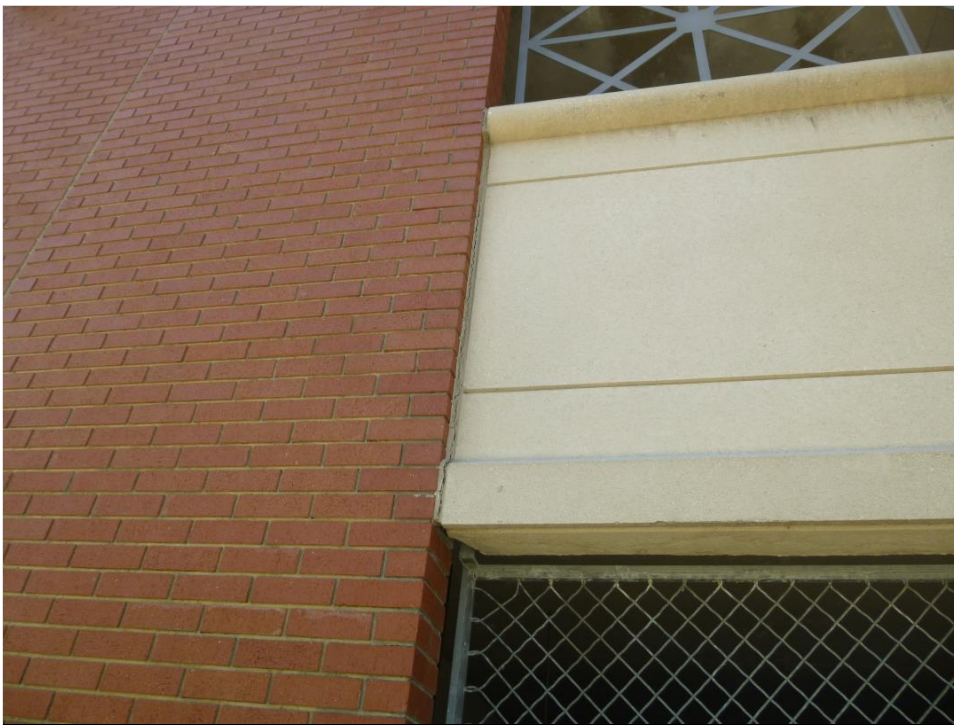
Photo 16 – View of façade panel and failed vertical sealant.

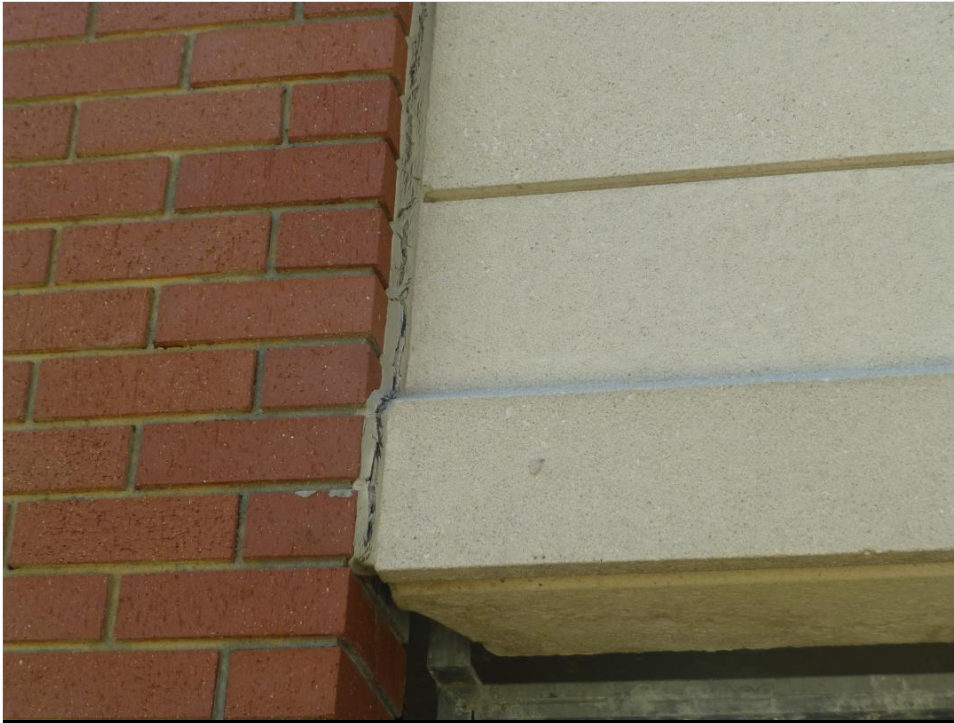
Photo 17 – Close-up of failed sealant between façade panel and brick veneer.

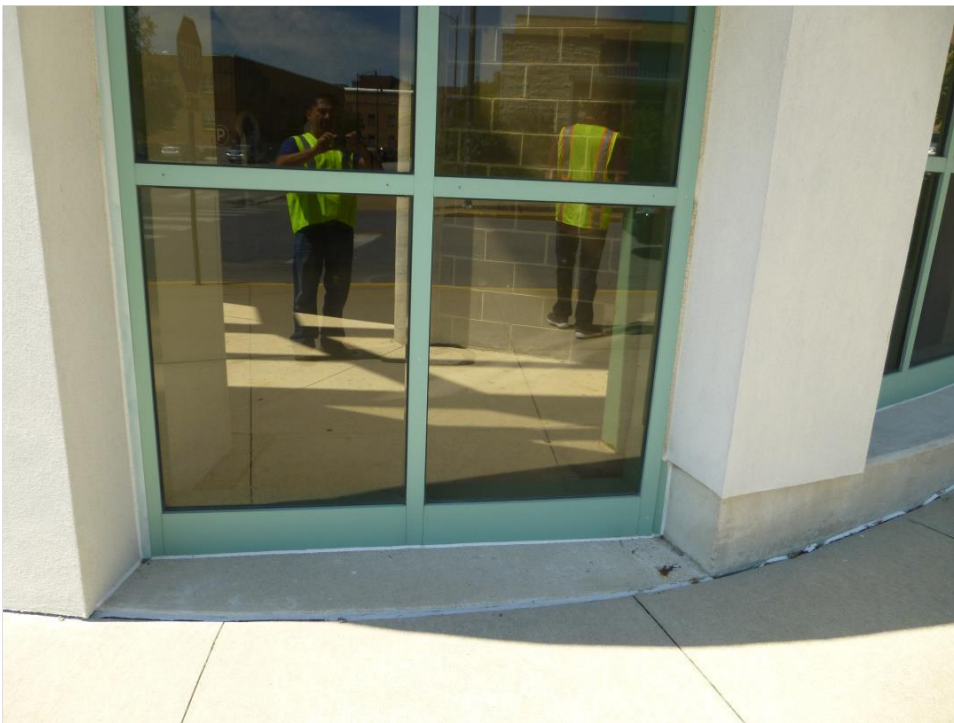
Photo 18 – View of storefront windows at stair towers.

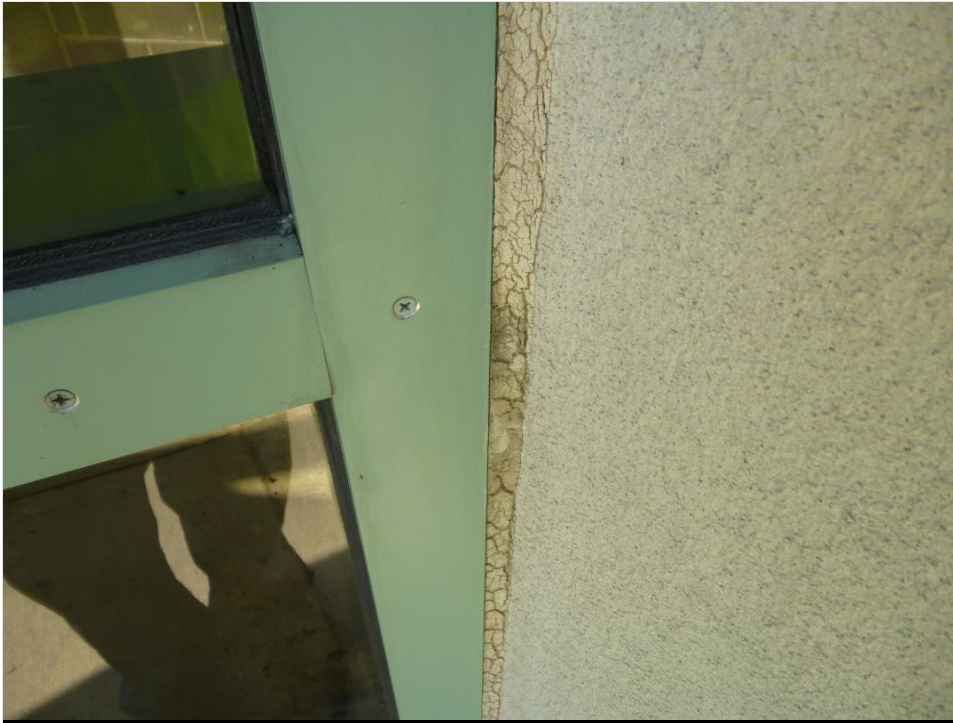
Photo 19 – Failed sealant at window perimeter joints.

joint sealants. Failure at these joints allows water to potentially enter the stair/elevator towers. We recommend replacing all these sealants.

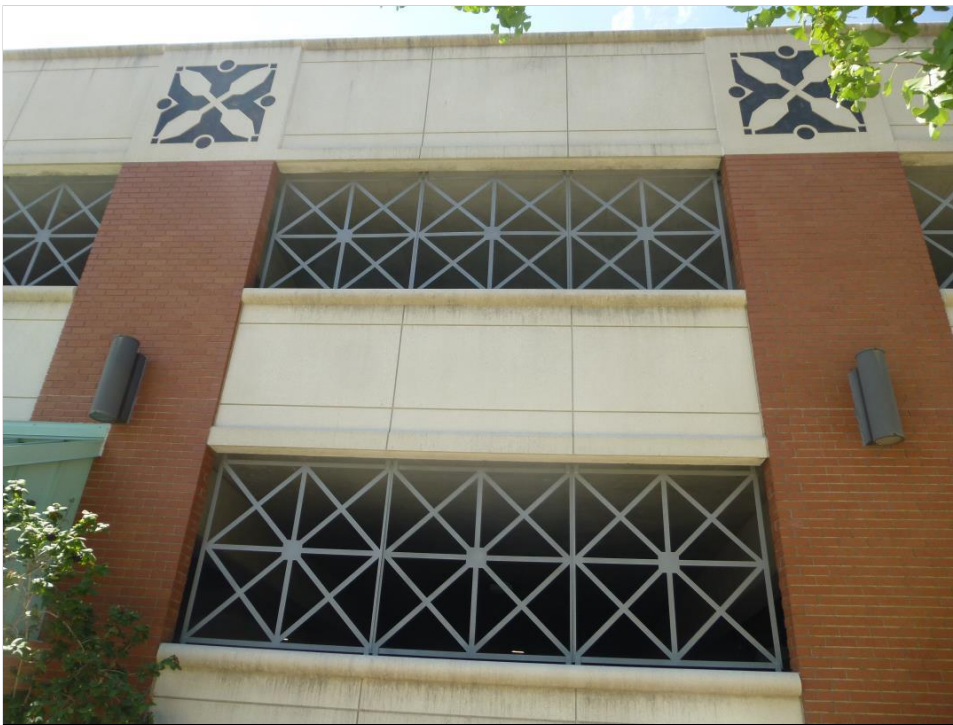
1. The façade panels have a build-up of embedded dirt and soot on them around the entire structure (Photo 20).

Photo 20 – View of concrete façade panel with embedded dirt and soot.

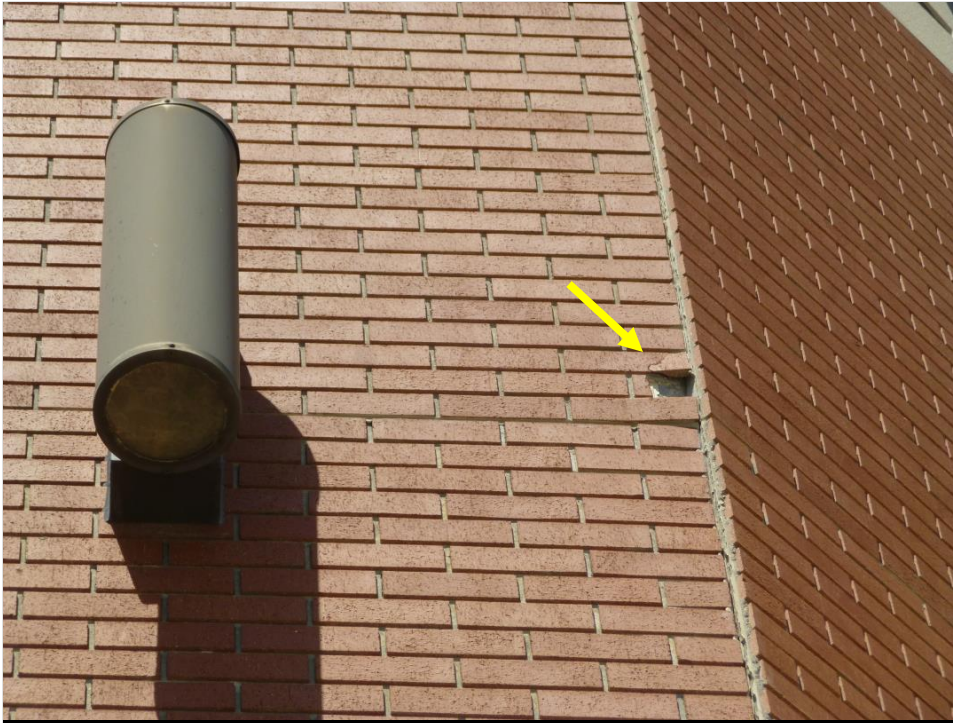
2. A few isolated brick spalls were observed throughout the façade. At one location, a brick was loosely hanging from the façade (Photos 21 and 22).
3. Surface corrosion observed at the metal base plates and handrails of the stairs. Additional surface corrosion was observed at the Roof Level snow-chute gate and at the east elevation handrails (Photos 23 and 24).

Photo 21 – Spalled brick at south elevation.

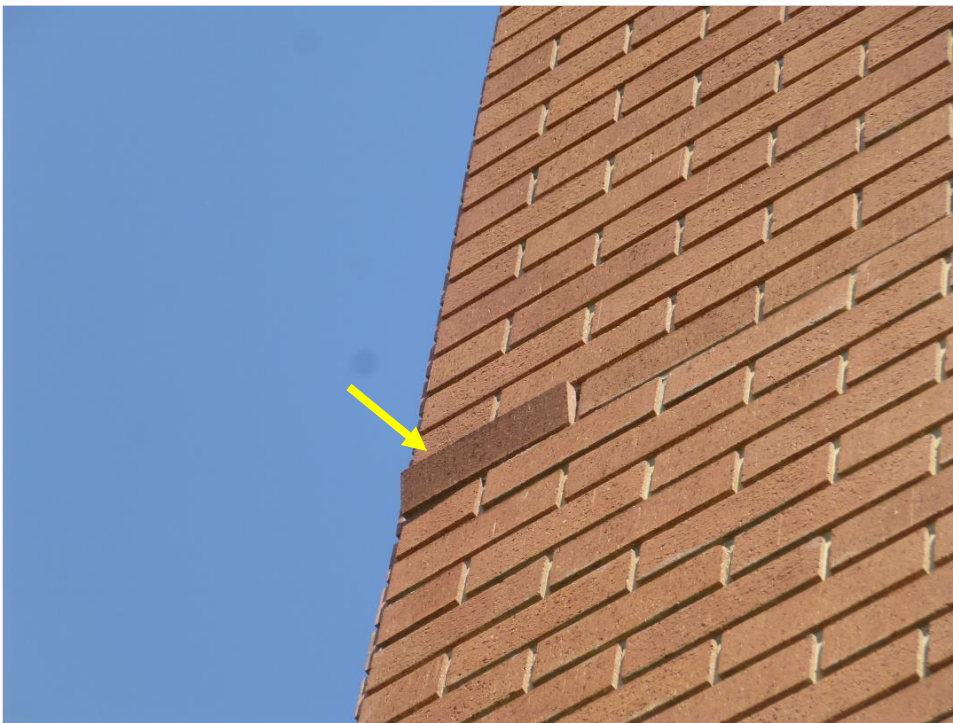
Photo 22 – Loose brick at west elevation, northwest corner of structure.

We did note minor surface corrosion at the base plates and handrails of the stairs. Currently this is not a structural problem, but more of an aesthetic concern. This condition was also observed at the Roof Level snow-chute gate and at the east elevation Ground Level handrails. We recommend cleaning and painting these locations to restore them to their original condition. Additionally, the exterior façade panels have a build-up of embedded dirt and soot on them around the entire structure. While this is more of an aesthetic concern, we recommend pressure washing these locations. Lastly, we observed a few isolated bricks that have spalled throughout the building's façade. At one location a brick was hanging loose and is about to fall (northwest corner of the structure, west elevation). We recommend removing this isolated brick as soon as possible.

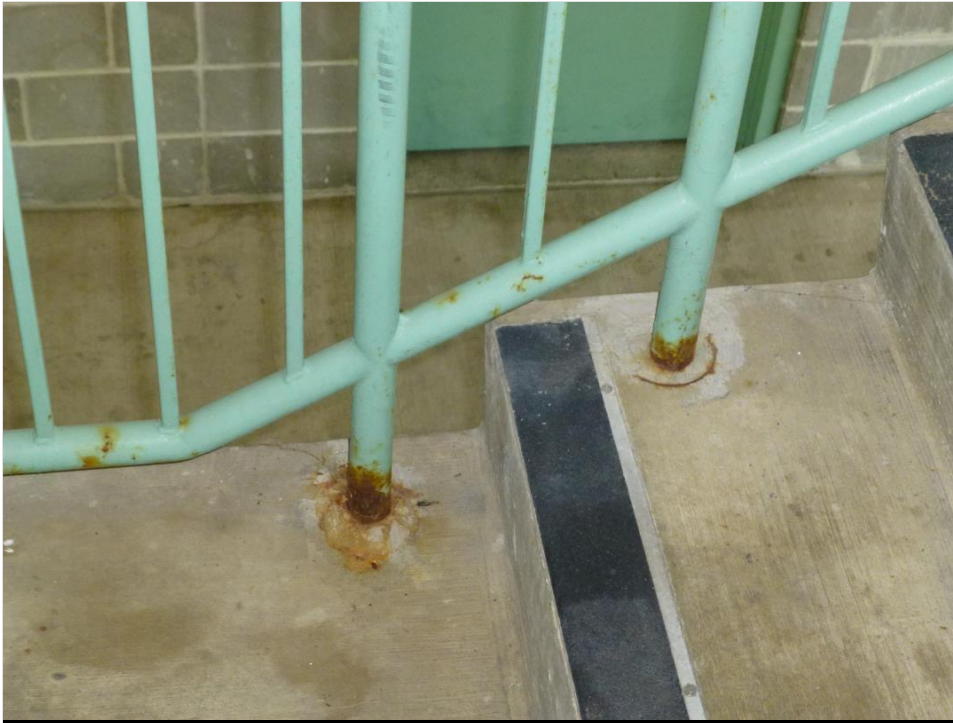
Photo 23 – Surface corrosion at stair handrails and base plate connections.

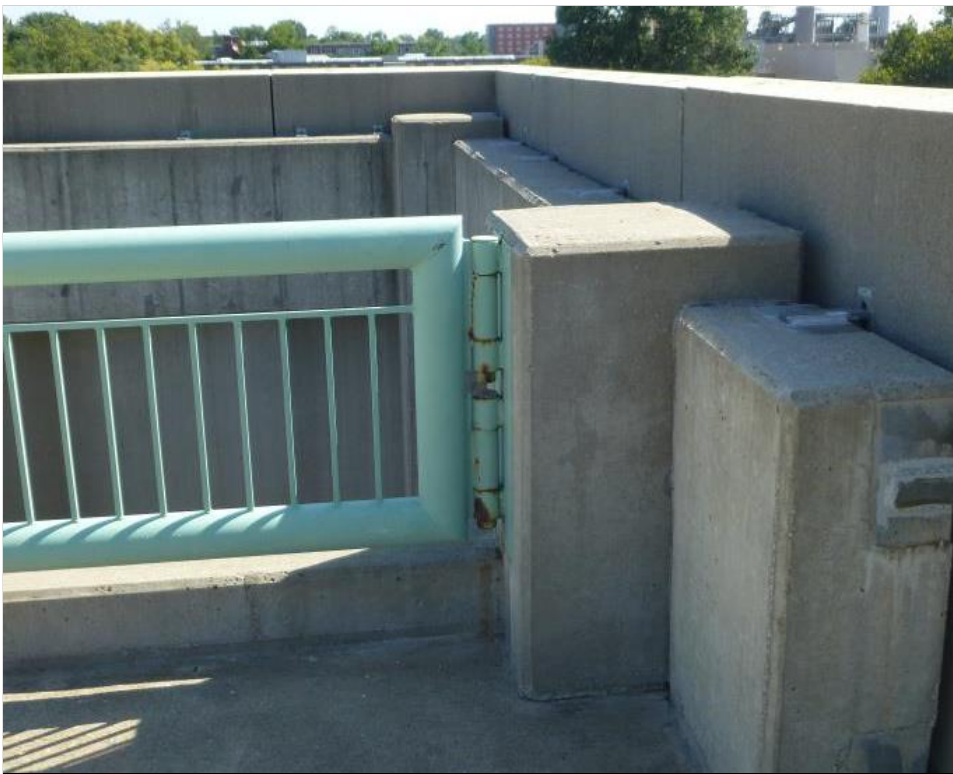
Photo 24 – Surface corrosion at snow-chute gate connection panel.
