Department Source: City Utilities - Water and Light

Council Meeting Date: March 4, 2019 Re: Report on East Campus Street Lighting

Executive Summary

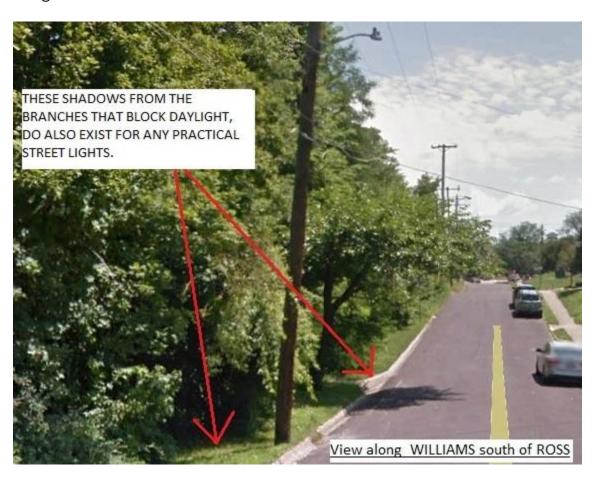
- B. Where existing light fixtures were not changed out (i.e. the existing light was not presently a mercury vapor type); significant changes in lighting levels were not expected; and generally, minimal differences were noted. (Example: along Bouchelle Ave)
- C. Where existing tree limbs block light, replacement of existing street light fixtures had only limited effectiveness. Significant trimming of tree limbs may help improve lighting levels considerably. The following pictures help illustrate some typical tree-vs-lighting conflicts.

These trees (on Williams south of Ross) block the sun; and also block the street light.

If increased lighting levels are still desired, staff recommends commissioning a study with an appropriate lighting consultant to evaluate the East Campus neighborhood to recommend an appropriate lighting project.

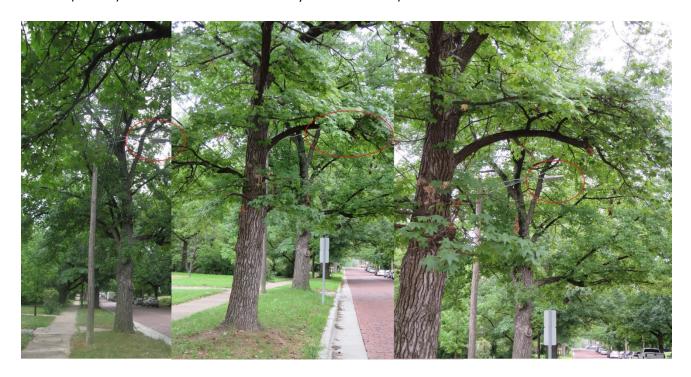
3 views of the same street light (mostly blocked by branches from the west & almost completely blocked from the east) on University Avenue.

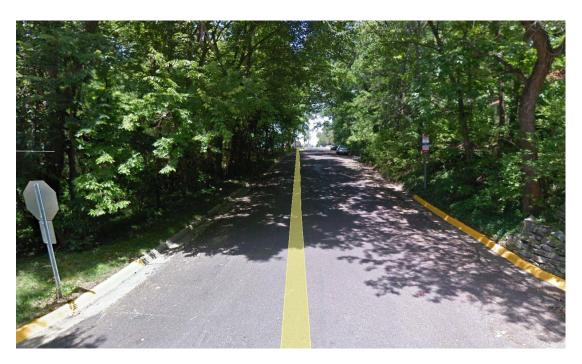
Parts of Ann St were commented about as being dark. Addition of any street lights in the southern most ~250' of Ann St (near University Avenue) will require that existing mature trees be significantly trimmed. This screen shot from Google Earth illustrates the conflict.
