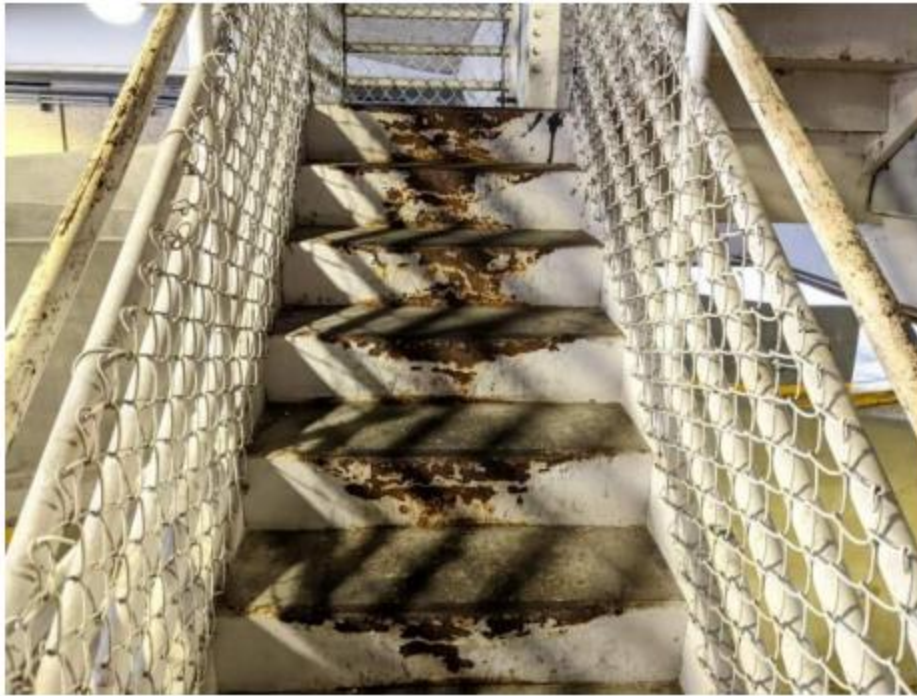
8&C -Photo 109. Interior stair tower with moderate to severe corrosion.

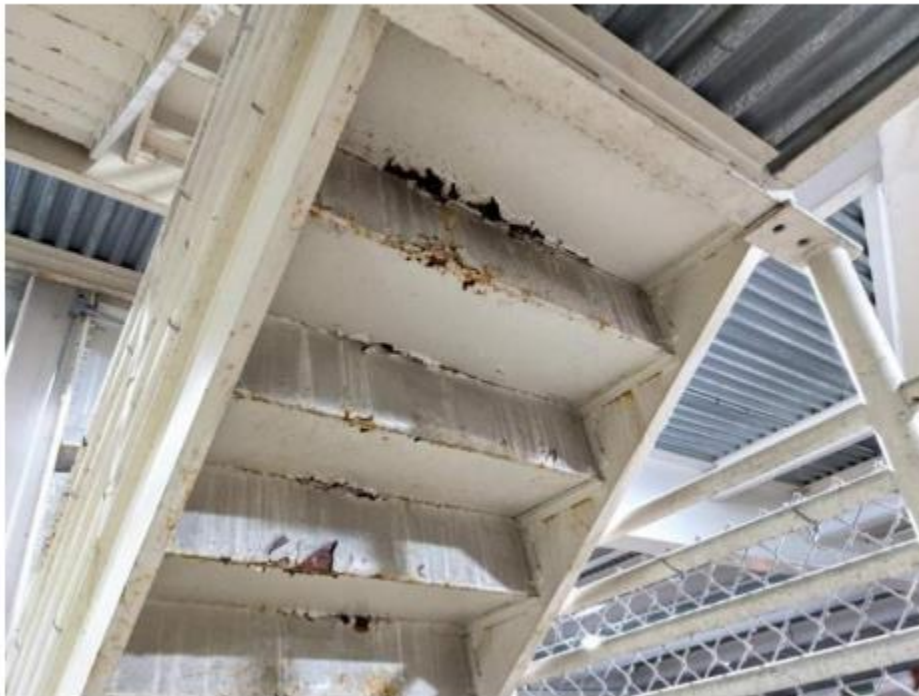
8&C -Photo 110. Underside of interior stair tower with moderate to severe corrosion.

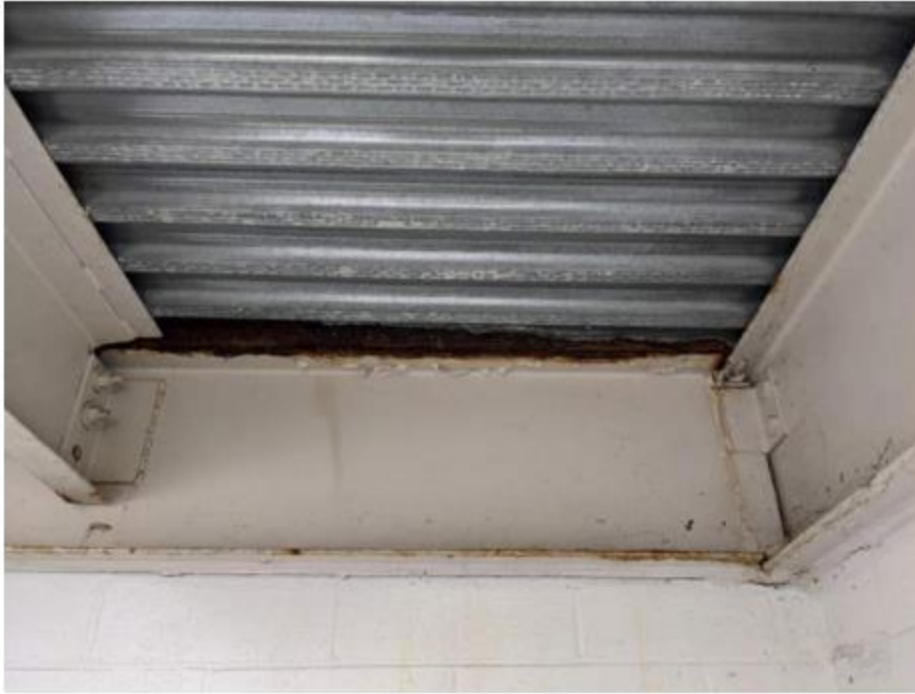
8&C -Photo 111. Typical corrosion on underside of southwest stair tower landings.

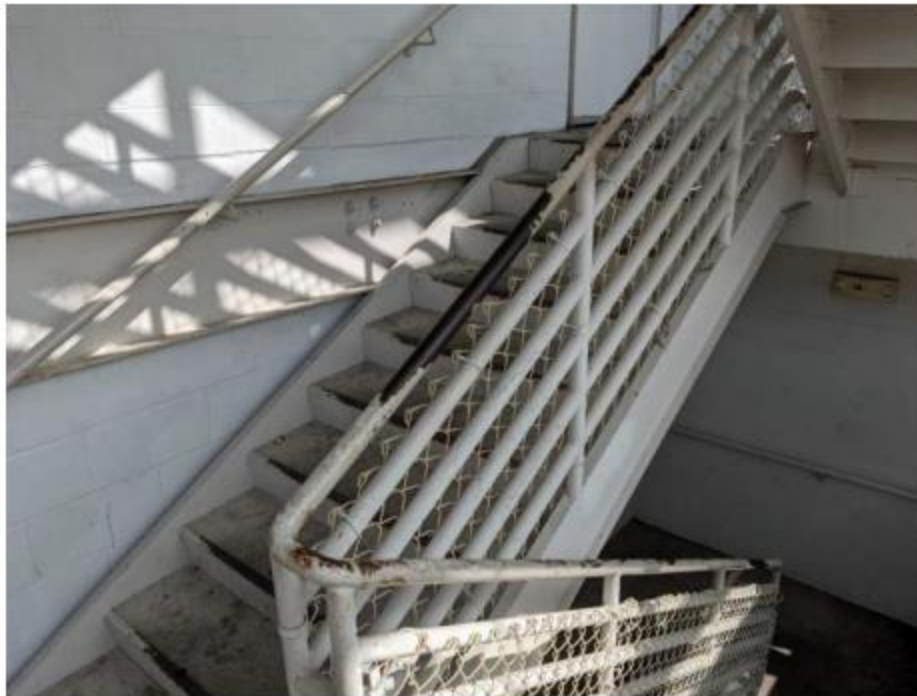
8&C -Photo 112. Typical worn paint on stair tower railings.
