# City of Columbia Pre-Council Meeting

Monday, August 17, 2020

# Hickman and 6<sup>th</sup> Stormwater

# HICKMAN AND 6<sup>TH</sup> STORMWATER

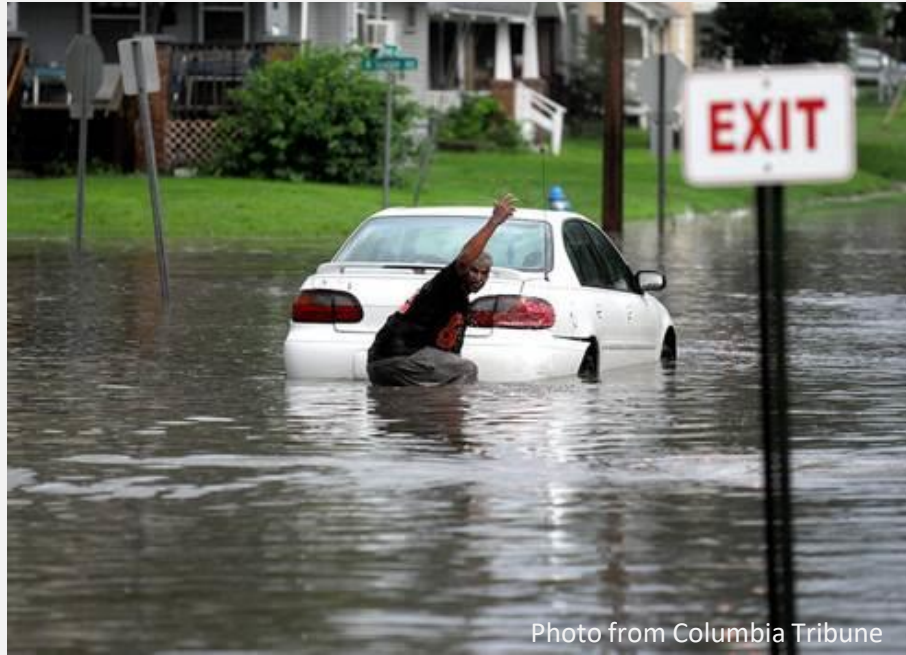
City Project: Sinclair Culvert at Mill Creek

## **Project Complete**

Fall 2018

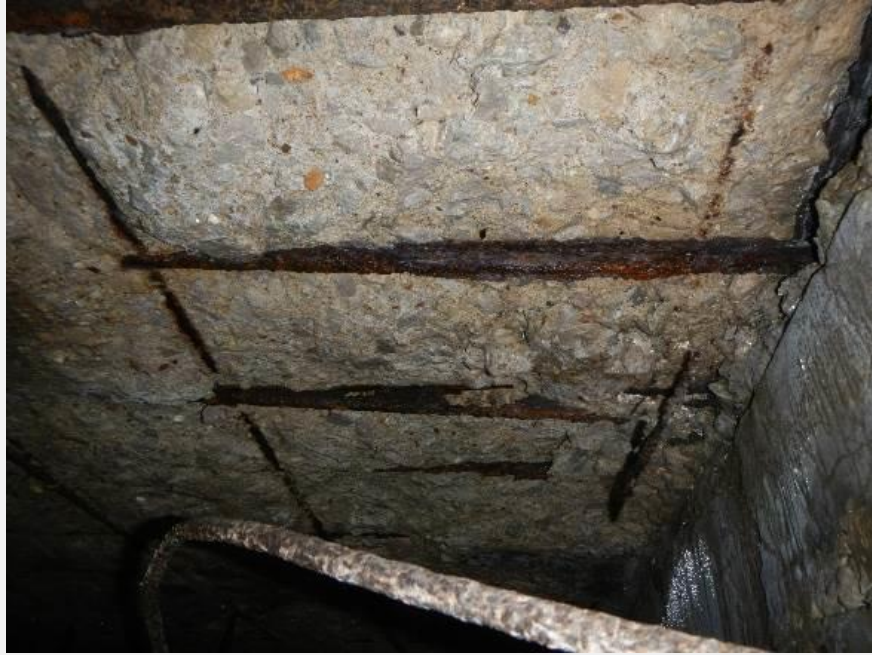
City Project: Hickman and 6<sup>th</sup>

## **Danger of Collapse**

1. Replace failing section of conveyance box.
  - Reinforced Concrete Box (RCB)
  - Built in Mid-Late 1930s
  - Steel in Top Slab Rusting Through

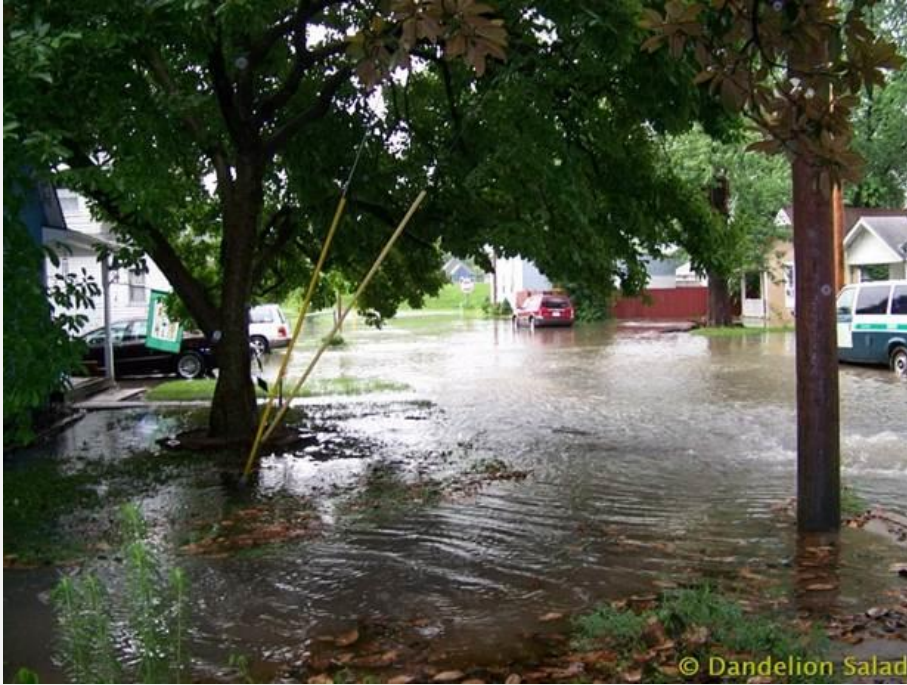
## 2. Reduce Flooding

- Improve Hydraulics of RCB
  - Steeper Slope
  - Less Abrupt Turns
- Improve Overflow, if possible
- Add Inlets to System

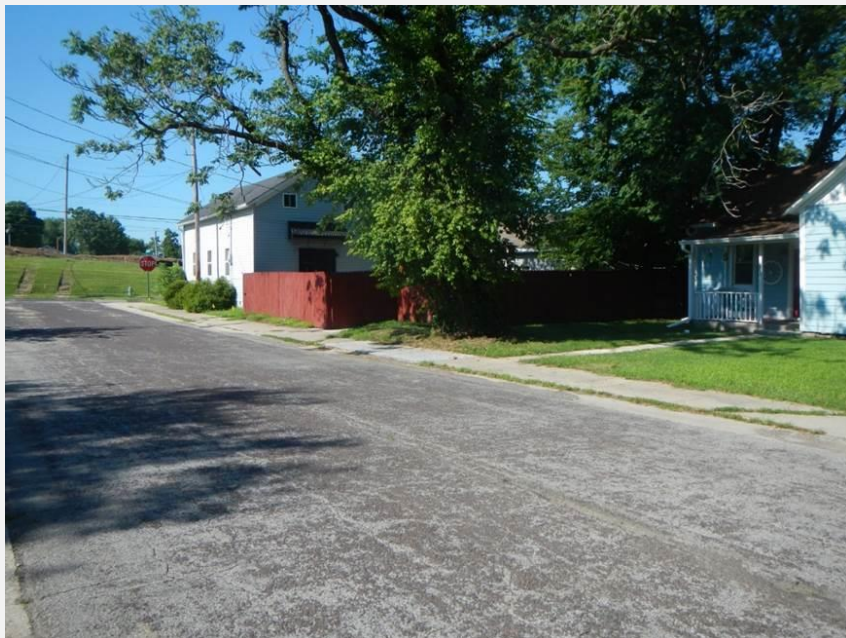
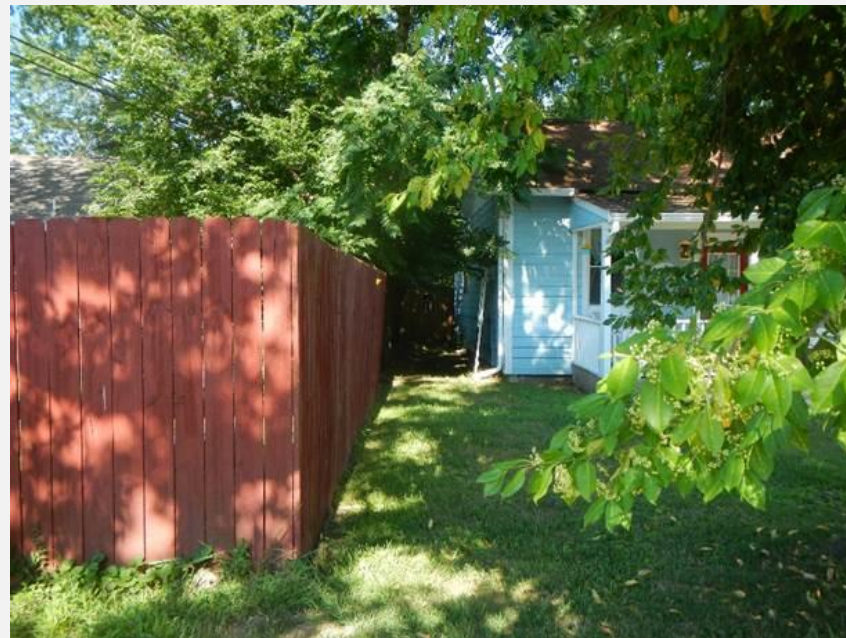
## **Overflow Path from 6<sup>th</sup> to Hickman**

Looking Downstream (southwest)

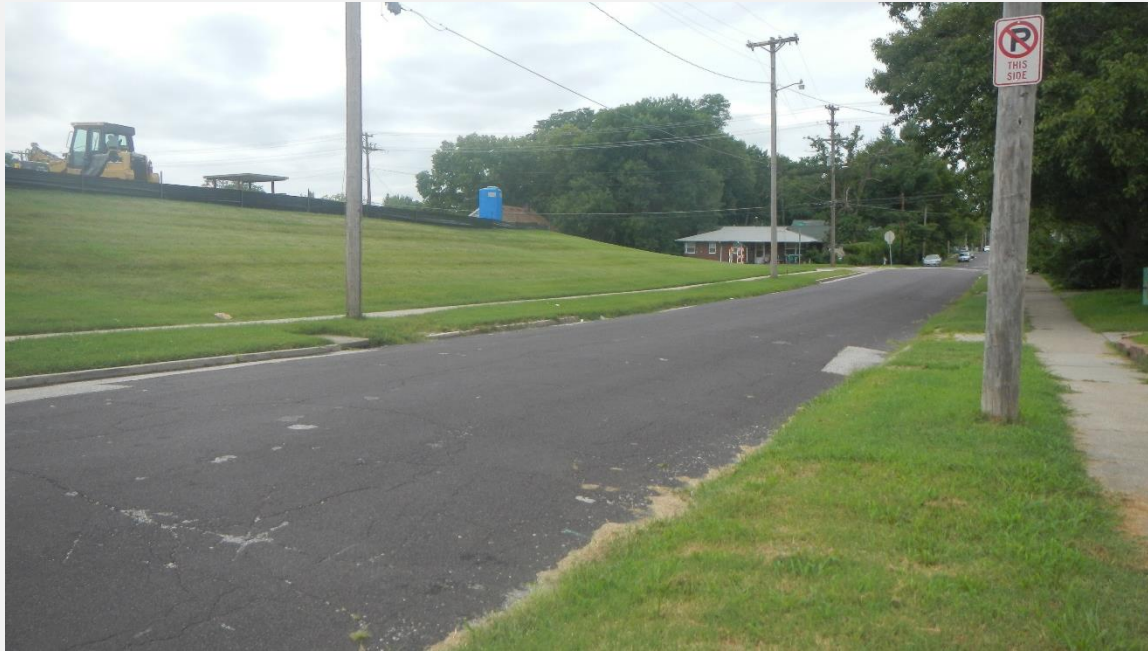
## **5<sup>th</sup> and Hickman Overflow**

Looking from low point on Hickman Toward Overflow

Ground rises 2 feet
