REPORT ON  
RECYCLING AND WASTE DIVERSION PROGRAM EVALUATION  
FINAL – SEPTEMBER 2024  
SUBMITTED TO

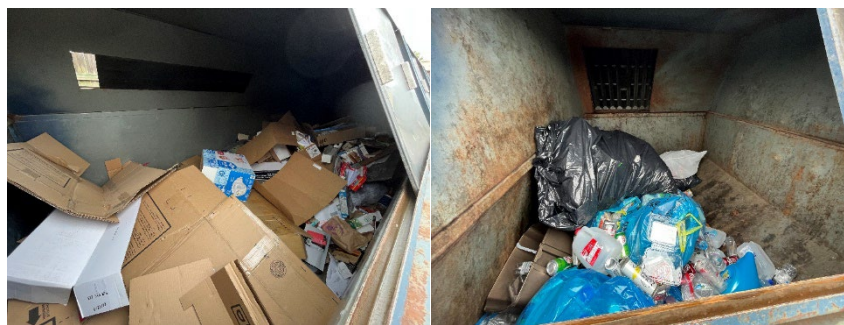
*Columbia College (Dulany Hall) – Near 8<sup>th</sup> Street and Hickman Avenue*

Users may perceive this location as being less accessible due to its location next to a loading dock. Contamination was relatively limited, which may be a function of the location being somewhat restricted. The posted instructions for use were not within line of sight when approaching and using the receptacles.

- **Monitor and respond.** The two sites at Columbia College along with the Downtown Armory location were observed to be serving their intended function acceptably. It is recommended they continue operating as-is, with the City monitoring them critically to evaluate their operation.

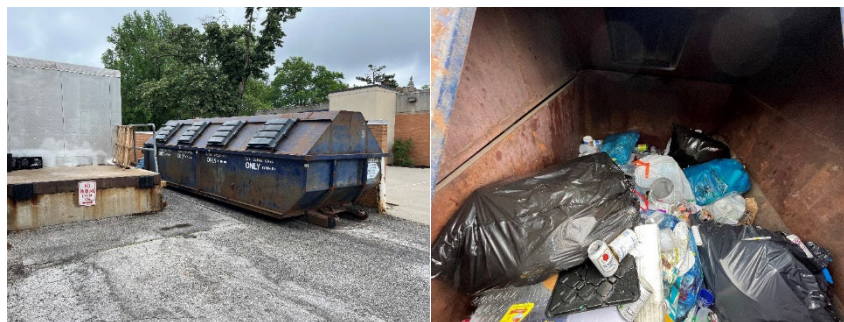
*Downtown (The Armory) – Along Park Ave, between 7<sup>th</sup> and 8<sup>th</sup> Street*

RRT observed this location to be busy with users. The receptacles are gable-top roll-offs for both streams. The site and the receptacles are out in the open. The receptacles were observed to be more contaminated than other sites, with bagged trash in both the container and fiber roll-offs, somewhat more so with the commingled containers. The recycling guidelines are posted directly on the roll-offs.

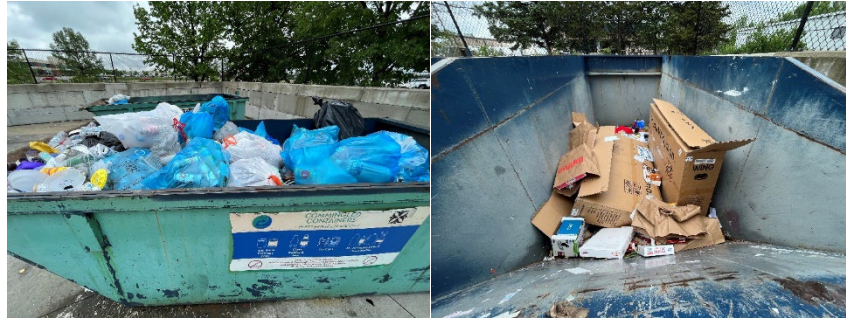
*State Farm Parkway – Near Grindstone, North of E. Nifong Blvd*

This site is another notably larger location. The containers are open top 8- to 12-cubic yard “dumpsters,” most without closures. This is the only drop-off center with a dedicated receptacle for glass. A City employee who happened to be on site noted this is the busiest location. The site was observed to be clean and had minimal contamination in containers and fiber dumpsters, despite the wide-open access for users, the somewhat secluded location, and being heavily screened from the street. There was minor contamination in the dumpsters from bagged trash, although much of the cardboard had Styrofoam inside of it and one of the fiber dumpsters had carpets placed inside of it.

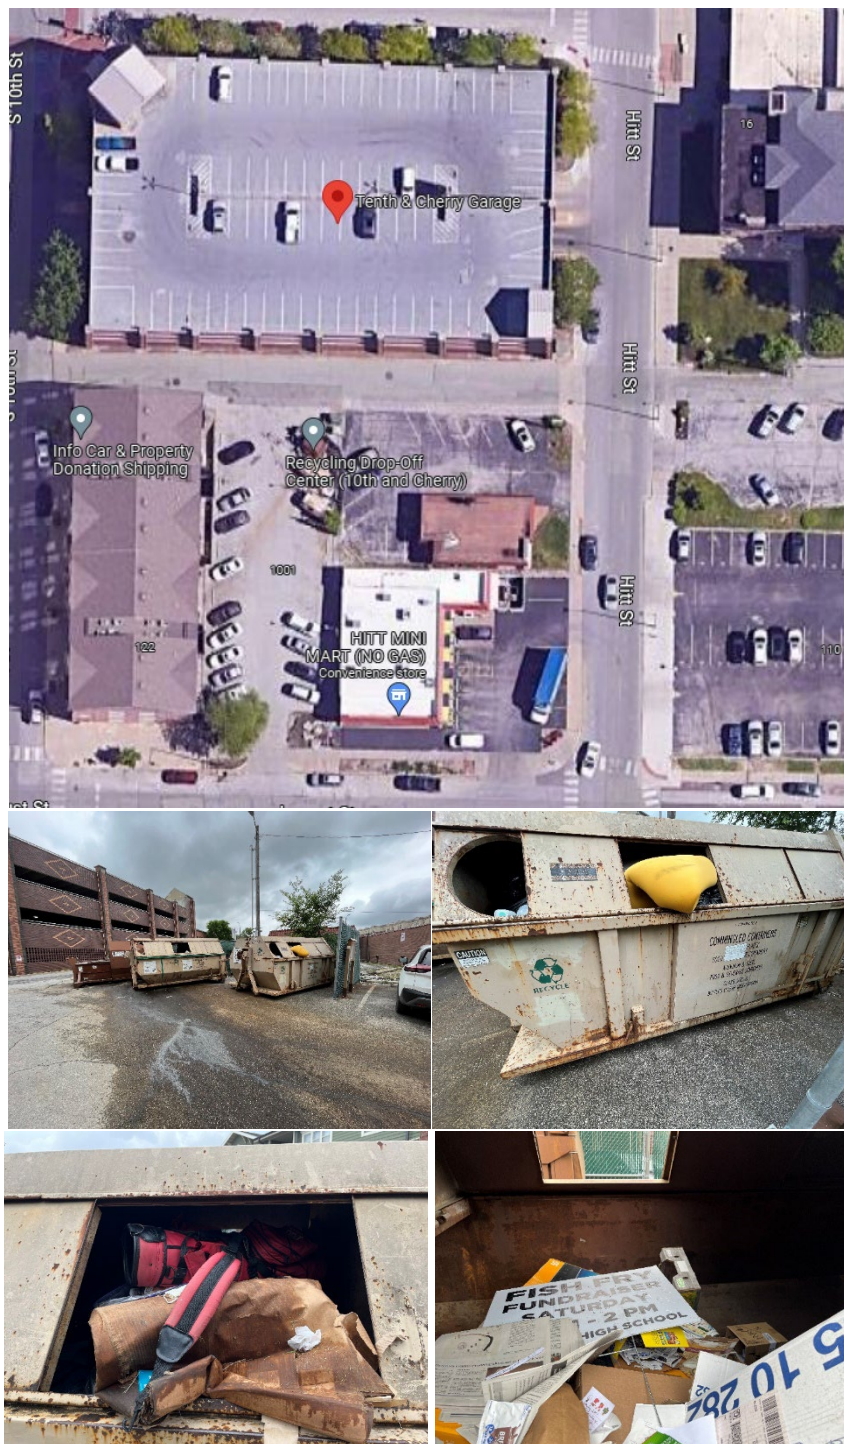
*Downtown (10<sup>th</sup> and Cherry) – South Side of 10<sup>th</sup> & Cherry Parking Garage*

The receptacles consist of a compactor for fiber and a gable-top roll-off for containers. Despite being in the middle of Downtown, the sightlines make it somewhat secluded because it is surrounded by an enclosure and faces a parking garage, the back sides of commercial buildings, and a small apartment building. This encourages improper dumping; the apartments may also be a source of contamination. RRT found this was the most contaminated site observed, with many dumped items forced into the openings of the roll-offs.

recommendation to close the two sites on the Mizzou campus and the site at 10<sup>th</sup> & Cherry, Downtown (See Section 2.1.2 for descriptions and pictures of the recycling drop-off centers and Section 8.1 for discussion of closing contaminated sites).

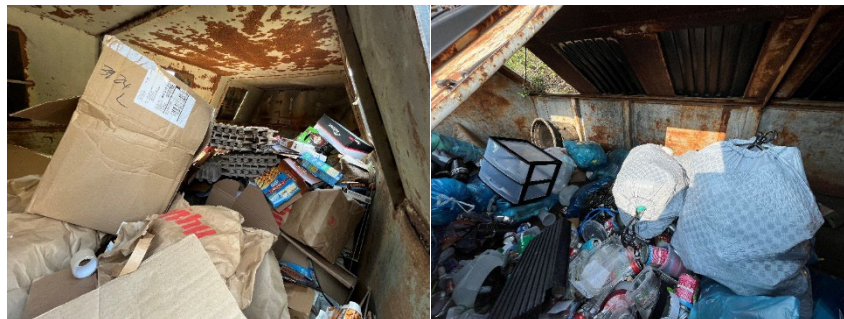
*University of Missouri (Bluford Hall) – Along Kentucky Boulevard*

The site is in a permit parking lot on the Mizzou campus. The receptacles consist of gable-top roll-offs for both streams. Contamination was uneven, with little contamination in the fiber receptacles but a high incidence of bagged trash, bulky plastics, and more in the commingled containers.

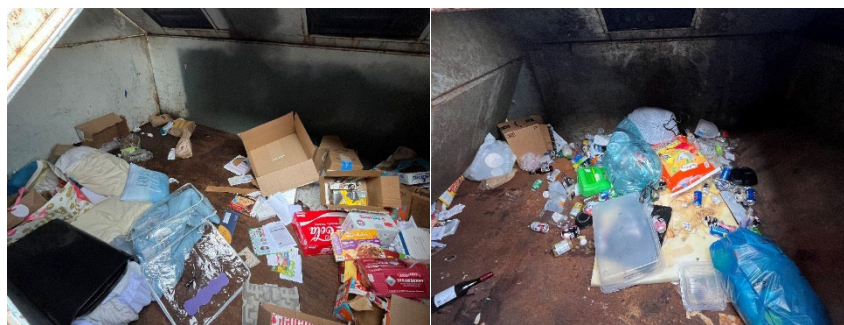
*University of Missouri (East Campus Plant Growth Facility) – Near East Campus Road and Ashland Road*

The site is adjacent to a residence hall on the Mizzou campus. The receptacles consist of gable-top roll-offs for both streams. The site had apparently been serviced relatively recently, but contamination in receptacles was already observed, including blankets, pillows, bulky plastic home goods, foam, crockery, film plastics, and cardboard in the wrong bin.

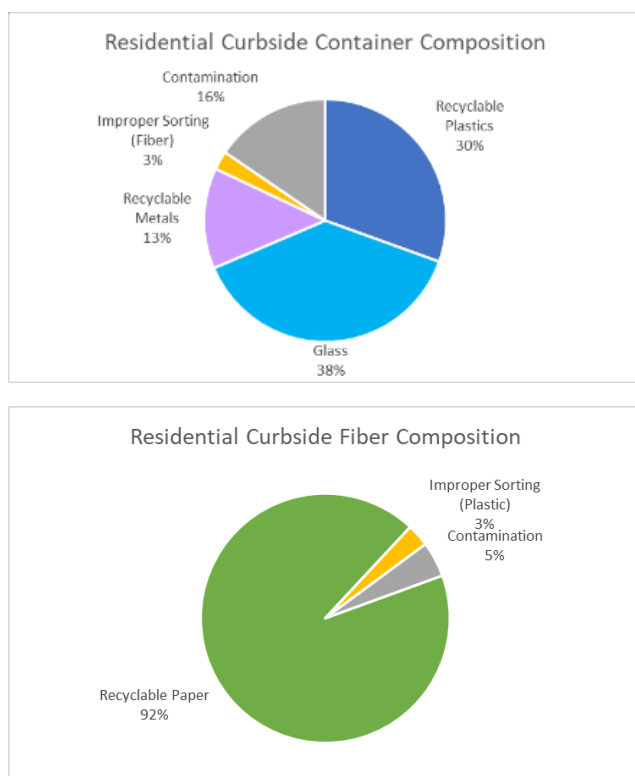
Figure 6: Composition of Curbside Recyclables—Commingled Containers and Fiber

- The contamination rate (15.5%) in the residential curbside container samples is on-track with the national average contamination rate (16.9%).
- The predominant material incoming in the residential curbside containers is glass. Glass accounts for approximately half of the total recyclable fraction by weight. Due to the density of the glass, it constitutes a larger proportion of the waste stream when compared to plastics and metals.
- The contamination levels in the residential curbside fiber samples are remarkably low (but a more robust analysis is needed to confirm).
- Enforcement at the curb helps to reduce contamination.

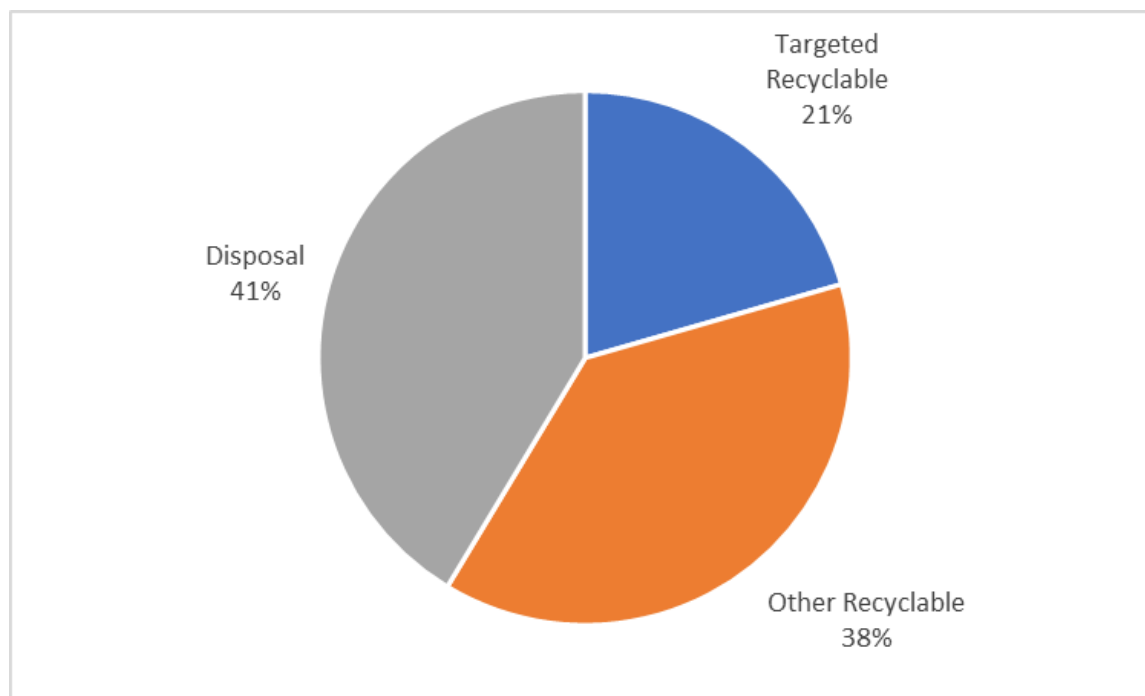
*Figure 9: Recyclability of City-Managed Waste Disposed of at City Landfill (2023)*

Of the City-managed waste disposed of at the landfill, over 50% has the potential to be diverted as presented in Figure 9. About 15% of residential waste comprised targeted recyclables while about 25% of commercial waste comprised targeted recyclables.

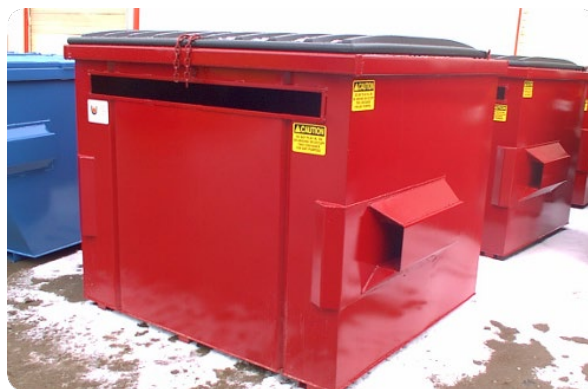
One example is a type known as a “slot-box.” Shown here, this is a closed receptacle with a locked lid and an opening which is restricted in shape and size to facilitate the insertion of cardboard and paper but discourage or even prevent users from putting in bagged waste. Evaluation of a site prone to abuse might find the customers are better served by this kind of container, so they can have better access to capacity. They may have little or no commingled containers, and can instead focus on paper and cardboard, knowing their recycling capacity is protected from random dumping or abuse. Educating customers of this benefit would ideally lead to them collapsing cardboard to put in the slot-boxes, further alleviating overflow situations. The cost to retrofit existing 2-yard receptacles would be marginal. The benefit is preserving container capacity for recycling participants. This option can be implemented in the near future.

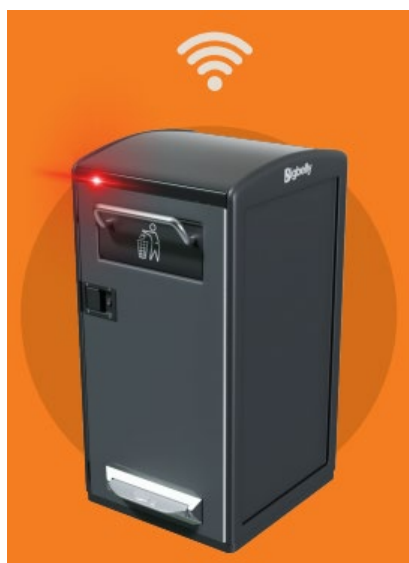
Another container type which can help with overcrowding of the Downtown recycling containers is a BigBelly solar compactor trash container. Many cities across the world, including North America, Central America, Europe, Australia, and Japan have implemented these containers to combat littering and other problems with waste in the wrong place. It is a receptacle for passersby to deposit their personal trash and litter. The container has either a 50-gallon or 150-gallon volume; however, due to the internal compactor, it can hold the equivalent of several times that amount. The compactor is powered by a 5-year battery and/or solar panels, and has a foot-pedal for hands-free use. The units can also communicate via wireless network to let the City know when they need to be emptied. These could be placed at the locations with the greatest issues of dumping and abuse of the recycling containers. The City could paint attention-getting signage directly on the

sidewalk next to the BigBelly containers, to make sure pedestrians see them, and the containers can be “wrapped” with color printing to communicate with users.

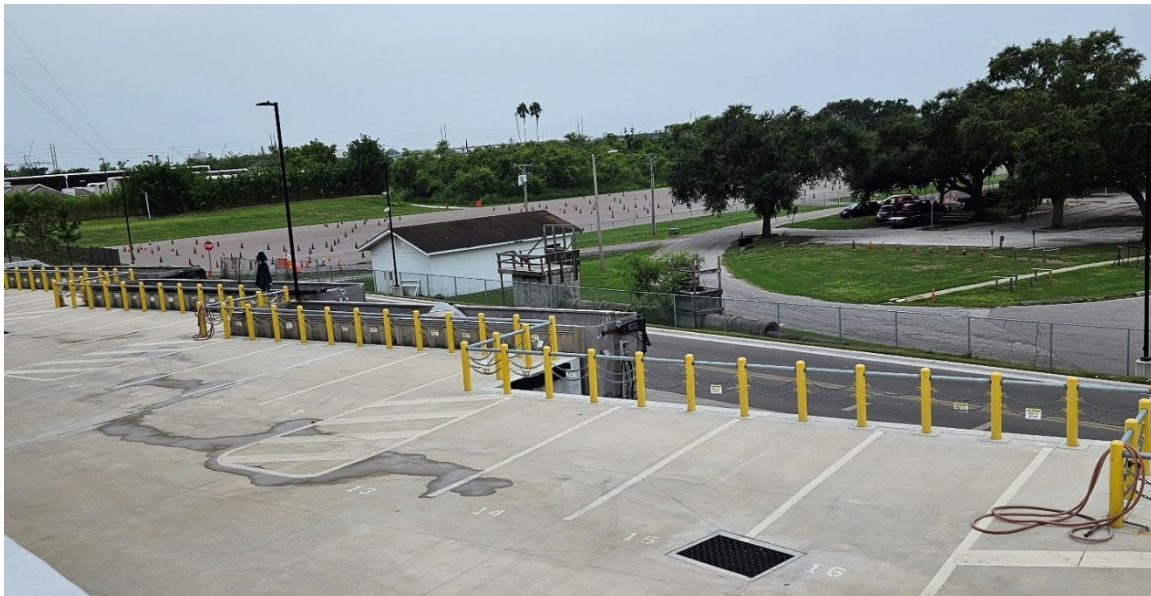
*Figure 20: Back-In Parking Areas for Customers, City of Tampa “Z-Wall” Recycling Center*

This recycling center is integrated with a waste transfer station where contractors and residents can bring debris such as furniture, brush, etc. Users drive up a curved incline ramp from ground level to the platform, from which they can discard their materials into open-top containers below at ground level. They exit by driving down another curved ramp, and can then leave the facility or proceed to the transfer station scales to dispose of additional materials.

Figure 20 is a photo taken from above the finished recycling center, showing the parking spaces and the difference between the elevation of the containers and the customer area. Note the bollards and chain to keep customers and vehicles on the platform, and the waiting containers below. In this design, customers enter from the left side of the photo, back into a parking spot, discard their items, and exit to the right of the photo.

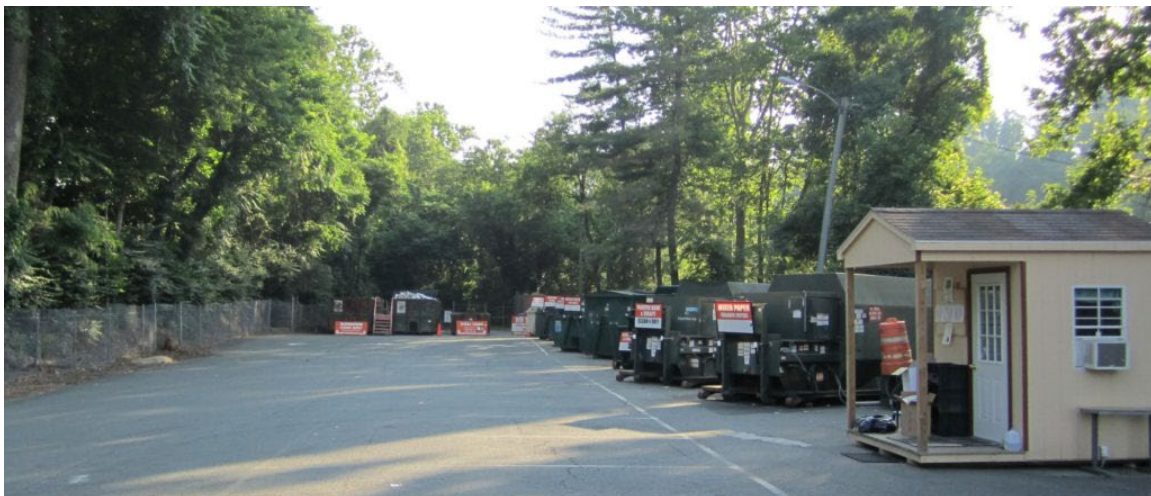
*Figure 22: McIntire Road Recycling Facility in Charlottesville, VA; Operated by Rivanna Solid Waste Authority*

The Rivanna Solid Waste Authority serves the City of Charlottesville, VA, and surrounding areas. The Authority operates a small, staffed recycling center near the heart of downtown Charlottesville. Home to the University of Virginia and a long-established progressive community, curbside recycling is offered but many residents avail themselves of this facility as needed. In addition to typical recyclables, the facility hosts collection points for used cooking oil, empty oyster shells, and a small-scale food scrap compost program. The facility is open 60 hours a week, 8:30 a.m. to 6:30 p.m. on most days but closed on Tuesdays. Accordingly, it is staffed by 1.5 FTEs. A small, air-conditioned shed provides workspace and shelter for the employee, shown in Figure 22.

The site is small in area—about half an acre not including the access driveway. As shown in Figure 22, the layout is simple. A row of roll-off compactors accept material. Visitors park in marked spots and walk in the pedestrian area from one container to the next as needed. Figure 24 provides an aerial view of the facility and the immediate surrounding area. The site is heavily screened from the street—there are single family homes across the street, and just out of frame in this photo is a baseball diamond, immediately adjacent. The access driveway is gated when the facility is closed, and the community uses a combination of police presence and surveillance cameras to discourage and pursue illegal dumping. All of these management techniques allow the facility to be a “good neighbor” and a popular resource for residents.

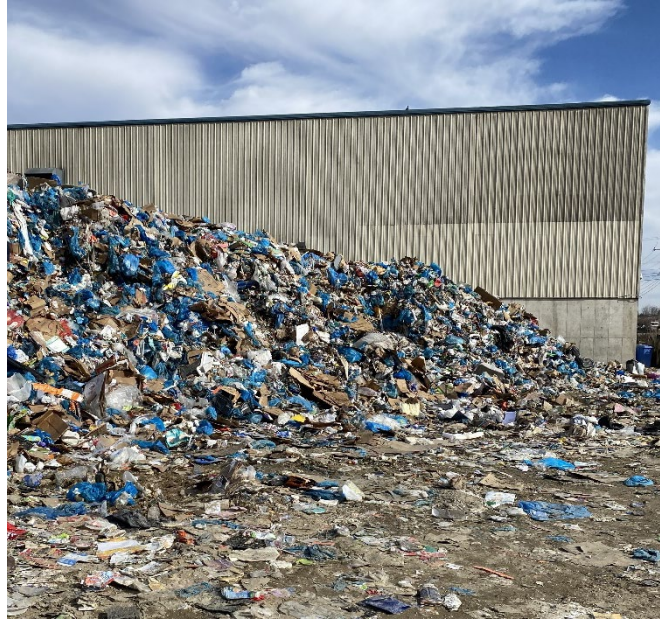
This stockpile continued to grow. If an inbound load is discovered to have an improper mix of fiber and commingled containers, Operators may direct it to dump on the stockpile rather than contaminate the material on the tipping floor. Because the stockpile is exposed to the atmosphere and weather, the material has degraded and any fiber or organic matter has begun to disintegrate. The contents of this stockpile cannot easily be processed due to the poor quality of the material and the mixture of fiber with the commingled containers. This stockpile is an eyesore, an environmental hazard and will encourage vectors including but not limited to the cats that were observed. This stockpile should be removed from the site.

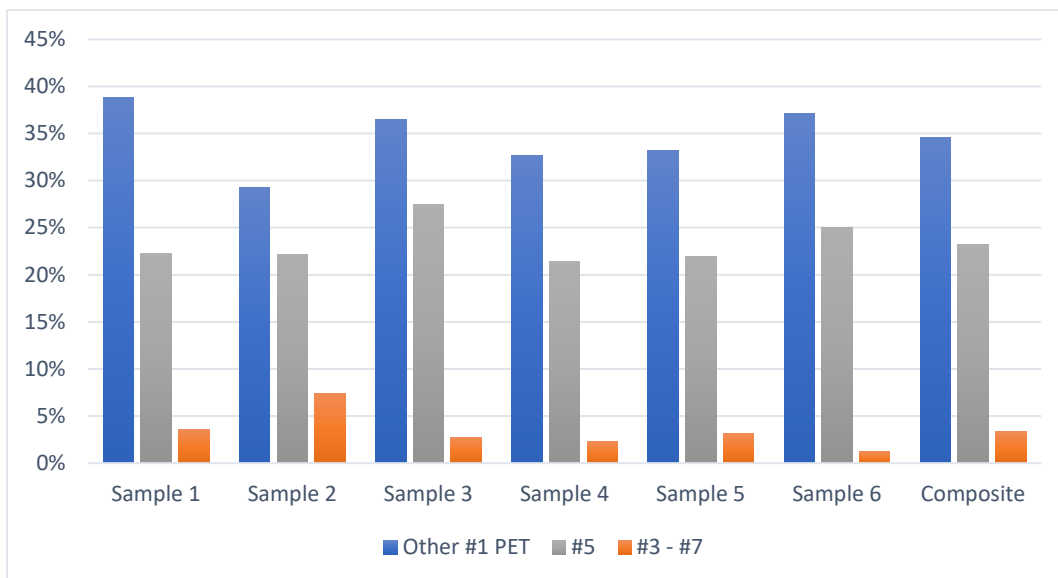
Figure 8. #3 - #7 Recyclable Constituents

The single largest constituent of the #3 - #7 bunker is other #1 PET at 34.6%, this is compared to the 23.2% for #5 plastics and 3.3% for #3 - #7 plastics. Marketing these materials as #3 - #7 is diminishing potential returns. Very little of the material in the #3 - #7 bunker is mixed plastic; rather, the material is primarily #1 and #5 plastics. Both polymers are significantly more valuable than the price currently received for the mixed plastic.

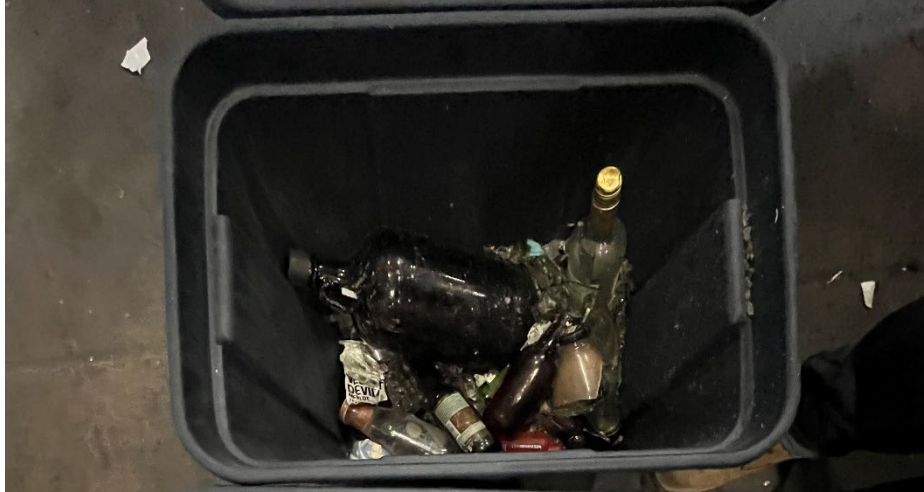
Figure 12. Glass Found in Container Residue

The amount of glass found in these samples is unexpected because glass is negatively sorted, meaning it remains on the conveyor belt. The image above was captured on a day with the largest volume of glass found in the container residue sample and depicts the type of glass found in the residue sample. Acceptable glass containers include beverage containers, food containers, and other glass containers. According to those requirements, all glass bottles in the image should be recyclable. Additionally, any glass fragments or shards should not be handled directly because it is a safety hazard for sorters.

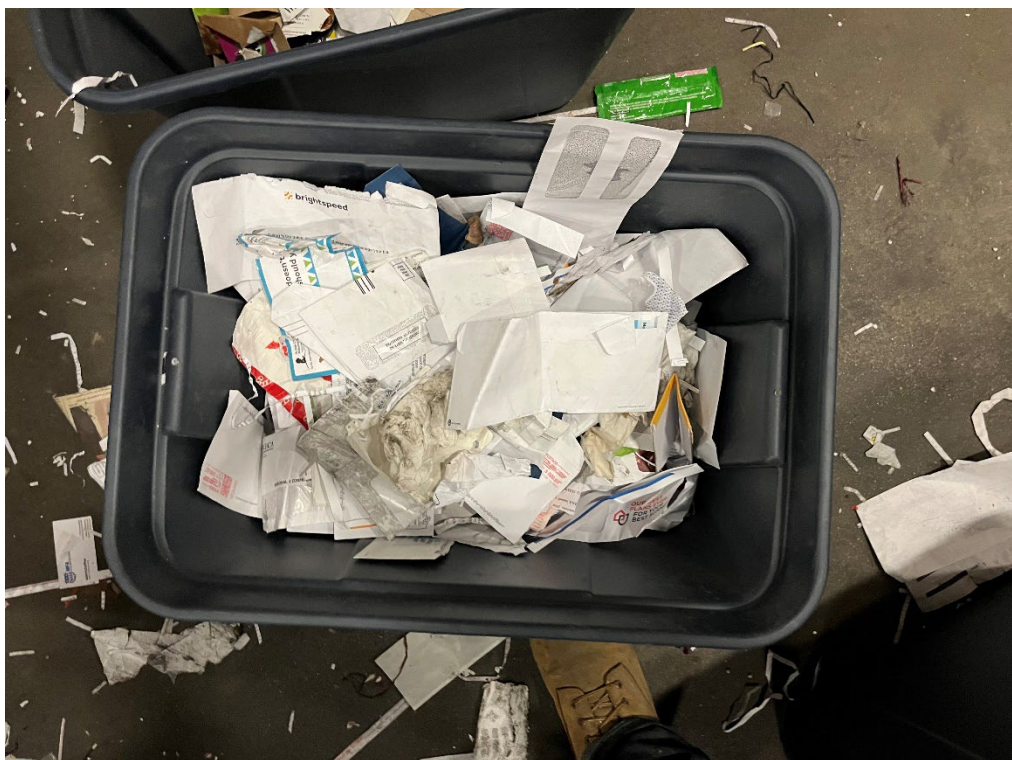
Figure 15. Remainder/Composite Paper

Typical examples of remainder/composite paper contamination include napkins, waxed cardboard, and paper plates. However, the most common remainder/composite paper sorted was envelopes with plastic windows. When on the fiber line, the composite envelopes can be confused as high-grade paper and be sorted into the corresponding bunker.

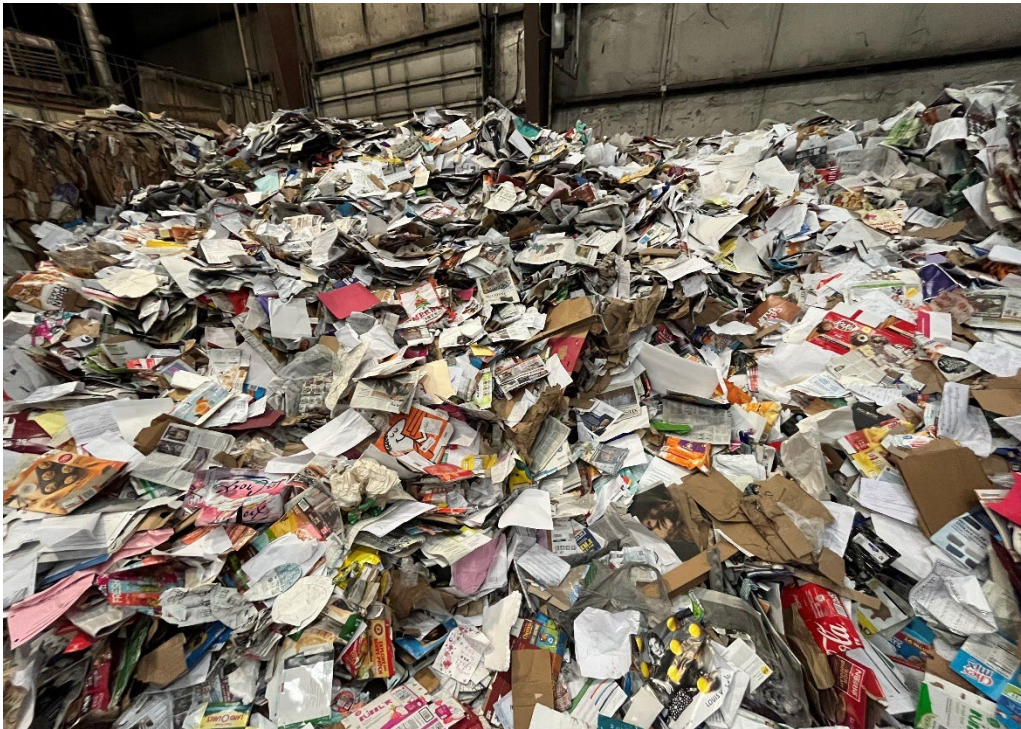
Figure 26. Representation of the ONP Bunker

As discussed, it appears that much of the material that is entering the ONP bunker is not newspaper. There is a mixture of kraft paper, high-grade paper- mixed paper, and ONP. However, based on discussions with MRF staff, vendors have no concerns regarding the outthrows found in the material. Therefore, it would be ill-advised to alter the composition of this material because selling the material at a lower paper grade would impact revenue at the MRF.

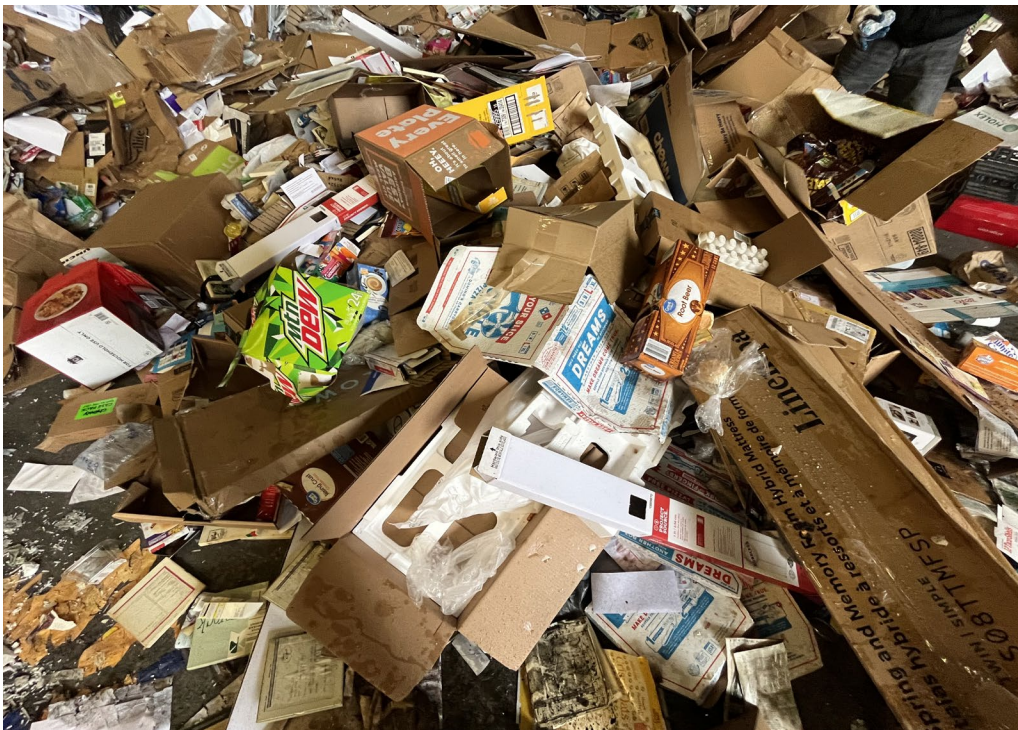
Figure 27. Drop-Off Center Fiber Load 1

The first visually inspected load (Load 1) from the fiber roll-off container had minimal contamination. Consistent with the results from the curbside residential fiber characterization, cardboard constitutes a significant proportion of the total fiber stream. Primary sources of contamination included EPS and film plastic.

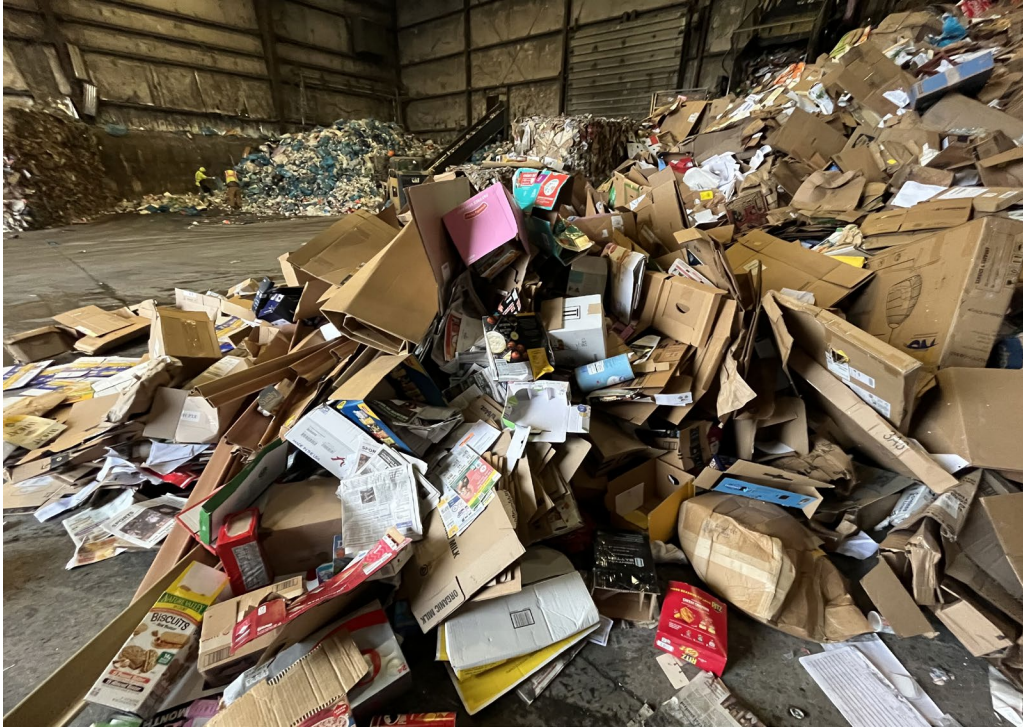
*Figure 28. Drop-Off Center Fiber Load 2*

Fiber Load 2 had lower levels of observed contamination compared to Fiber Load 1. Much of the contamination was caused by user error, including separating film and plastic contamination, such as EPS, from the fiber. Many appliance boxes were observed to have expanded polystyrene inside.

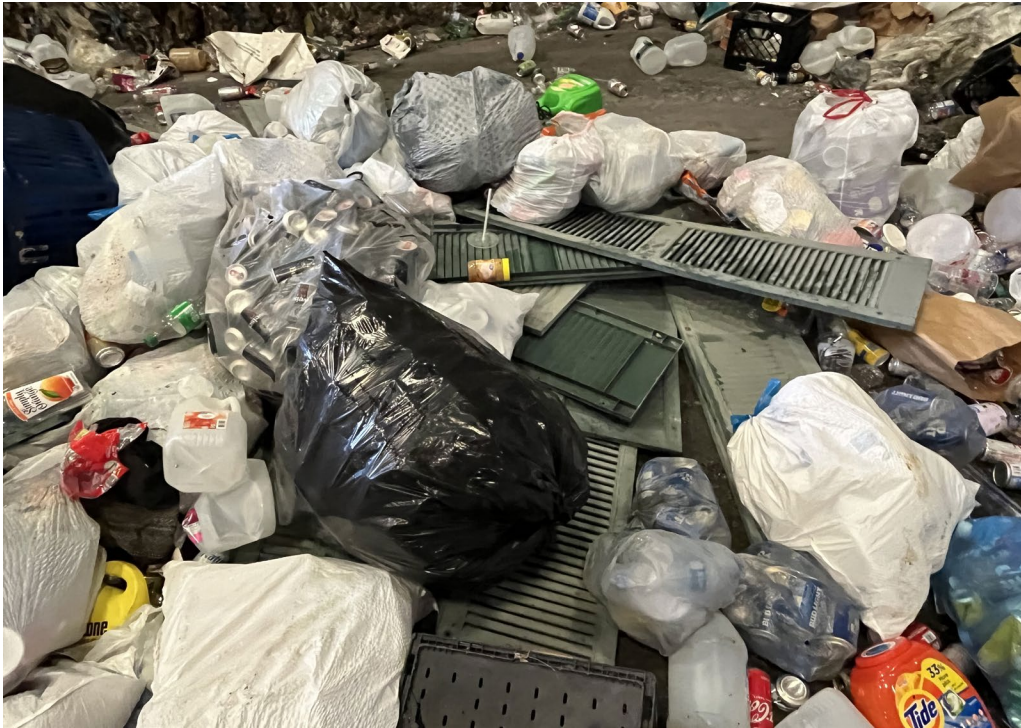
*Figure 29. Drop-Off Center Container Load 1*

Container Load 1 had significant amounts of observed contamination, primarily from bulky plastic. Additionally, many of the containers were improperly prepared by users because they were not placed in a blue bag.

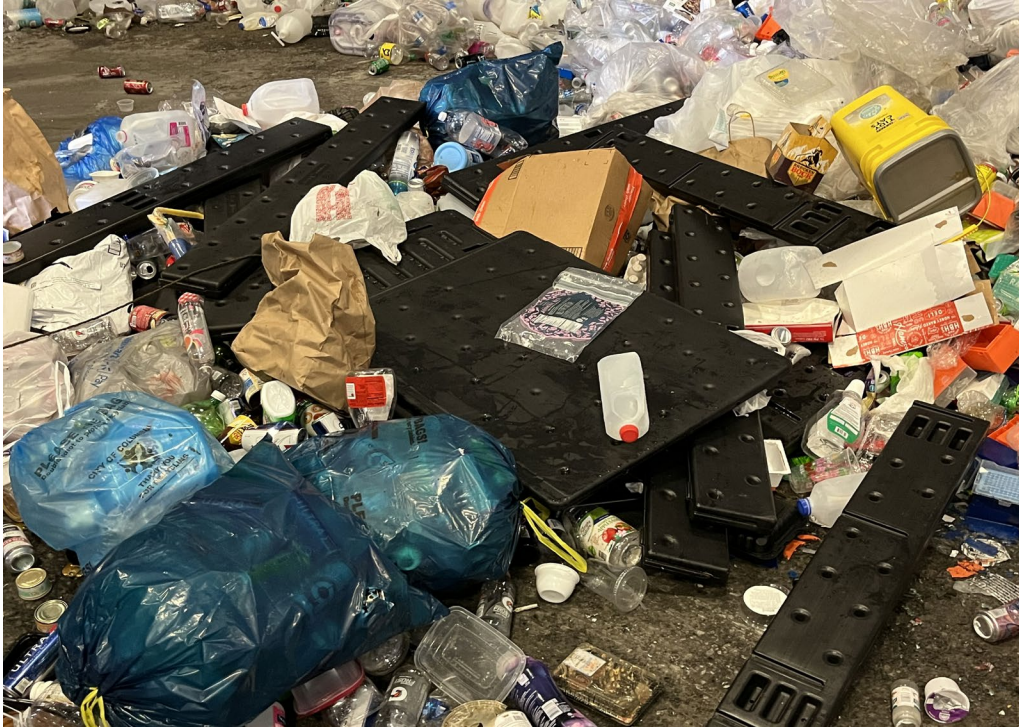
*Figure 30. Drop-Off Center Container Load 2*

Container Load 2 had significant amounts of observed contamination, primarily from bulky plastic and recyclable fiber. Most of the containers in Load 2 were properly prepared in blue bags.

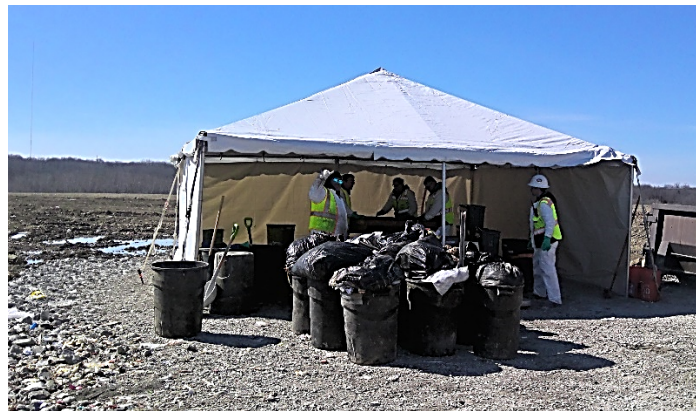
**Figure 3-2 Sorting Setup at Columbia Landfill**

Once the sample has been acquired and appropriately staged for sorting, the material was manually sorted into the prescribed component categories. Plastic 20-gallon bins, 35-gallon barrels, and 5-gallon buckets labeled with the appropriate material category to sort the sampled material. A picture of the sorting area is shown in Figure 3-2 below.
