**REPORT ON
RECYCLING AND WASTE DIVERSION PROGRAM EVALUATION
FINAL – NOVEMBER 17, 2023
SUBMITTED TO**

City of Columbia – Recycling and Waste Diversion Program Evaluation
Final Report

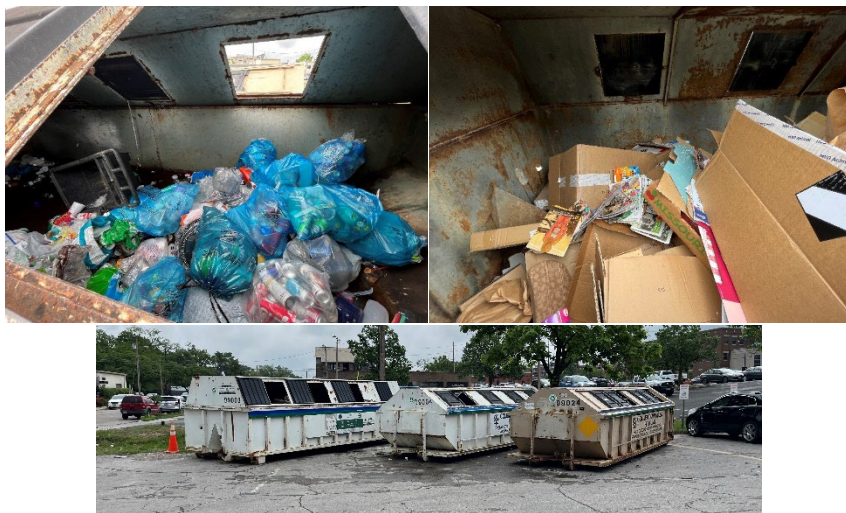
Downtown (The Armory) – Along Park Ave, between 7th and 8th Street

RRT observed this location to be busy with users. The receptacles are gable-top roll-offs for both streams. The site and the receptacles are out in the open. The receptacles were observed to be more contaminated than other sites, with bagged trash in both the container and fiber roll-offs, somewhat more so with the commingled containers. The recycling guidelines are posted directly on the roll-offs.

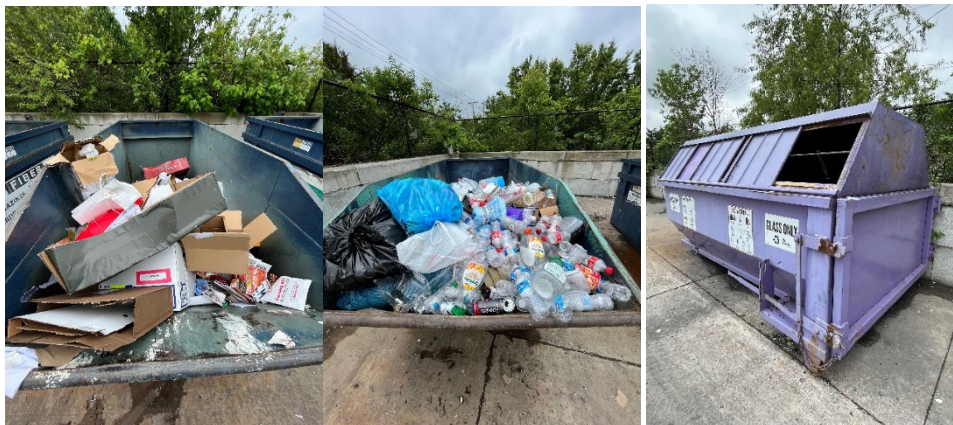
State Farm Parkway – Near Grindstone, North of E. Nifong Blvd

This site is another notably larger location. The containers are open top 8- to 12-cubic yard “dumpsters,” most without closures. This is the only drop-off center with a dedicated receptacle for glass. A City employee who happened to be on site noted this is the busiest location. The site was observed to be clean and had minimal contamination in containers and fiber dumpsters, despite the wide-open access for users, the somewhat secluded location, and being heavily screened from the street. There was minor contamination in the dumpsters from bagged trash, although much of the cardboard had Styrofoam inside of it and one of the fiber dumpsters had carpets placed inside of it.

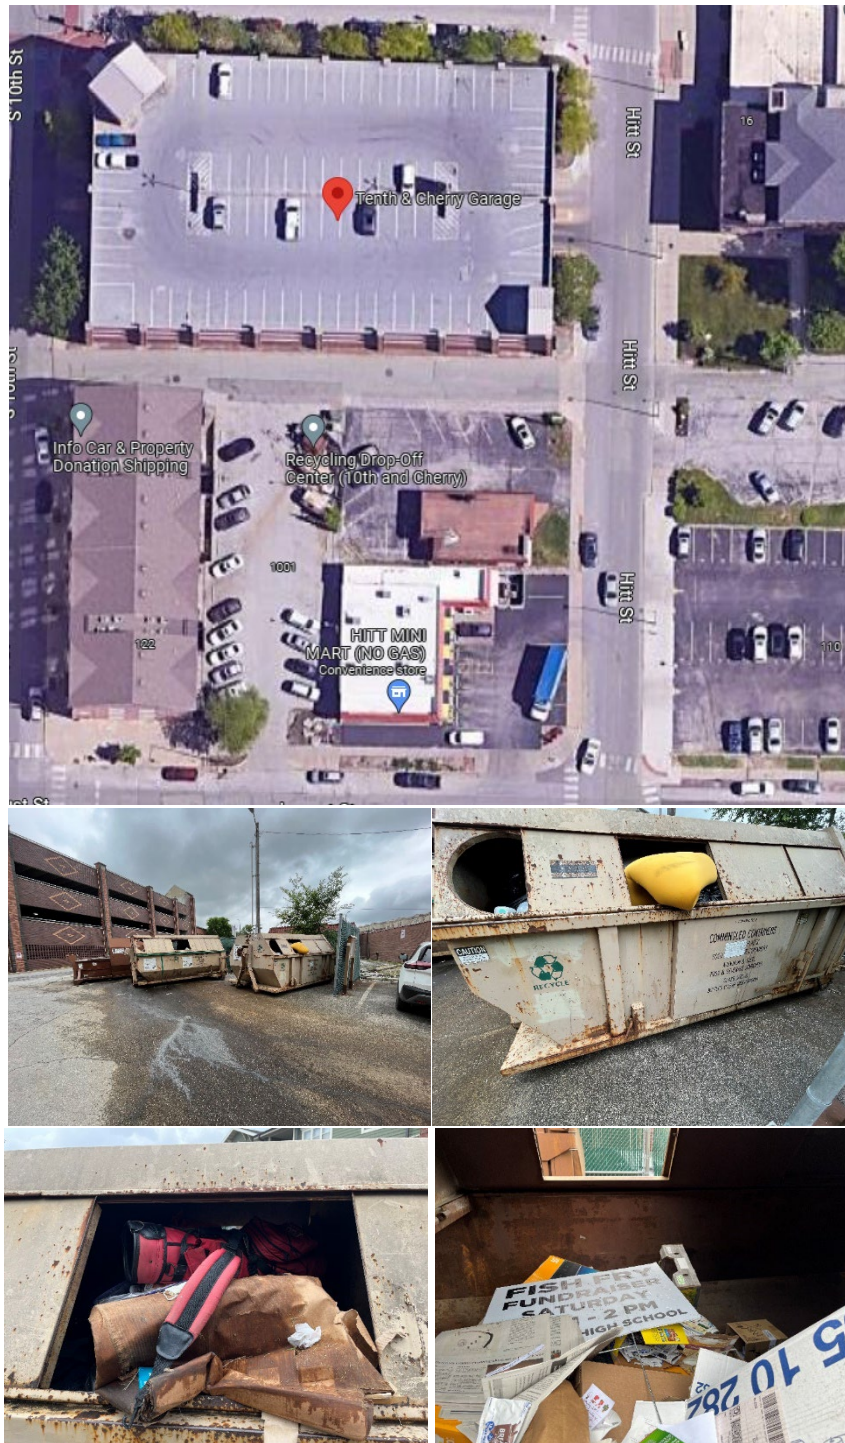
Downtown (10th and Cherry) – South Side of 10th & Cherry Parking Garage

The receptacles consist of a compactor for fiber and a gable-top roll-off for containers. Despite being in the middle of Downtown, the sightlines make it somewhat secluded because it is surrounded by an enclosure and faces a parking garage, the back sides of commercial buildings, and a small apartment building. This encourages improper dumping; the apartments may also be a source of contamination. RRT found this was the most contaminated site observed, with many dumped items forced into the openings of the roll-offs.

recommendation to close the two sites on the Mizzou campus and the site at 10th & Cherry, Downtown (See Section 2.1.2 for descriptions and pictures of the recycling drop-off centers and Section 8.1 for discussion of closing contaminated sites).

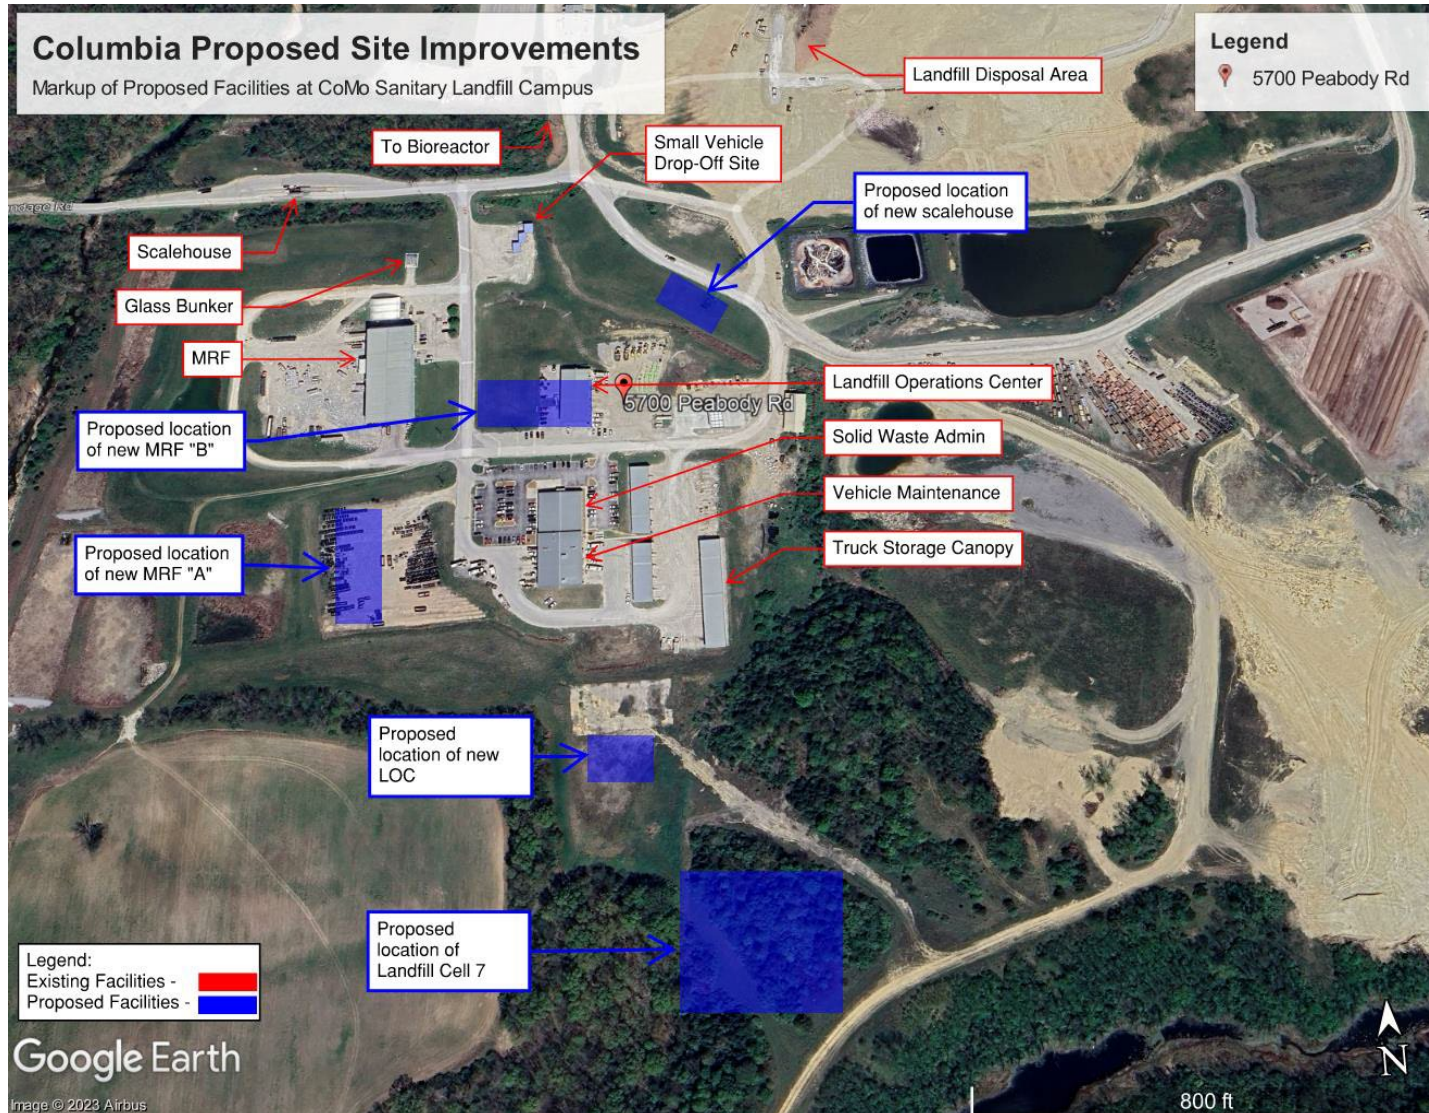
Figure 16: Aerial Photo of Columbia Landfill Property, Showing Proposed Locations for Infrastructure

The City is also planning on relocating the LOC which would free up that area for redevelopment for the new MRF. The current container repair operations would need to be accommodated elsewhere.

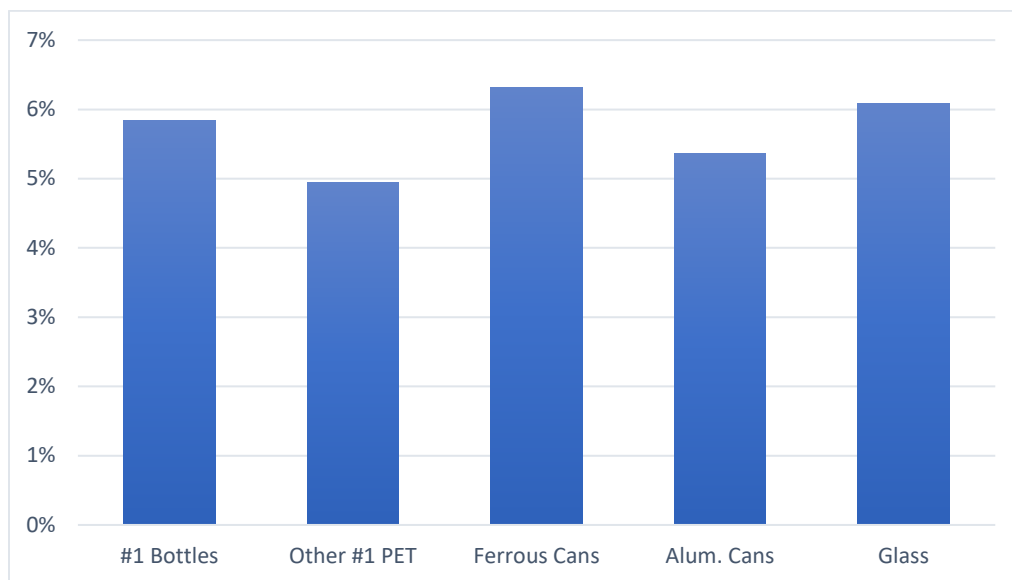
Figure 11. Container Residue 5 Most Common Recyclables

The most common recyclable materials in the container residue bunker were ferrous cans, glass, #1 PET bottle, aluminum cans, and other #1 PET. It should be noted that every commingled container program material was found in the refuse. Ferrous cans and aluminum cans are found in the container residue in a higher volume than anticipated because these materials are sorted via a belt magnet and ECS, respectively. This result could be indicative that the equipment is not performing optimally due to wear and/or age.

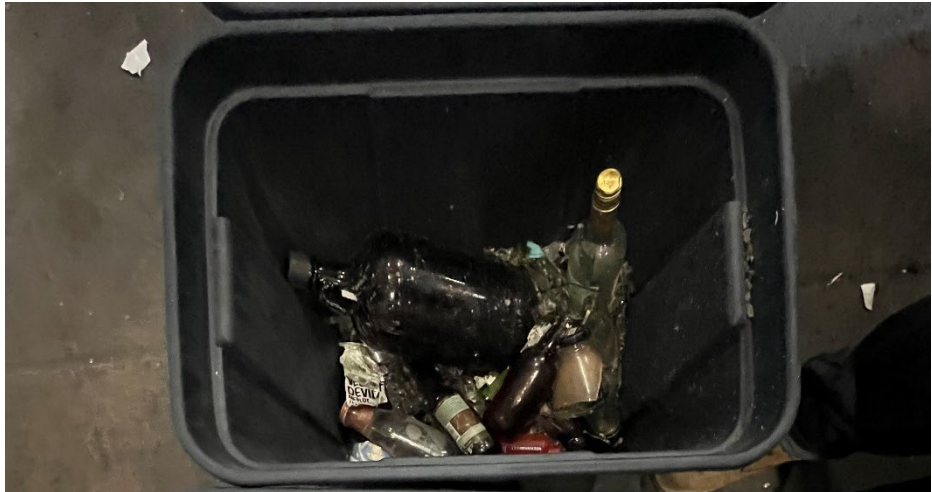
Figure 12. Glass Found in Container Residue

The amount of glass found in these samples is unexpected because glass is negatively sorted, meaning it remains on the conveyor belt. The image above was captured on a day with the largest volume of glass found in the container residue sample and depicts the type of glass found in the residue sample. Acceptable glass containers include beverage containers, food containers, and other glass containers. According to those requirements, all glass bottles in the image should be recyclable. Additionally, any glass fragments or shards should not be handled directly because it is a safety hazard for sorters.
