To: Shaun & Olga Morris, Culver's Franchise Owners
From: Julie Nolfo, PE, PTOE
Michelle Bresnahan
Date: February 23, 2021
Subject: Traffic Assessment for Proposed Culver's adjacent to Commerce Bank, Columbia, MO

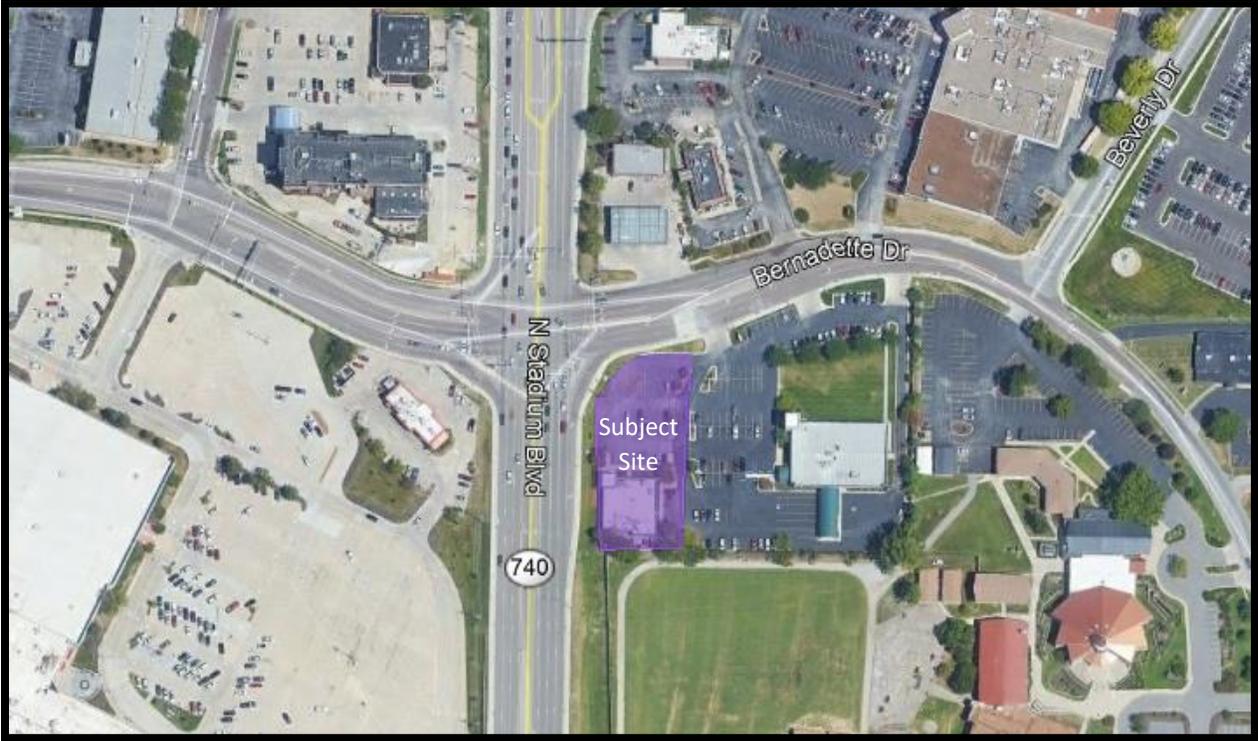
Figure 1: Subject Site – Proposed Culver's Restaurant

The current site under consideration for the proposed Culver's restaurant is immediately west of the existing Commerce Bank located in western Columbia. Both sites are along the south side of Bernadette Drive, immediately east of Stadium Boulevard. The surrounding land uses are predominantly commercial in nature (except for Our Lady of Lourdes Church and Interparish school to the east), with Columbia Mall located just west of Stadium Boulevard. **Figure 1** depicts the overall site, shown in purple, as well as the adjacent Commerce Bank.

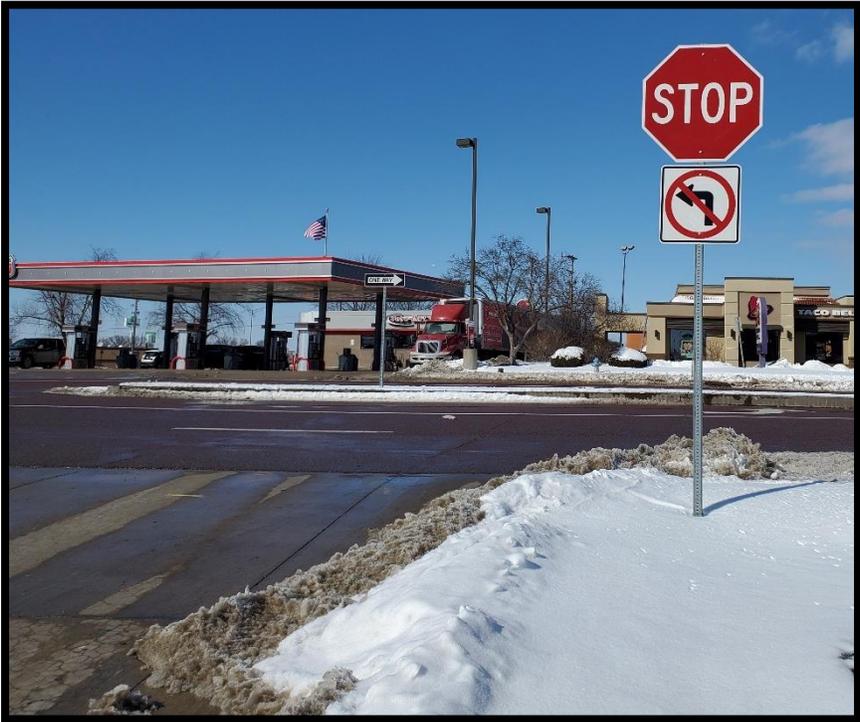
Figure 2: No Left Turn from Western Drive

The subject site does not have any direct access to either Bernadette Drive or Stadium Boulevard, as is in keeping with good access management practices. Rather, the parcel has a cross access agreement with the adjacent property owned and operated by Commerce Bank. The Commerce Bank property has three access drives onto Bernadette Drive within approximately 325 feet of frontage, each drive measuring approximately 35 feet in width. The two easternmost drives are full access, meaning motorists can turn left or right into or out of the drives. A dedicated westbound left turn lane is provided on Bernadette Drive at the middle drive. The western drive is restricted to right turns only via the presence of signage and a raised median on Bernadette Drive. **Figure 2** illustrates the existing western drive with the median on Bernadette Drive and the "NO LEFT TURN" sign upon exiting.

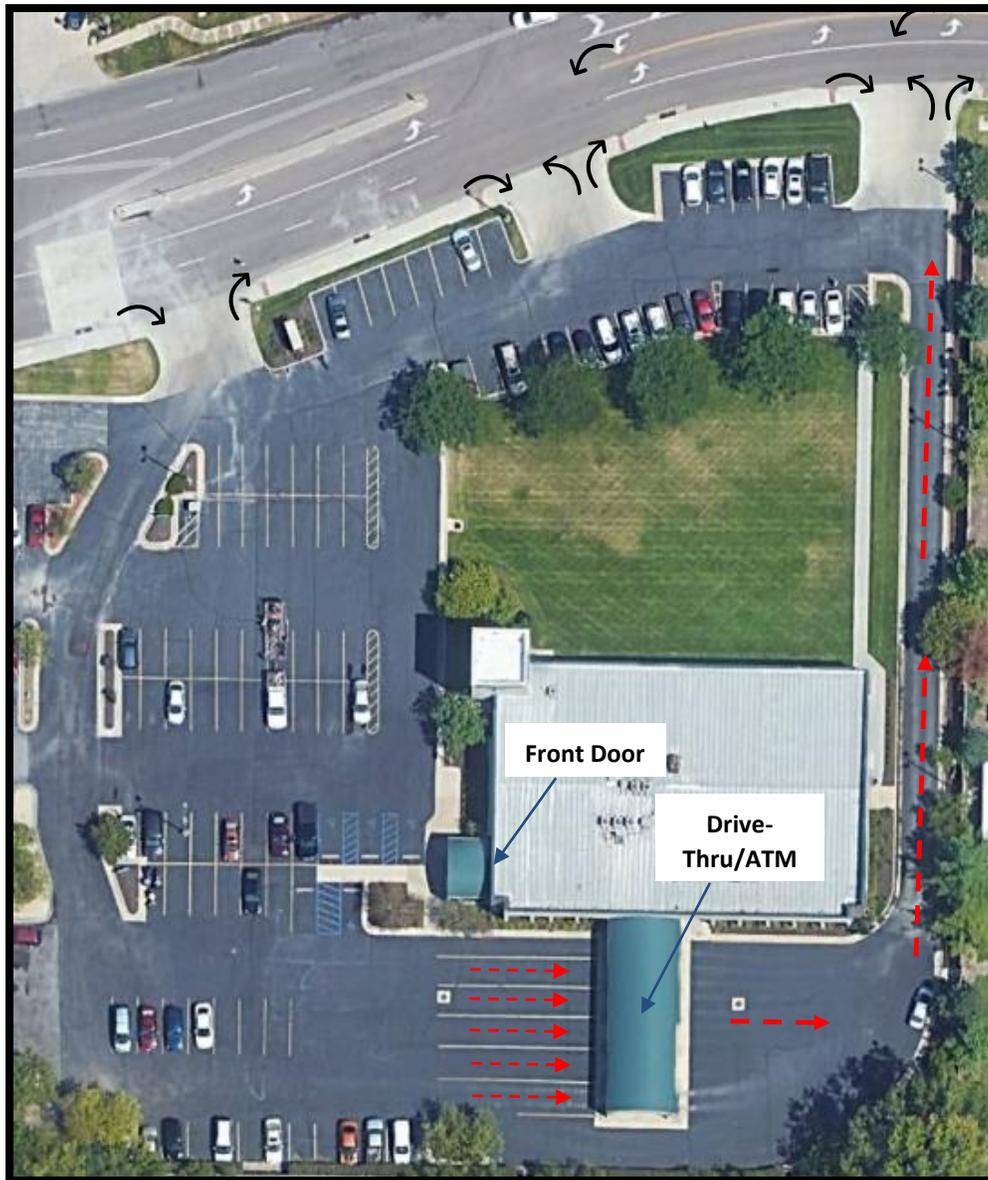
Figure 3: Commerce Bank Circulation

The Commerce Bank is situated on the site so that the front door into the building faces west and that the drive-thru teller (4 lanes) and ATM (one lane) is located along the south side of the building. There is a one-way (northbound) access drive along the east side of the building that allows for vehicles exiting the drive-thru and/or ATM to simply pull forward and exit to the left, with the drive ultimately ending at the easternmost access drive onto Bernadette Drive. **Figure 3** depicts the site's circulation.

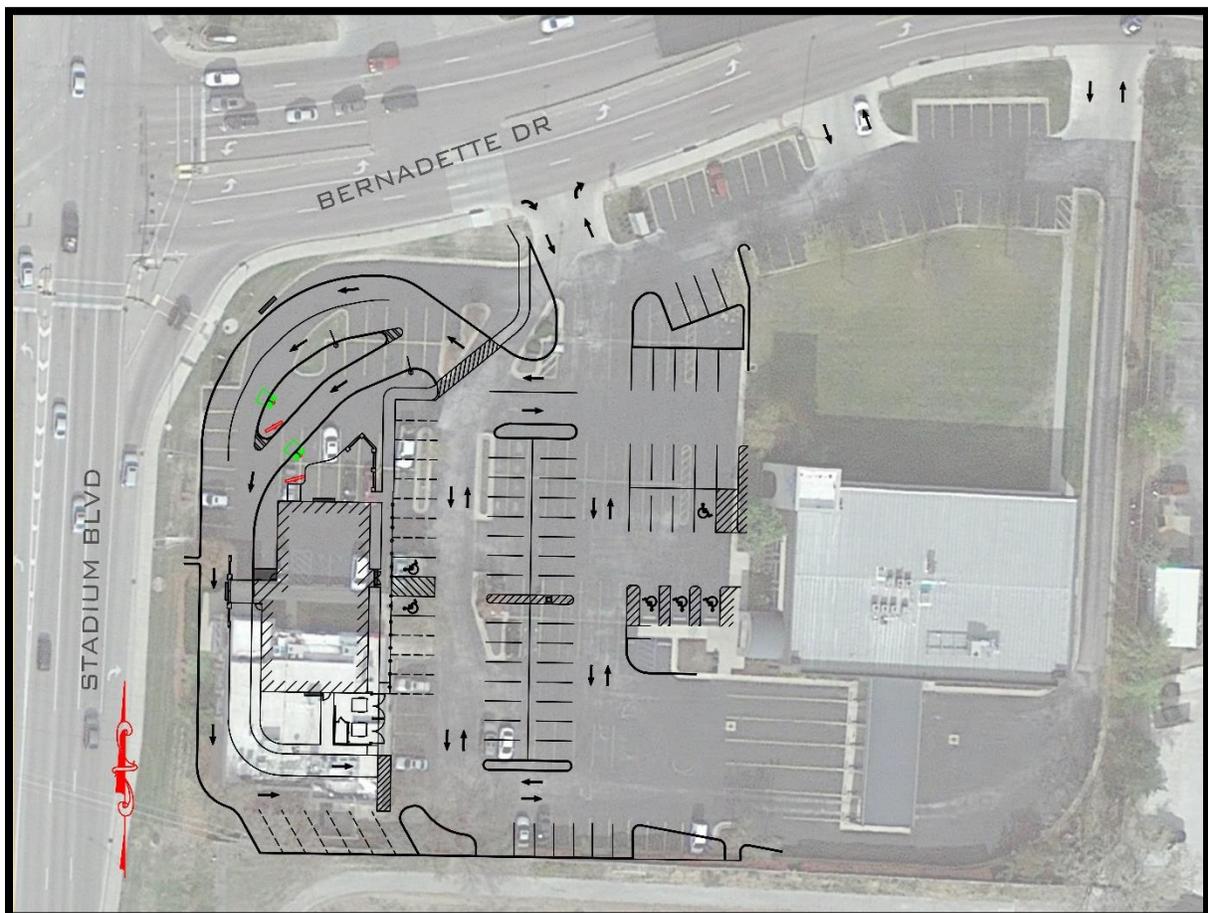
Figure 4: Proposed Culver's Restaurant & Parking Modifications

The proposed development would include a 4,100 SF quick serve restaurant with a double drive-thru with access via the existing three access drives to Bernadette Drive on the property controlled by Commerce Bank (cross access is provided). **Figure 4** illustrates the proposed Culver's restaurant. In conjunction with the development, the parking field located between Commerce Bank and the proposed Culver's would be reconfigured, as shown.

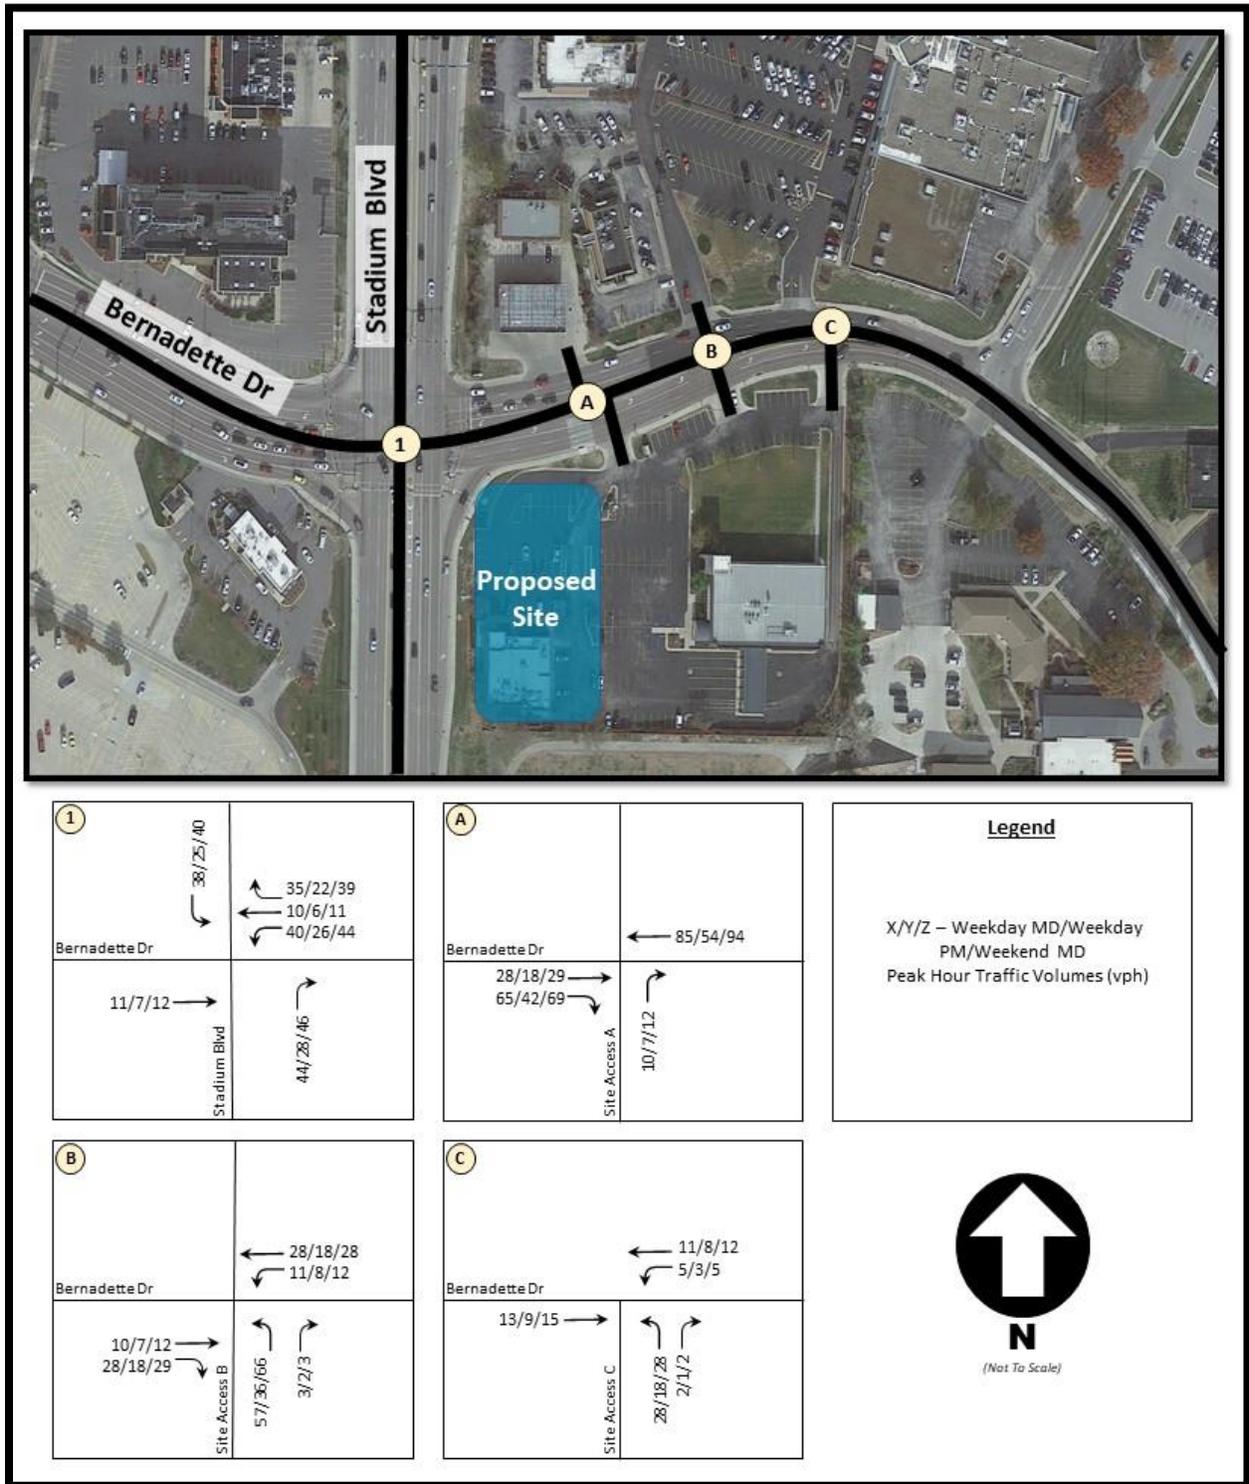
Figure 5: Proposed Culver's Restaurant Site Generated Trips

The distribution percentages above were multiplied by Culver's trip generation presented in Table 2 to obtain the site generated traffic assigned to each of the three access drives, as shown in **Figure 5**. It should be noted that in an effort to be conservative, all of Culver's traffic was assigned to the access drives rather than just the incremental increase in traffic reflected in Table 3 given Ruby Tuesday has been closed for nearly a year.

As can be seen, the proposed restaurant's traffic would distribute amongst the three existing drives. Most of the traffic originating from Stadium Boulevard or from the west would migrate to the westernmost drive, which would see an increase in turning movements of 75 additional vehicles during the weekday midday peak hour, 49 additional vehicles during the weekday PM peak hour, and 81 additional vehicles during the Saturday midday peak hour, the majority of which would be attributable to inbound trips given the left turn restriction. The middle access drive would experience the greatest increase in traffic with 99 additional vehicles during the weekday midday peak hour, 64 additional vehicles during the weekday PM peak hour, and 110 additional vehicles during the Saturday midday peak hour. The movement most impacted at this drive would be the outbound left turn, which would increase by as much as 66 additional movements during the Saturday midday peak hour. The easternmost drive would experience a nominal increase in traffic as compared to the other two drives; a total of 35 additional vehicles during the weekday midday peak hour, 22 additional vehicles during the weekday PM peak hour, and 35 additional vehicles during the Saturday midday peak hour.

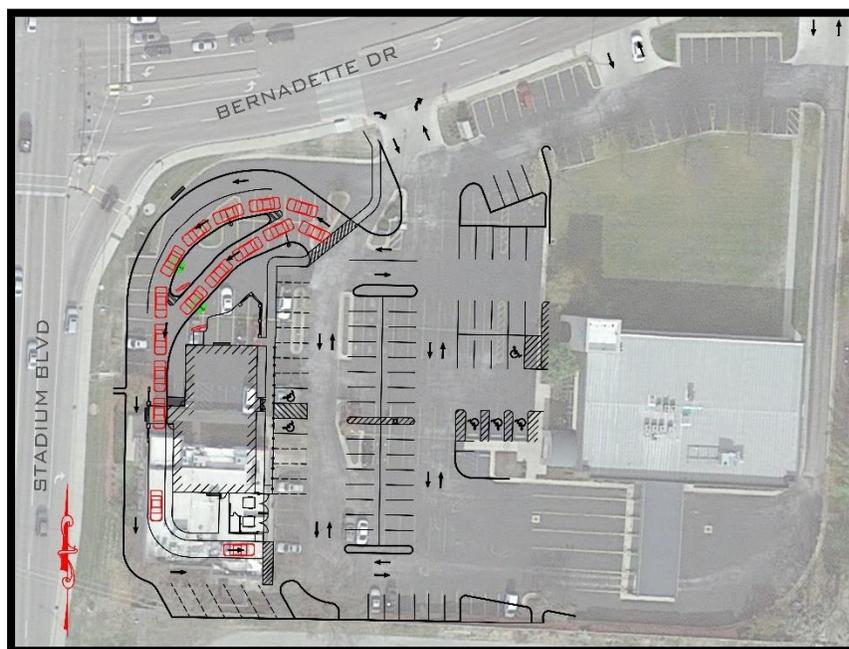
Figure 6: Culver’s Drive-thru with Ten Vehicles Queued Back from Order Board

For the purposes of reviewing the provided plan, the adjusted average queue of five vehicles and peak queue of ten vehicles back from the order board were utilized. With the current site plan, a total of approximately ten vehicles (5 per lane) can be accommodated back from the order boards before the drive-thru queue begins to extend out of the drive-thru lanes, as shown in **Figure 6**. As such, the average and peak drive-thru queue lengths would be contained within the designated drive-thru area.

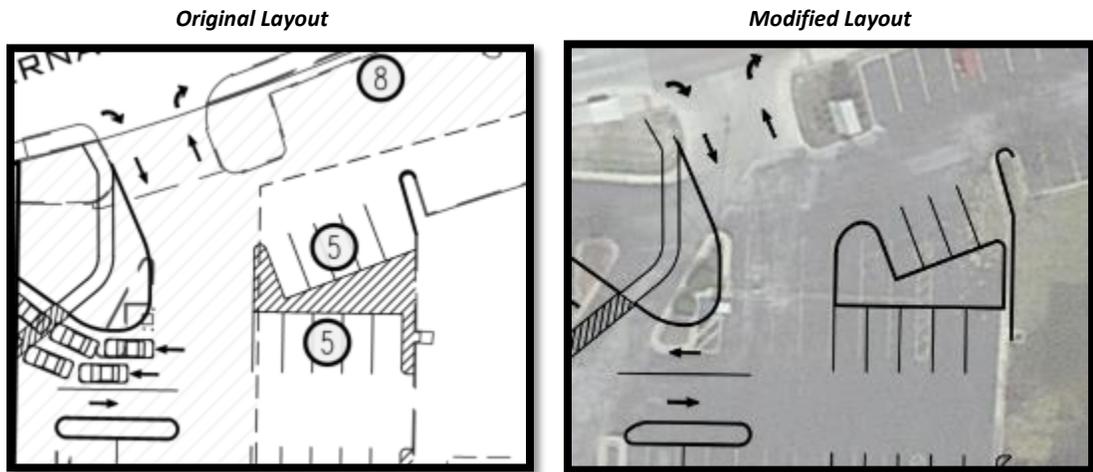
Figure 7: Modifications to the Western Access Drive and the Adjacent Internal Intersection

- Replacement of a proposed painted island adjacent to Commerce Bank with a hardscape island to better define the drive aisle and the non-aligned east/west drive aisles. This hardscape also facilitates a refuge for proposed directional signage installation. In addition, the removal of one parking space was also proposed to minimize the potential for a customer to back out into the internal intersection. The throat depth at the western drive was modified slightly in order to create better definition of the drive aisles and the entry to the Culver’s drive-thru. **Figure 7** illustrates the original and the modified layout.

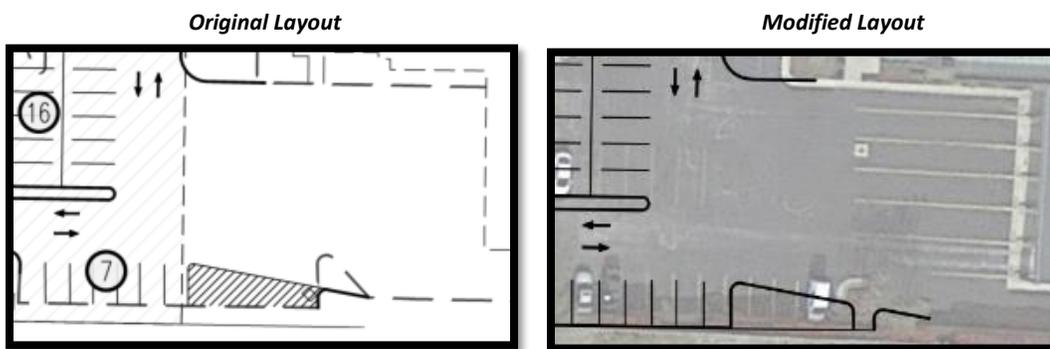
Figure 8: Modifications to Proposed Island Along South Property Line

- Replacement of a proposed painted island along the south side of Commerce Bank property with a hardscape island to better define the drive aisles and clearly define a bypass to the Commerce Bank drive-thru tellers/ATM. In addition, this hardscape allows for refuge for the proposed directional signage installation. **Figure 8** illustrates the original and the modified layout.

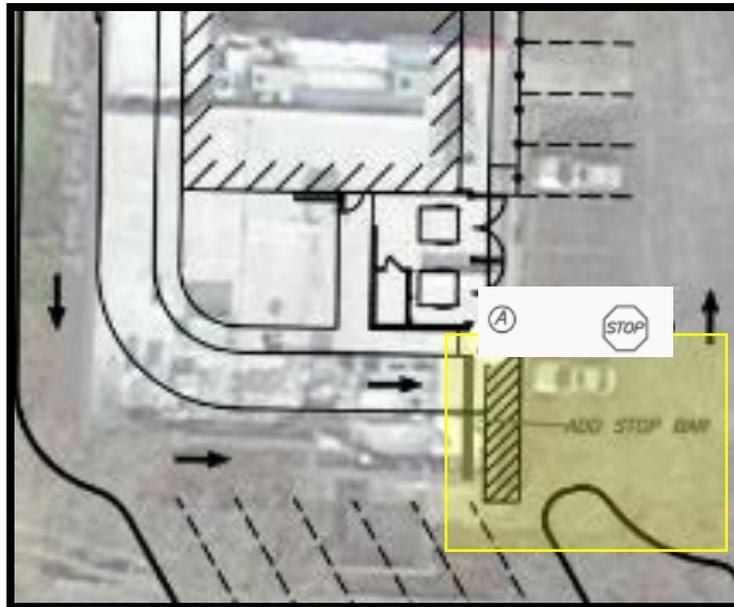
Figure 9: Proposed STOP Bar & Sign for Drive-Thru Exit

- Provide a STOP bar and sign upon exit from Culver's drive-thru, as shown in **Figure 9**.

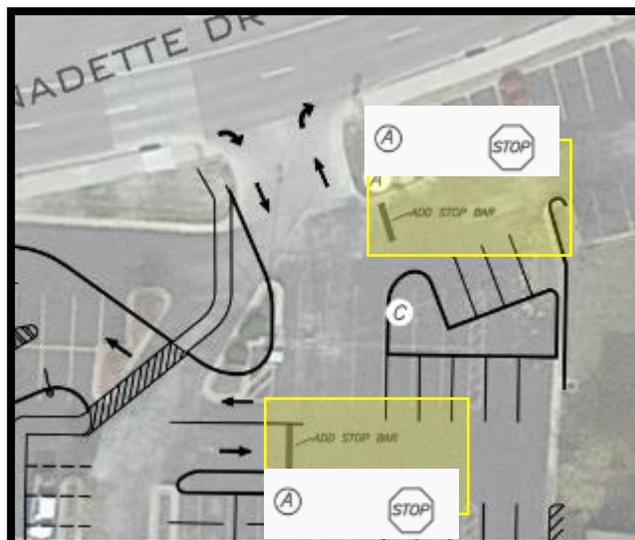
Figure 10: Proposed STOP Bar & Sign for Internal Intersection between Culver's and Commerce Bank

- At the internal intersection adjacent to the western access drive to the site, STOP bars and signs should be installed on the east and west approaches to reinforce that north/south traffic in the drive aisle or entering from the western drive has the right-of-way. **Figure 10** illustrates the proposed installation.

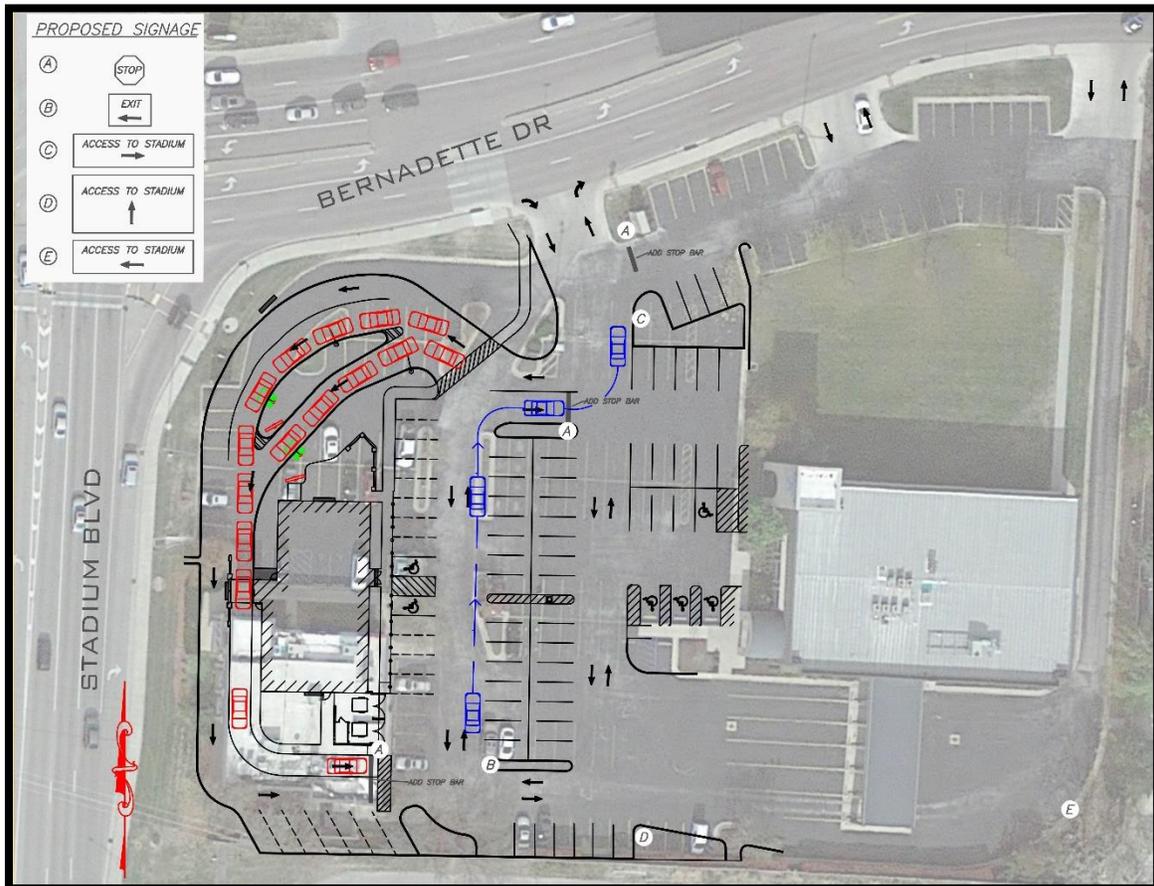
Figure 11: Proposed Directional Signage for the Primary Route from Culver's Restaurant

The primary means of egress for Culver's customers, including those exiting the drive-thru, should be via the north/south drive aisle adjacent to the restaurant. Furthermore, every effort should be made to discourage Culver's traffic from utilizing the drive aisle adjacent to Commerce Bank's front door. Therefore, an EXIT sign (identified as (B)) is recommended to direct a customer to turn left upon departing the drive-thru, as shown in **Figure 11**. These motorists would then proceed to the internal intersection, where they would then need to make a left onto the main drive aisle. Given that the western drive does not provide access back to Stadium Boulevard, an additional directional sign (identified as (C)) is needed within the hardscape island to direct all motorists (Culver's and Commerce Bank's) to turn right towards the other two full access drives, both of which will allow customers to exit left towards Stadium Boulevard.

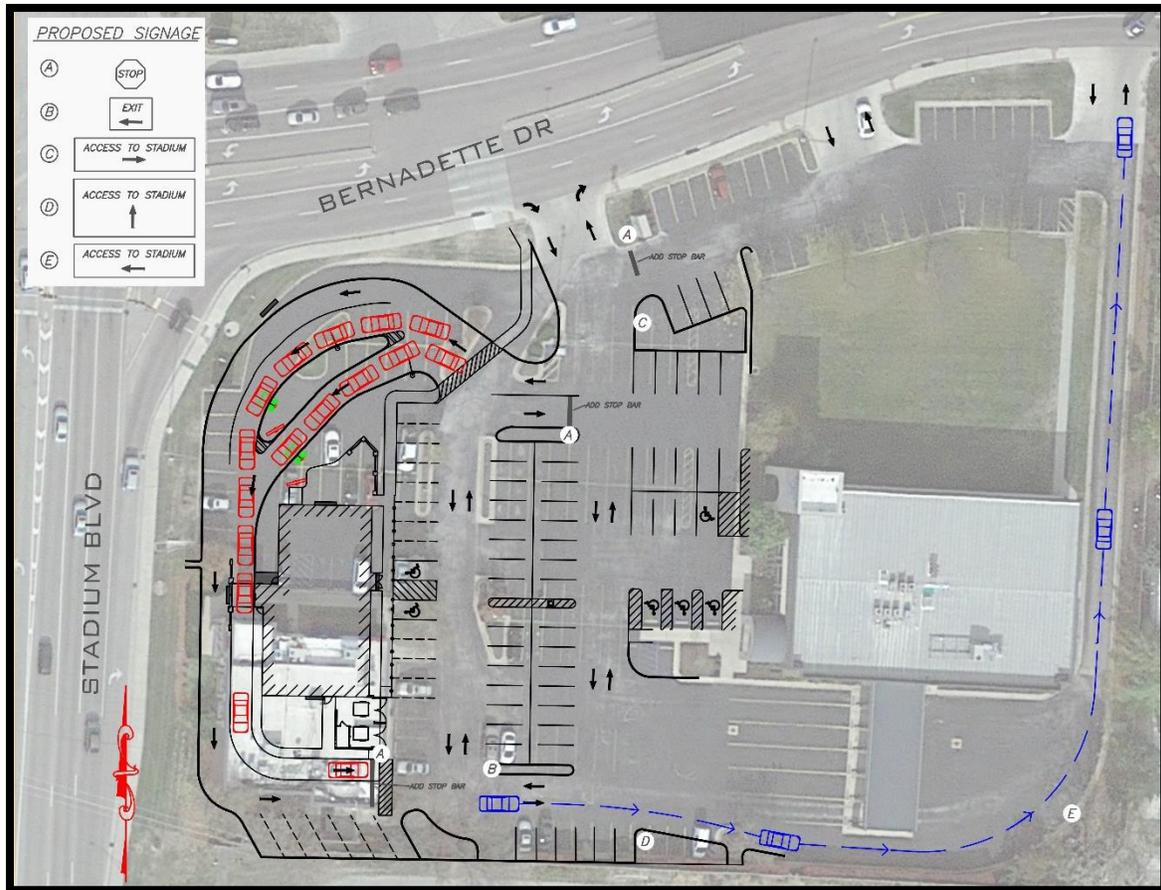
Figure 12: Proposed Directional Signage for the Secondary Route from Culver's Restaurant

southern perimeter of the Commerce Bank site to ensure any deviant motorists exiting Culver's drive-thru in this manner would be directed around Commerce Bank's drive-thru teller/ATM and towards the one-way northbound lane along the east side of the bank building, as shown in **Figure 12**. Specifically, two directional signs (identified as **D** and **E**) would be installed in the proposed hardscape island and within the landscaped area along the curve in the southeast portion of the bank site. It is suspected that that route may also be attractive to those Culver's drive-thru customers who are familiar with the bank and how to exit the existing tellers/ATM area.
