Fairview and Rollins Speed Study

To collect and record speed data within the mini roundabout at Fairview Road and Rollins Road.

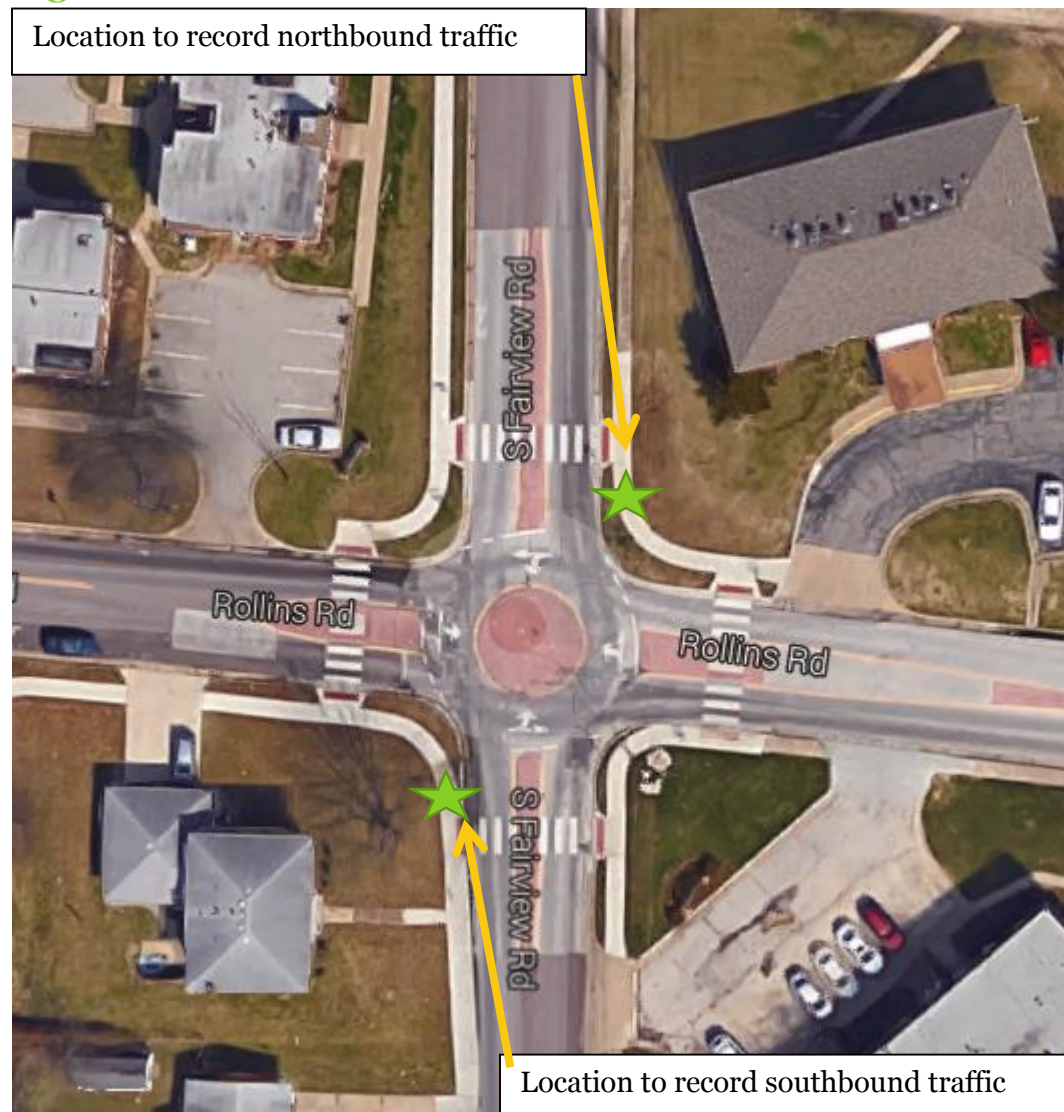
Figure 1

Using a radar unit to record speeds of vehicles within the mini roundabout at Fairview Road and Rollins Road. To obtain accurate speed data the recording location was near the downstream crosswalk to obtain a clear parallel view of the approaching vehicles (see figure 1). Speeds were recorded from 2:55 p.m. to 3:42 p.m., these times coincide with dismissal of Fairview elementary school which occurs at 3:20 p.m.
