Department Source: Cultural Affairs

Council Meeting Date: June 6, 2022

Re: "Look Out Point" sculpture in Stephens Lake Park decommissioning

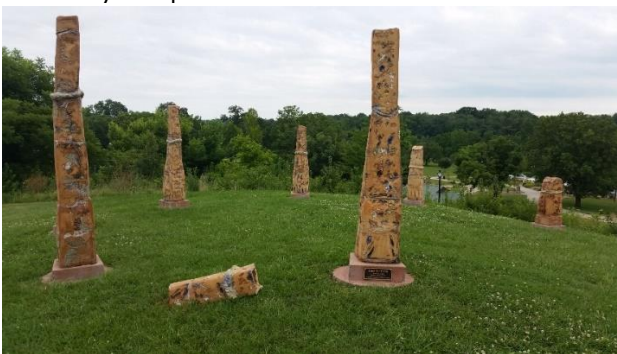
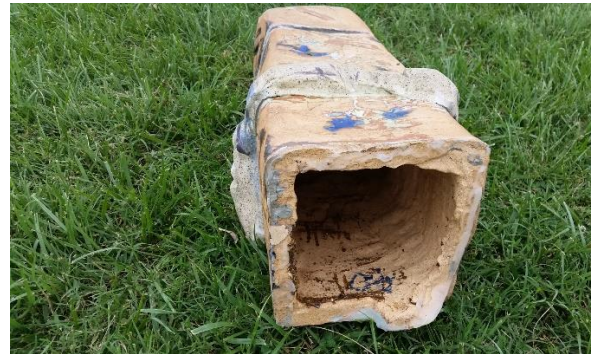
In 2015, the tallest column was damaged with the top section detaching, weighing approximately 50 pounds.

Russell-Marti Conservation Services repaired the sculpture in 2016. The following steps were taken to repair the tallest column (column 12):

- Removed caulk from previous repairs.
- Excavated holes (3 ½ inches in depth by 1-inch diameter) in the pea gravel at each corner of column cross-section.
- Mounted All Thread stainless steel rods (6 inches in length by ¼-inch diameter) in the corners of upper loose portion with 3 inches of rod extending outward from portion's edge.
- Filled the drilled 1-inch diameter holes in pea gravel with Sika anchoring epoxy and after aligning rods, secured the upper portion in place.
- After Sika anchoring epoxy was cured, a clear silicone was applied in the remaining open joint to complete the seal.

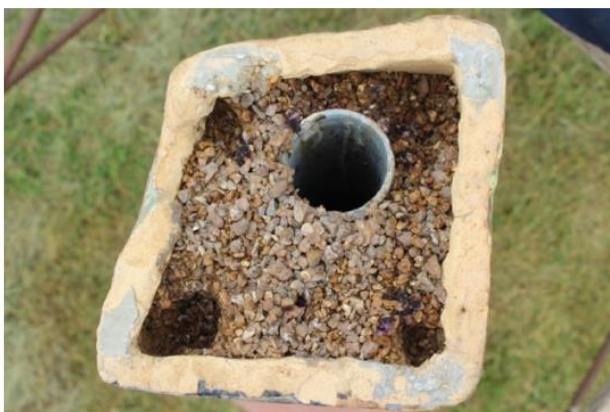
*Example of repairs in progress for column 12*

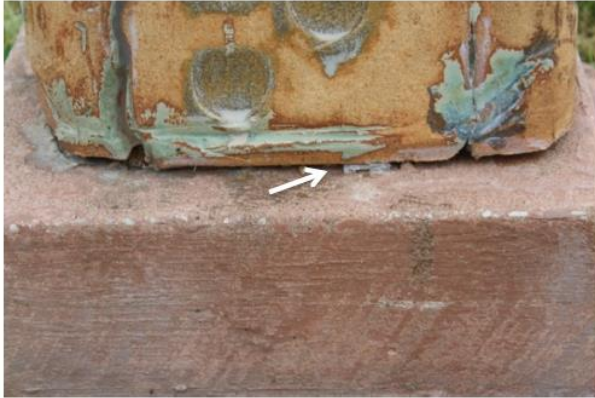
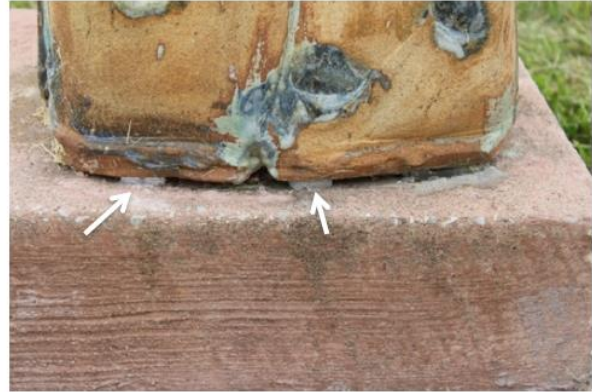
*Spacers on column 10 to prevent wobbling*

- In addition to the repair to the tallest column, tapered spacers were pinched between the bottom edge and the concrete pedestal on all four sides of column 10 to secure it.

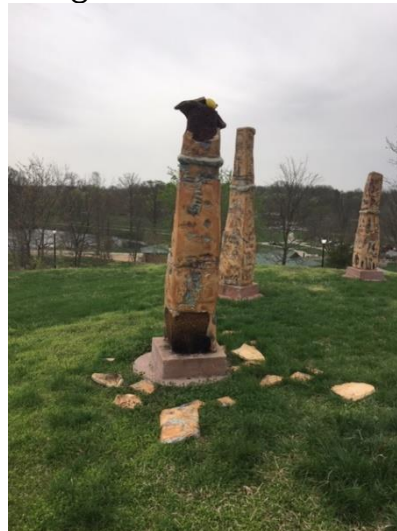
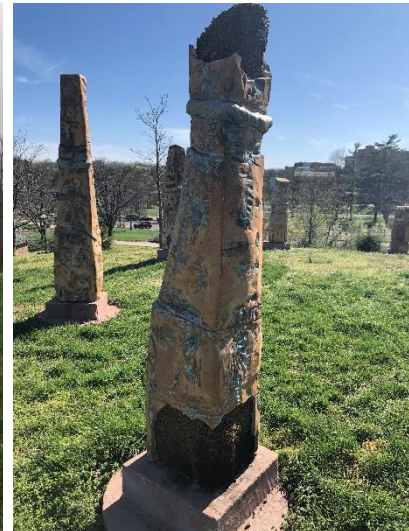
In 2019, the sculpture sustained damage and additional vandalism. Column 12 (tallest column) was once again broken, with the top section detaching but not completely falling off of the pedestal. Column 11 (second tallest) appeared to have been vandalized with many of the ceramic pieces shattering.

*Column 12 (far left) and Column 11 (middle, far right) damage*

Creative Sculpture and Restoration, Inc. repaired the columns. They used the salvaged ceramic pieces to reconstruct Column 11, and had to recreate many ceramic sections to fill in the gaps when rebuilding. The conservators had the unique challenge of best matching the original design and glazing colors.
