# City of Columbia

Department Source: Cultural Affairs

Re: "Look Out Point" sculpture in Stephens Lake Park decommissioning

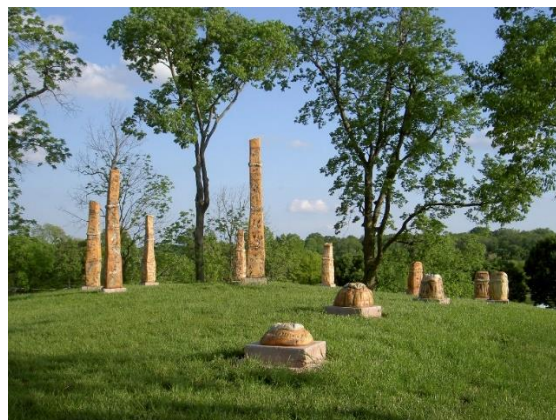
The sculpture "Look Out Point" by artist Carol Fleming Marks was commissioned as a Percent for Art project in Stephens Lake Park and installed in 2005. The artwork is a site-specific installation of twelve hollow ceramic columns ranging in height from one to nine feet. The columns are mounted on individual concrete footings, arranged in an open spiral that progresses from the shortest to tallest column. Each column is hand-built of several fired ceramic sections, one to two or more feet in height, that are joined together after firing. Some areas of the column surfaces are glazed while others are not, creating visually interesting and varied surfaces.

Upon installation in 2005, six of the twelve columns required repairs due to various components being loose. The artist made initial repairs to these columns and extended her warranty to three years after installation to handle any issues that would arise in that time. Parks and Recreation and Office of Cultural Affairs staff have regularly checked the columns to ensure they remain sturdy and secure.

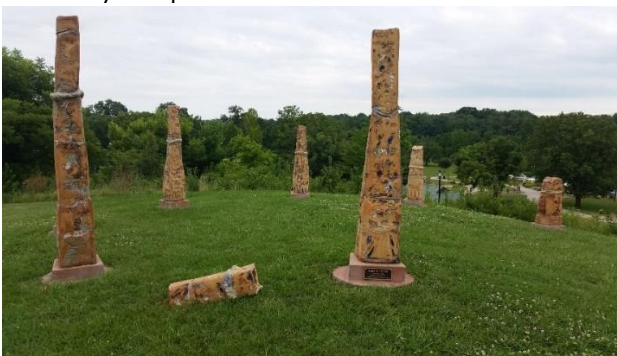
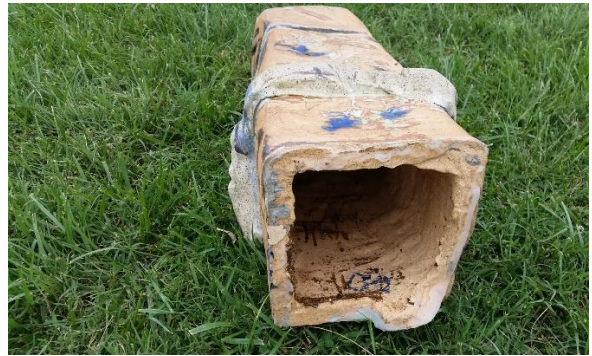
In 2015, the tallest column was damaged with the top section detaching, weighing approximately 50 pounds.

Russell-Marti Conservation Services repaired the sculpture in 2016. The following steps were taken to repair the tallest column (column 12):

- Removed caulk from previous repairs.
- Excavated holes (3 ½ inches in depth by 1-inch diameter) in the pea gravel at each corner of column cross-section.
- Mounted All Thread stainless steel rods (6 inches in length by ¼-inch diameter) in the corners of upper loose portion with 3 inches of rod extending outward from portion's edge.
- Filled the drilled 1-inch diameter holes in pea gravel with Sika anchoring epoxy and after aligning rods, secured the upper portion in place.
- After Sika anchoring epoxy was cured, a clear silicone was applied in the remaining open joint to complete the seal.

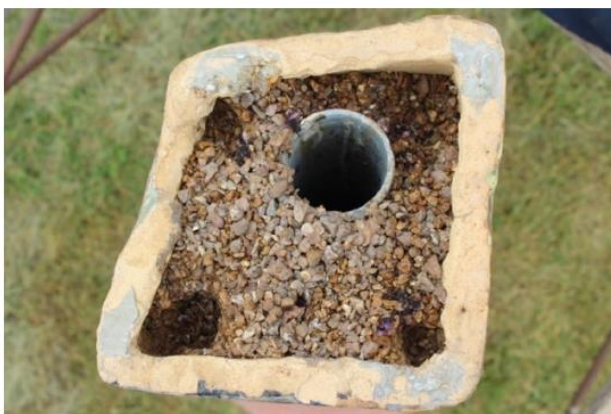
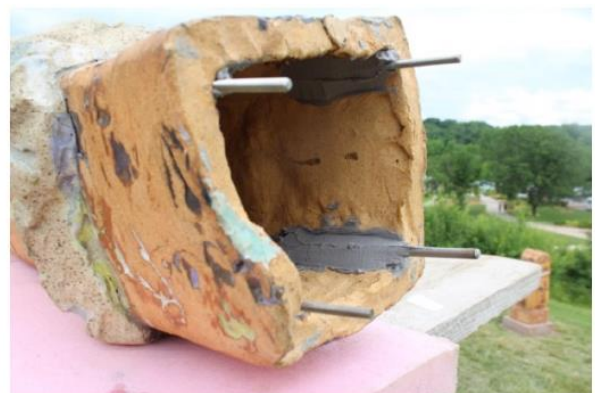
*Example of repairs in progress for column 12*

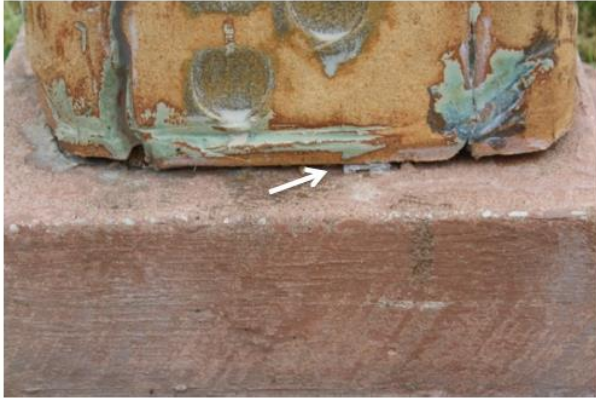
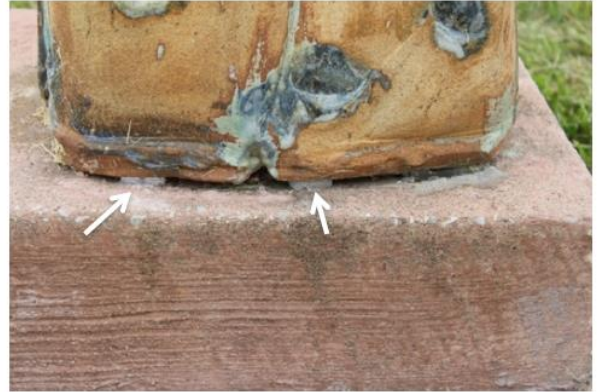
*Spacers on column 10 to prevent wobbling*

- In addition to the repair to the tallest column, tapered spacers were pinched between the bottom edge and the concrete pedestal on all four sides of column 10 to secure it.

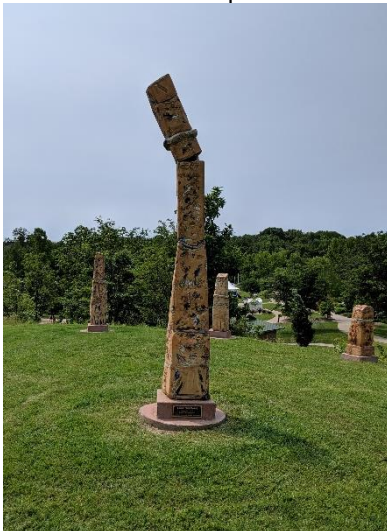
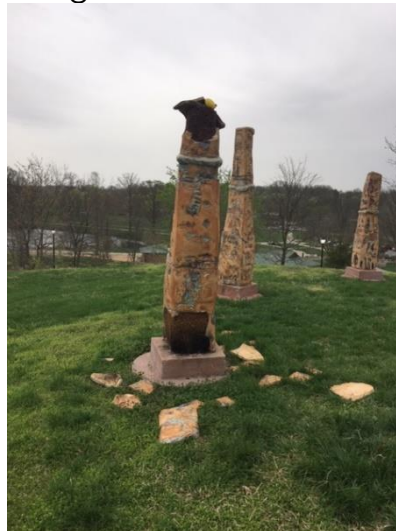
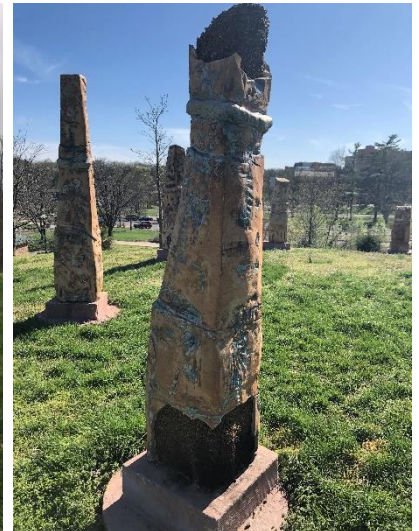
In 2019, the sculpture sustained damage and additional vandalism. Column 12 (tallest column) was once again broken, with the top section detaching but not completely falling off of the pedestal. Column 11 (second tallest) appeared to have been vandalized with many of the ceramic pieces shattering.

*Column 12 (far left) and Column 11 (middle, far right) damage*

Creative Sculpture and Restoration, Inc. repaired the columns. They used the salvaged ceramic pieces to reconstruct Column 11, and had to recreate many ceramic sections to fill in the gaps when rebuilding. The conservators had the unique challenge of best matching the original design and glazing colors.

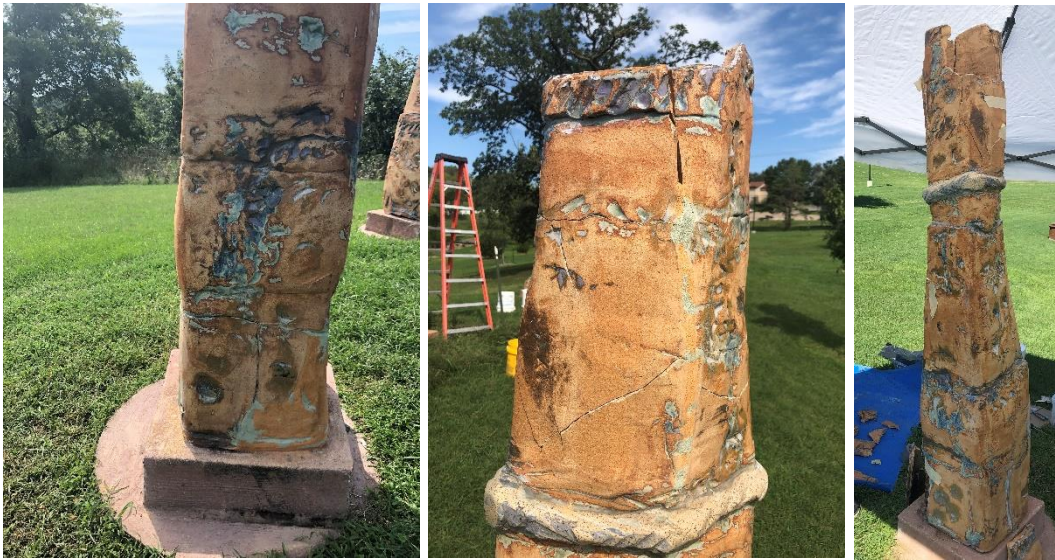
*Column 11 repairs in progress*

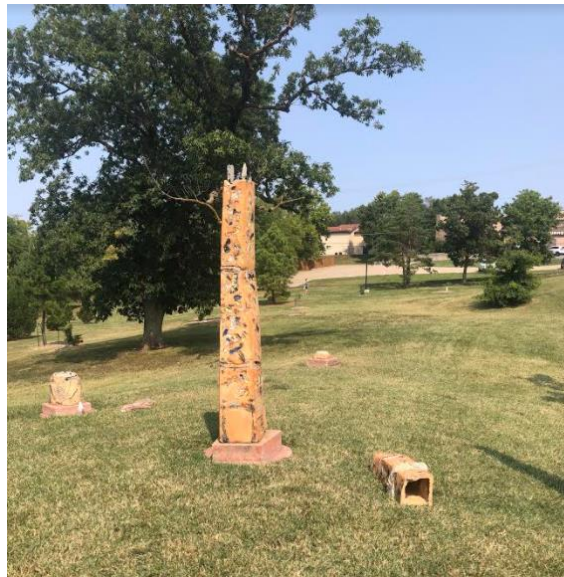
In 2021 while preparing to do some maintenance on the sculpture (filling in new cracks with clear silicone), the hired contractor encountered the tallest column once again damaged with the top section detached.

Currently, the tallest column has had a tarp covering the hole and the top section is in storage while City staff has evaluated the best approach to handling this most recent damage.
